STAFF REPORT: 12/16/2020 MEETING

APPLICATION NUMBER: #20-6988

ADDRESS: 701 W. CANFIELD

SCOPE: REPLACE EXISTING VINYL AND WOOD WINDOWS WITH ALUMINUM CLAD WOOD WINDOWS

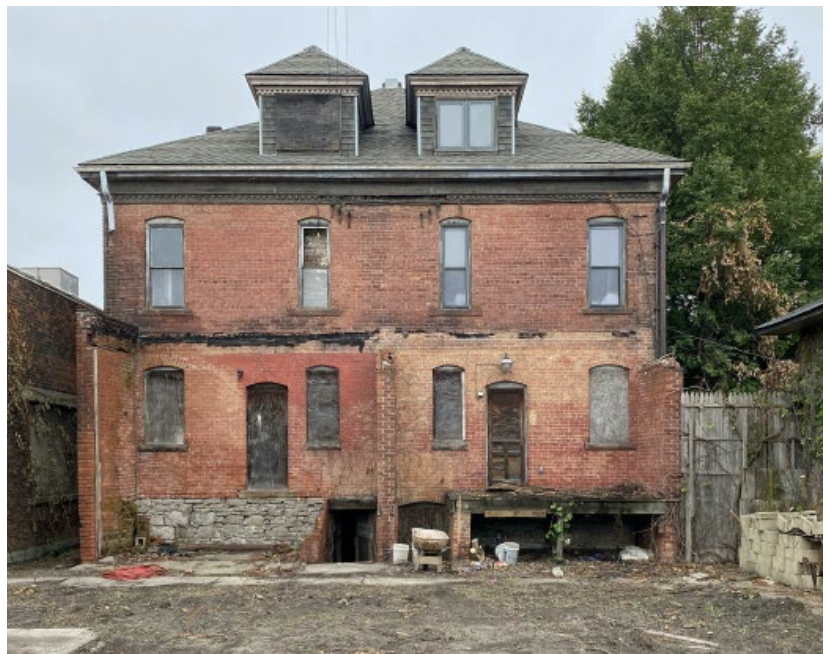
Site Photo 2 by Applicant: Existing Conditions Rear Elevation. Date unknown

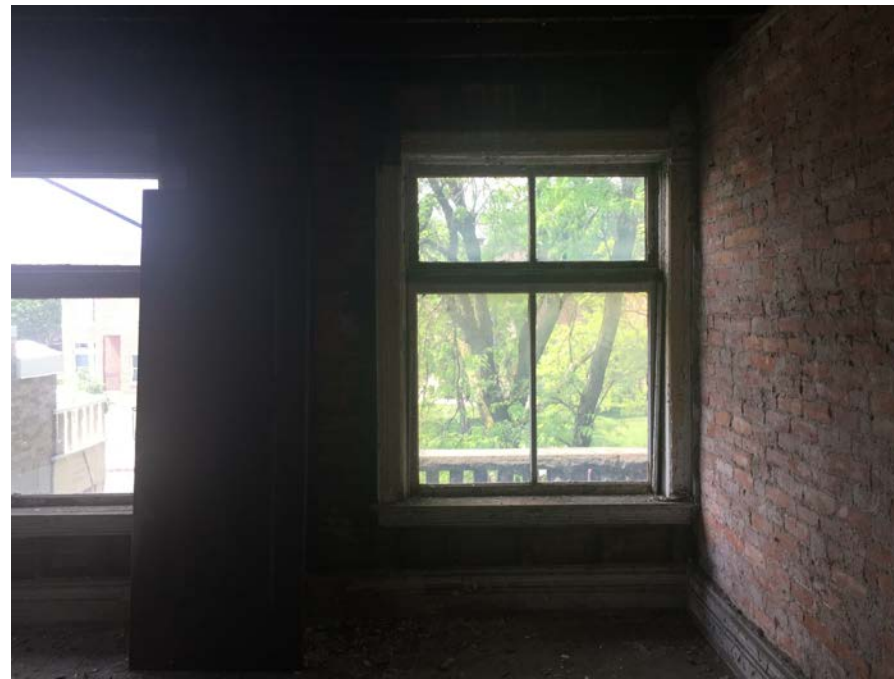
2. EXISTING WINDOW TYPE 2A (WEST)

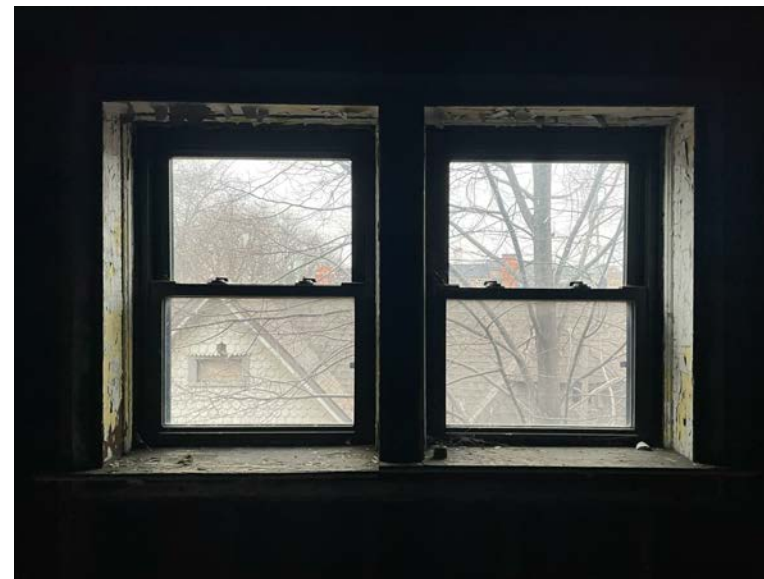
1 WINDOW TYPE 3C

EXISTING WINDOW 2F:
EAST: VINYL DOUBLE-HUNG
WEST: WOOD DOUBLE-HUNG

WINDOW 3C - EAST (INTERIOR)
(2) VINYL DOUBLE-HUNG

WINDOW 3C - WEST
(2) WOOD DOUBLE-HUNG

PROPOSED WINDOW:
MARVIN CLAD ULTIMATE DBL-HUNG G2
