**STAFF REPORT: FEBURARY 17, 2021 MEETING**

**APPLICATION NUMBER: 21-7091**

**ADDRESS: 19365 WARRINGTON**

**SCOPE OF WORK: REPLACE STEEL CASEMENT WINDOWS AS PROPOSED**

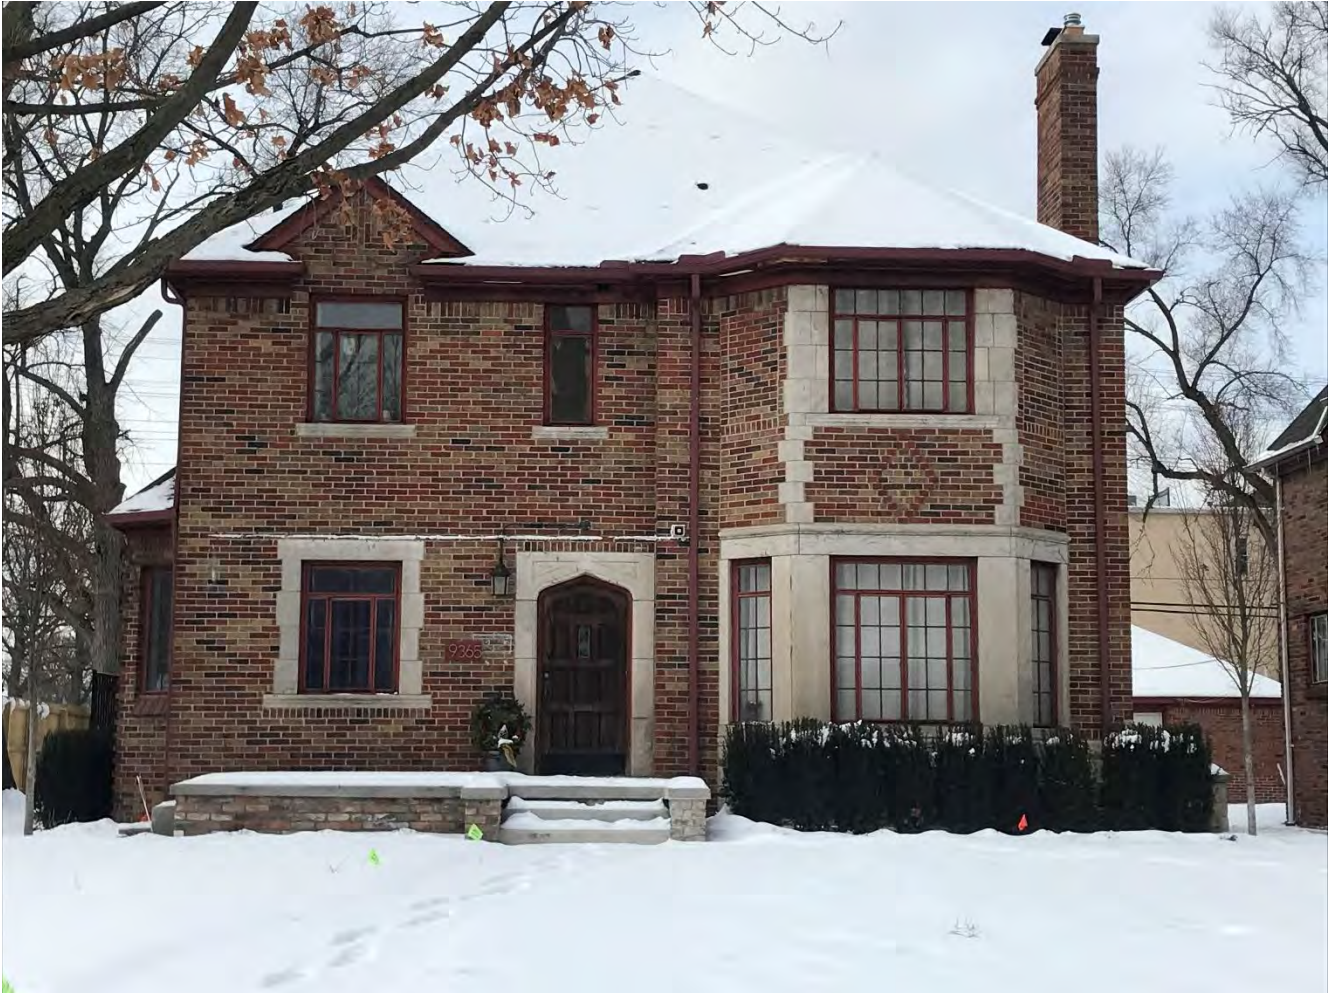
*19365 Warrington, Front (East) elevation, staff photo.*

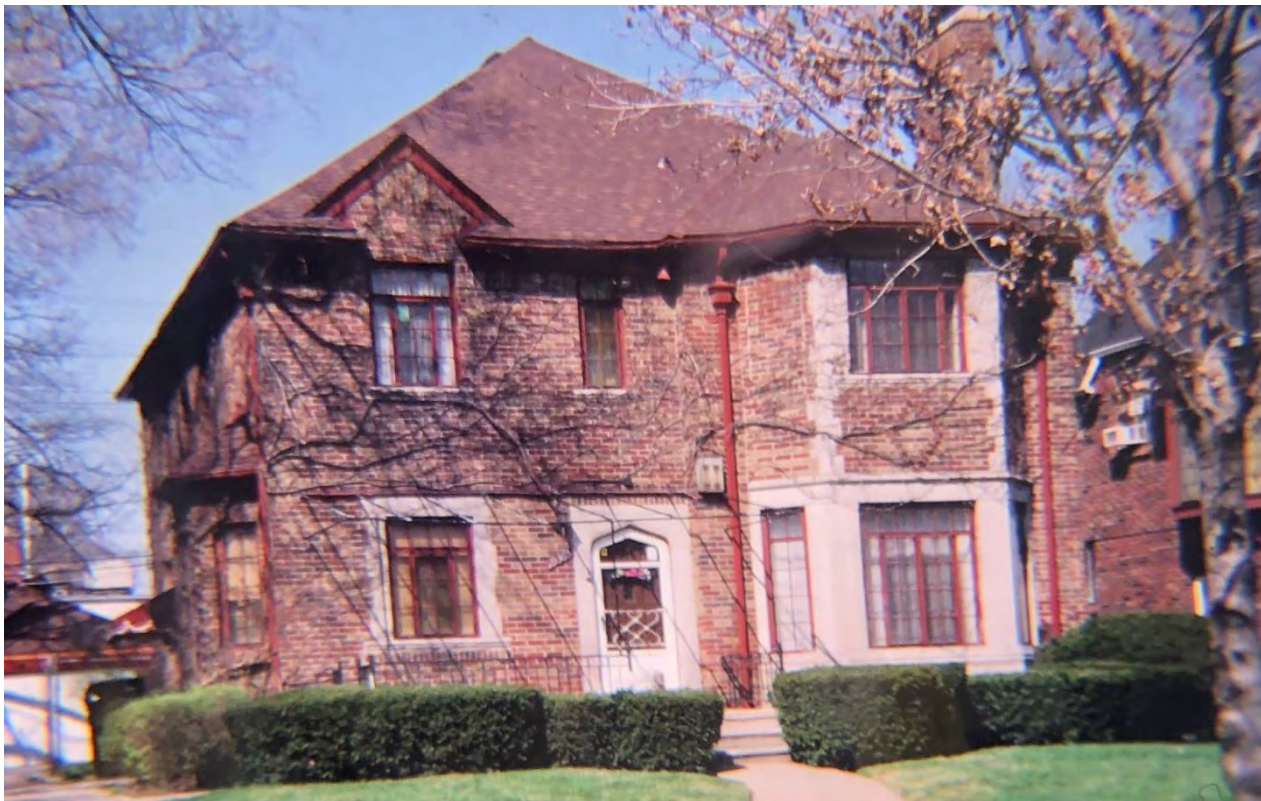
*19365 Warrington 2002 HDC designation photo.*

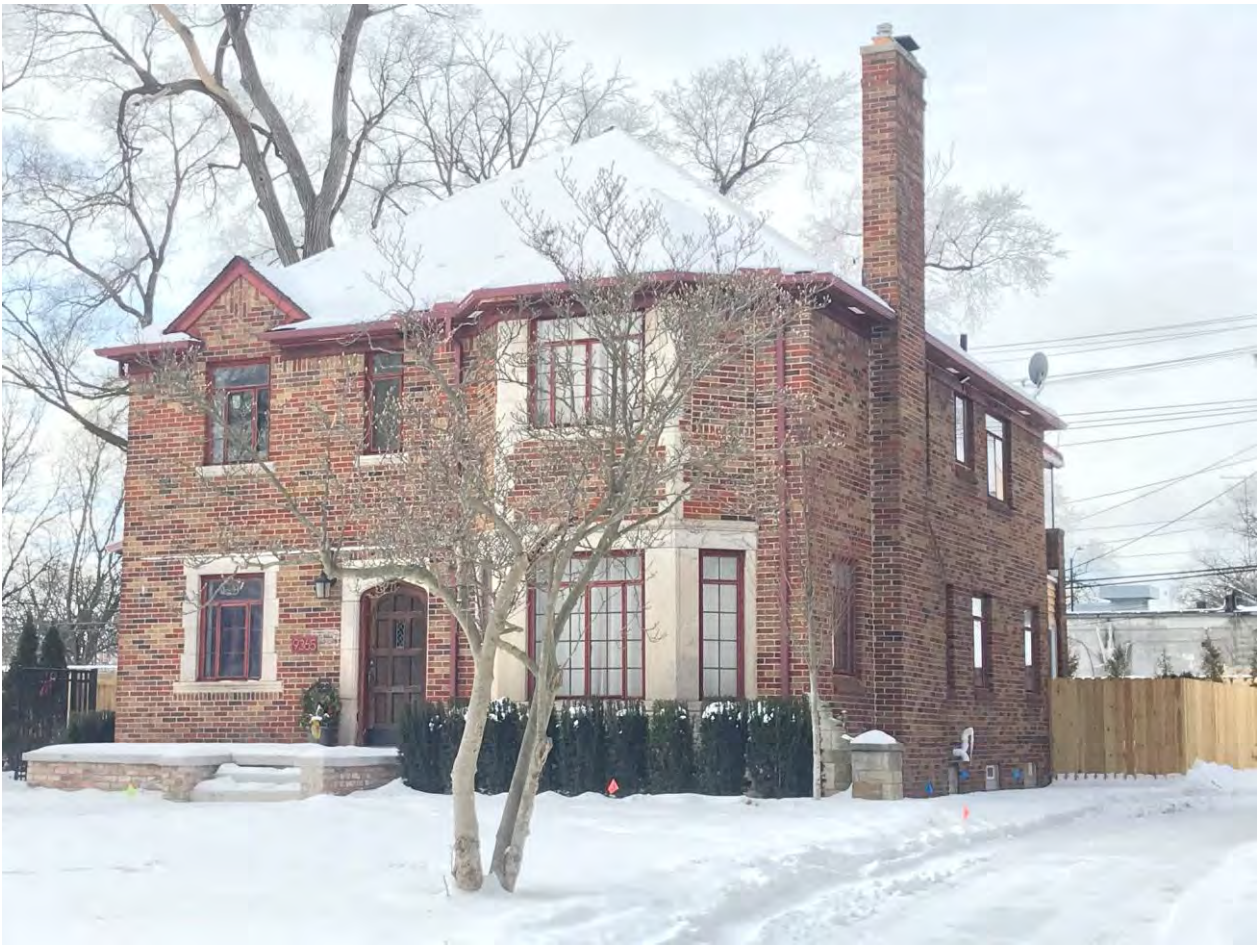
*19365 Warrington, southeast view, staff photo.*

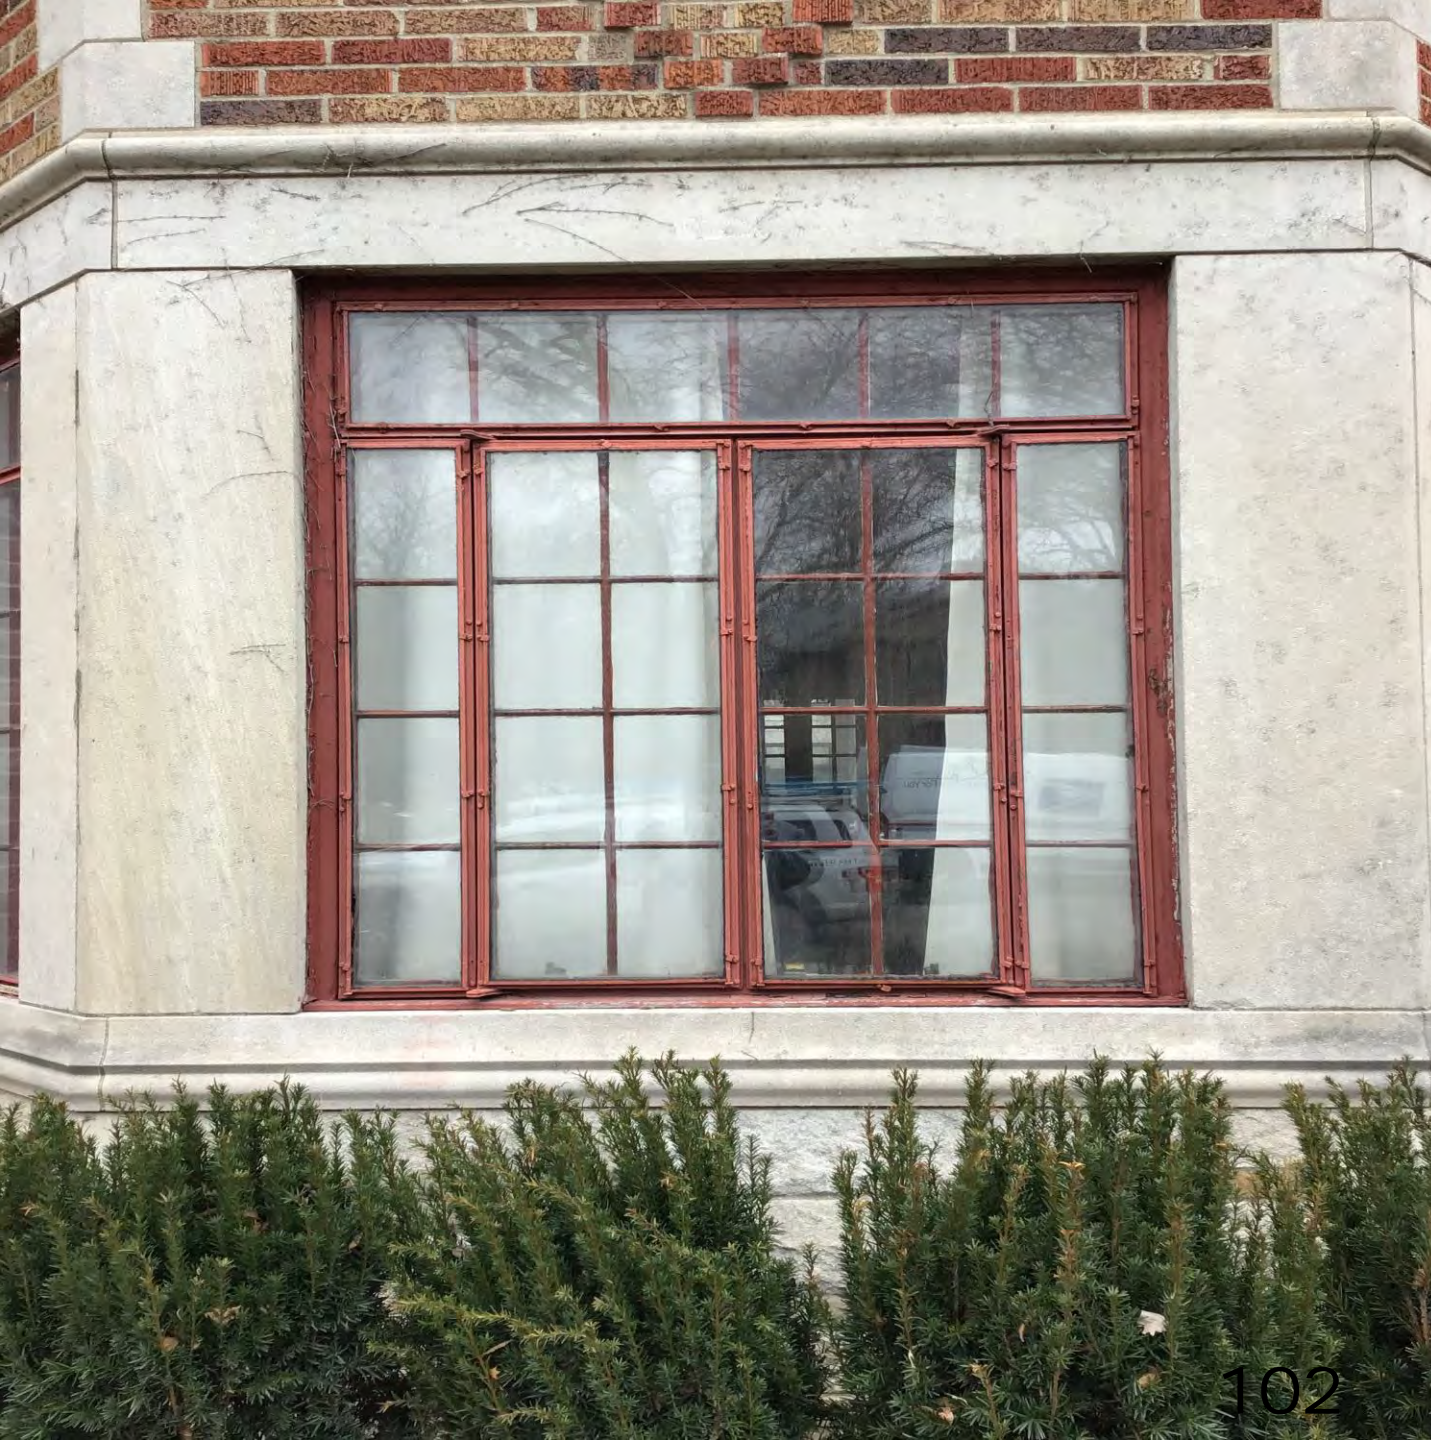
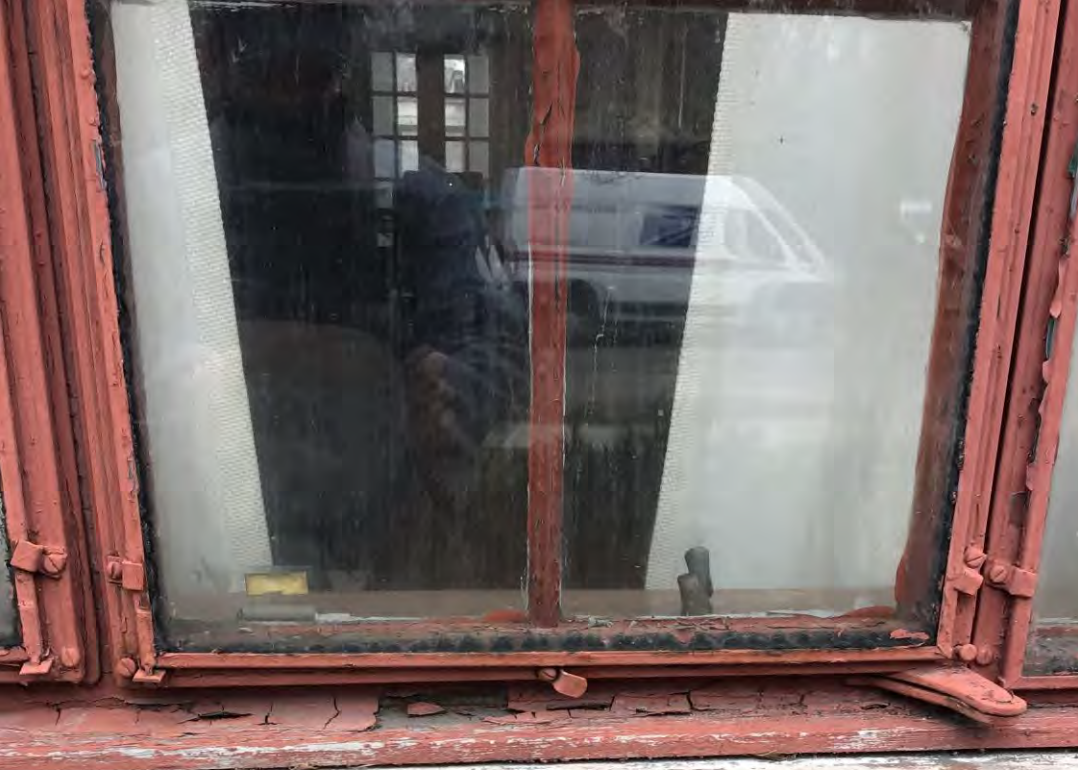
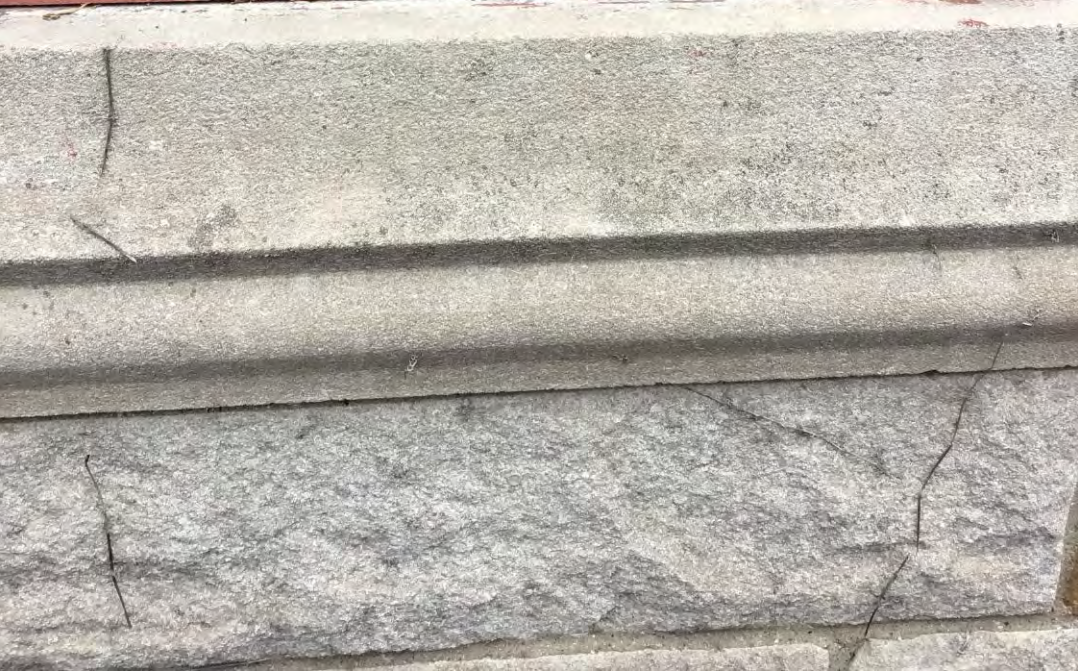
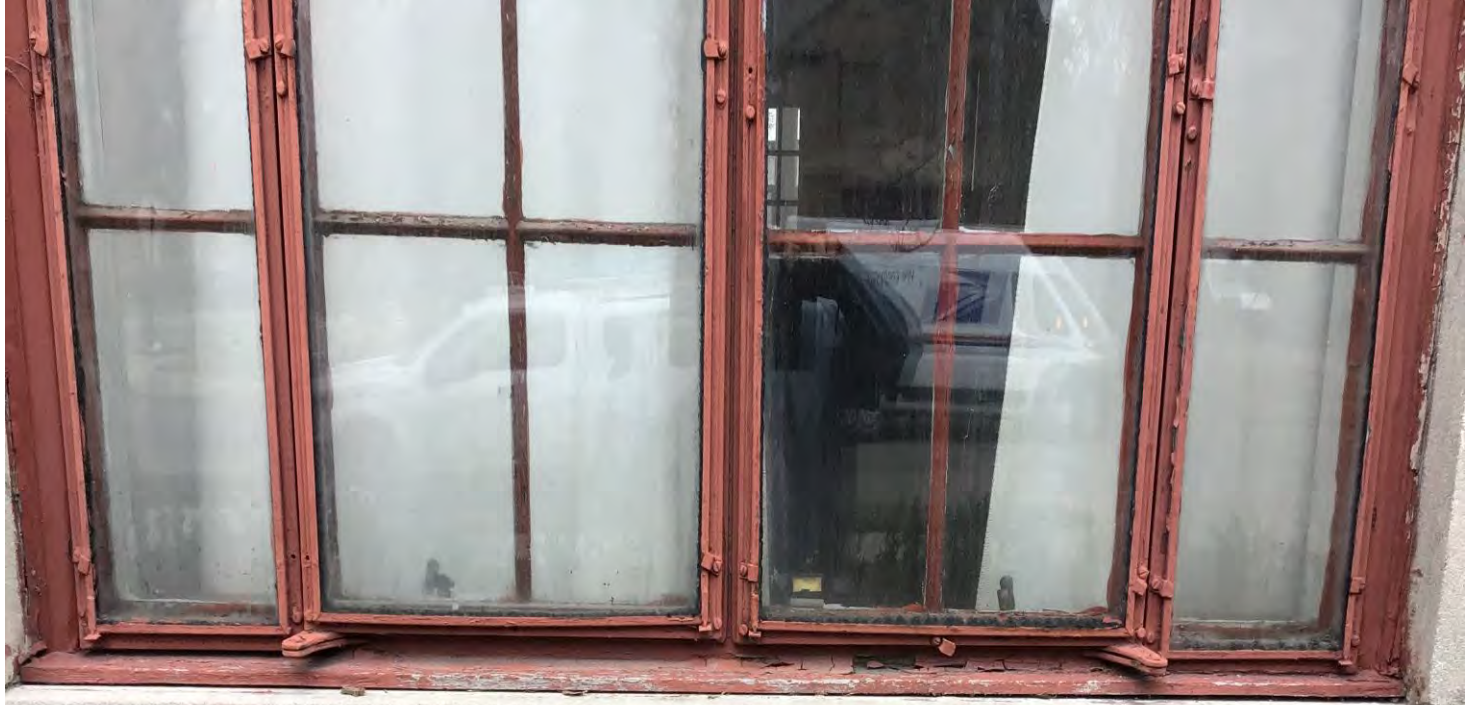
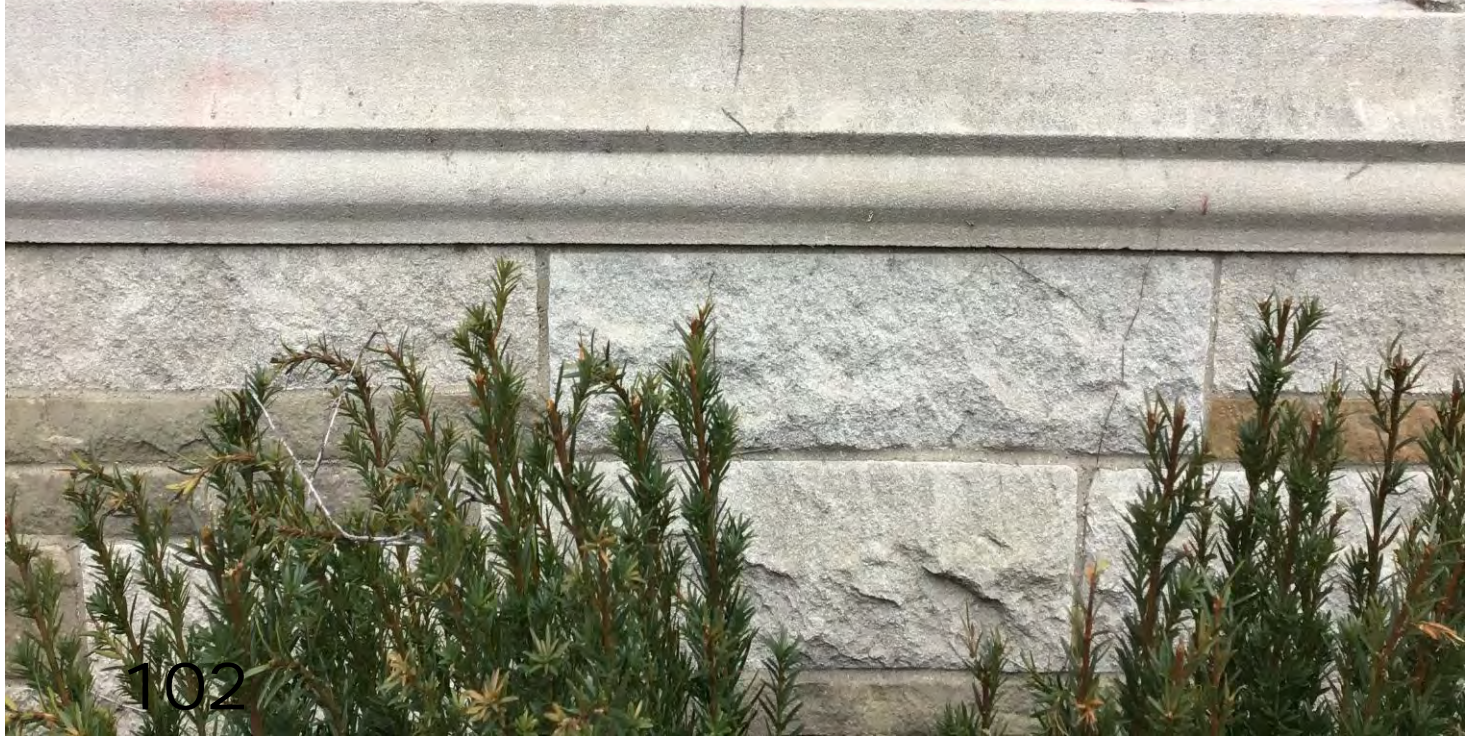
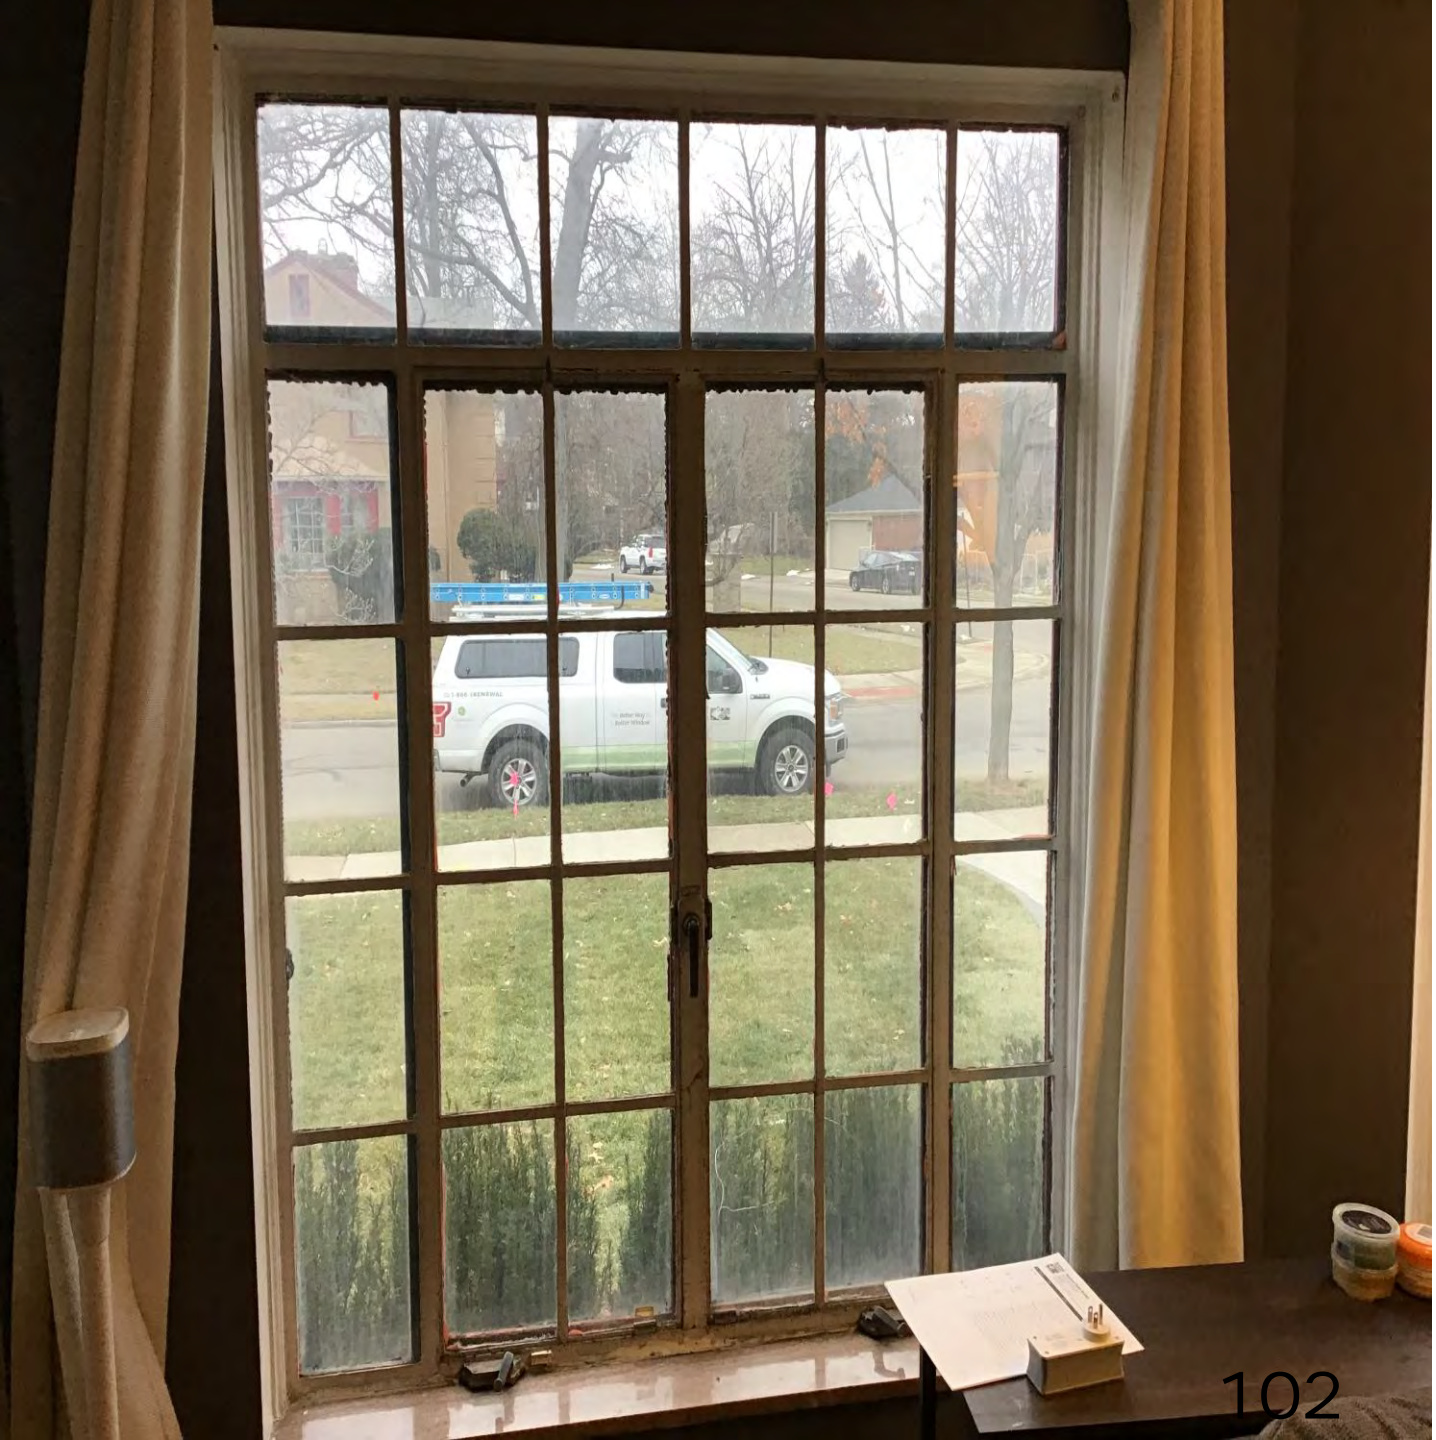
102

- Double casement
- Window is in Living room
- Window is hard to close if opened
- Exterior of window showing signs of rotting around frame
- Missing screen

**Window:** Casement, Fixed Window, Base Frame, Exterior Black, Interior Black, **Glass:** All Sash: High Performance SmartSun Glass, No Pattern, Tempered Glass, **Grille Style:** Grilles Between Glass (GBG), **Grille Pattern:** All Sash: Colonial 6w x 5h, **Misc:** None

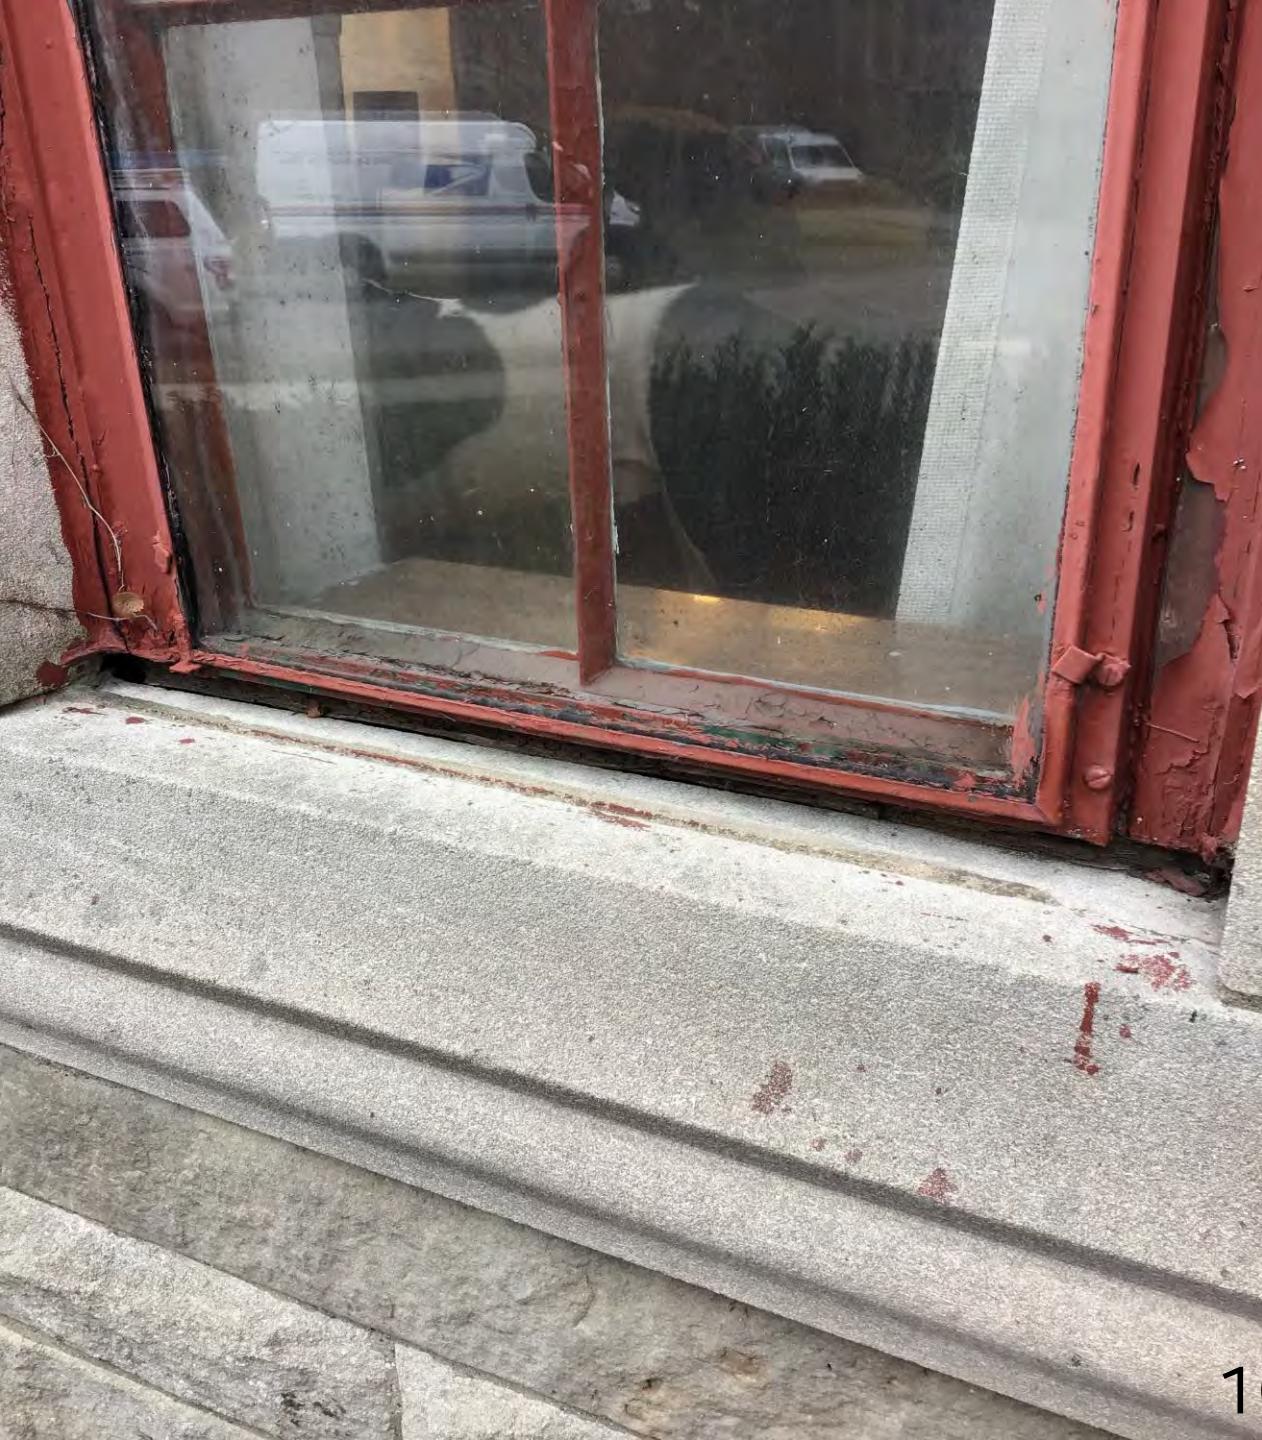
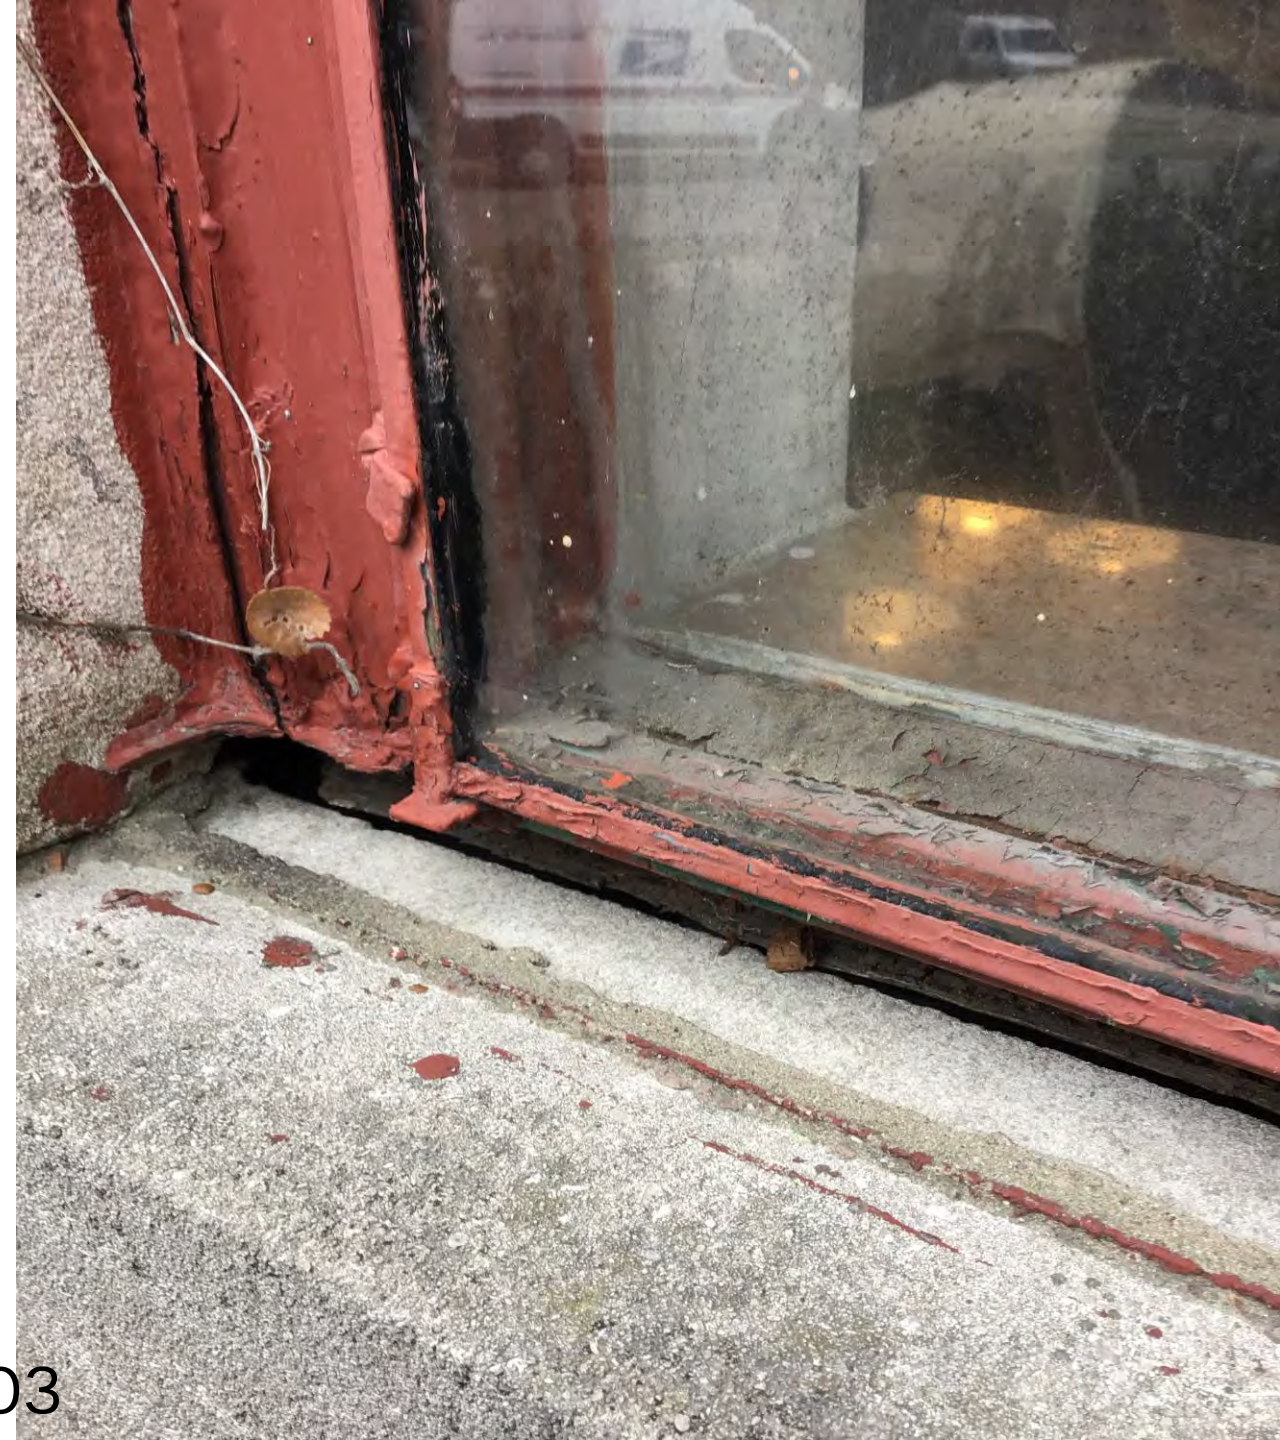
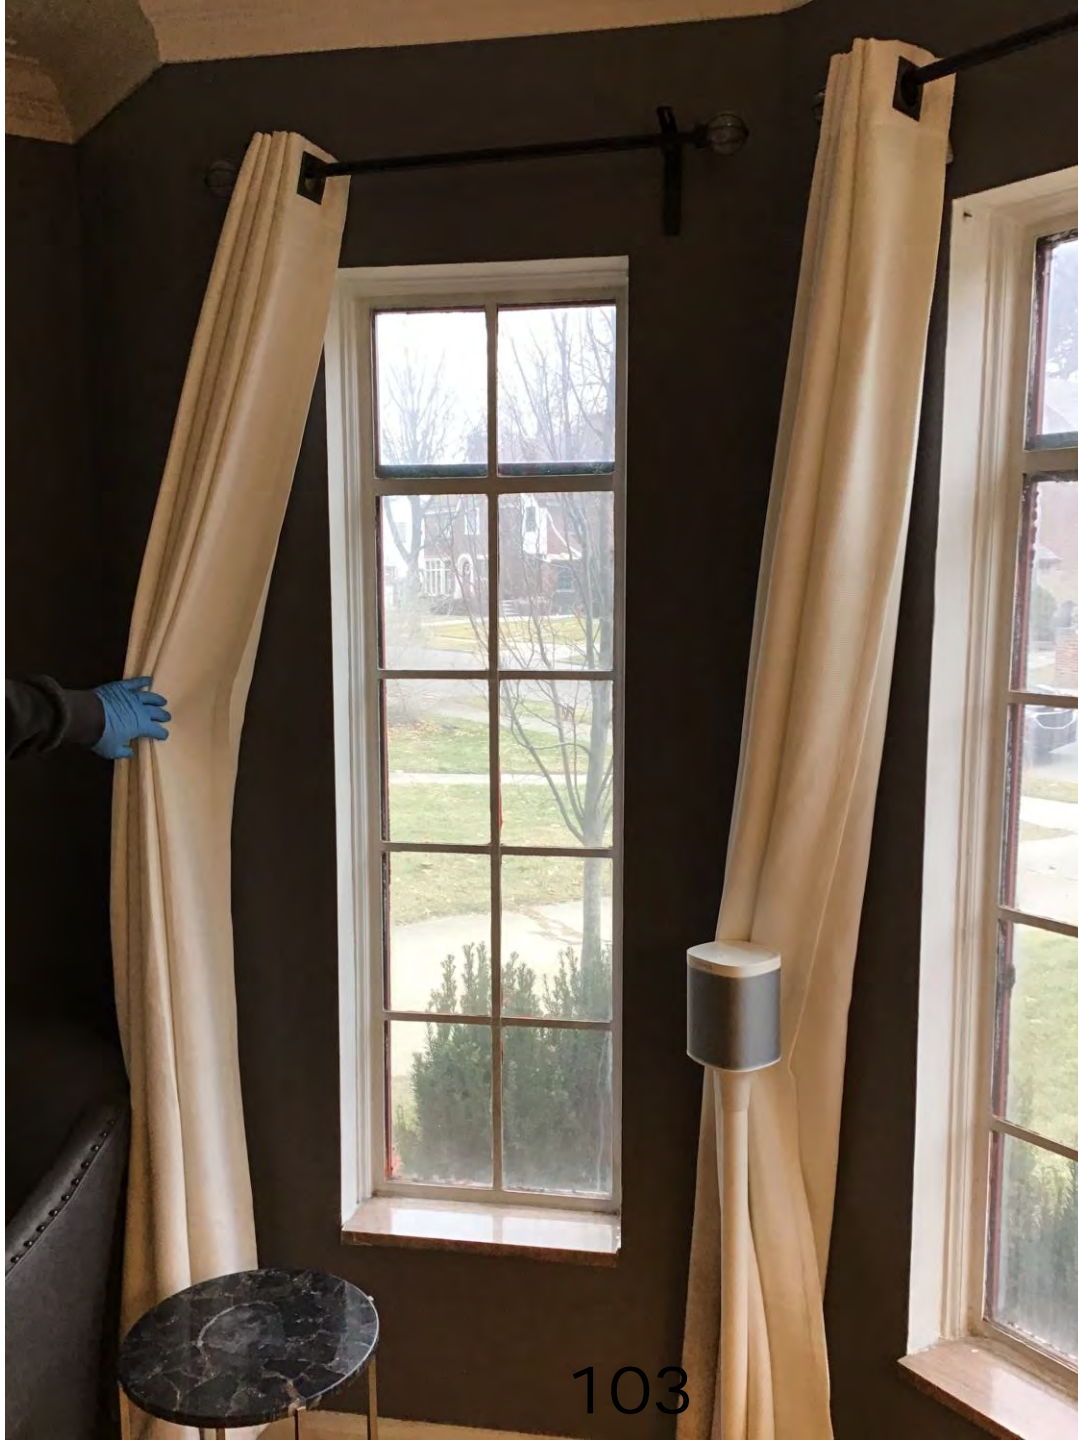
103

- Fixed window – Steel casement
- Window is in Living room
- Window is hard to close if opened
- Exterior of window showing signs of rotting around frame – bottom exterior sill missing

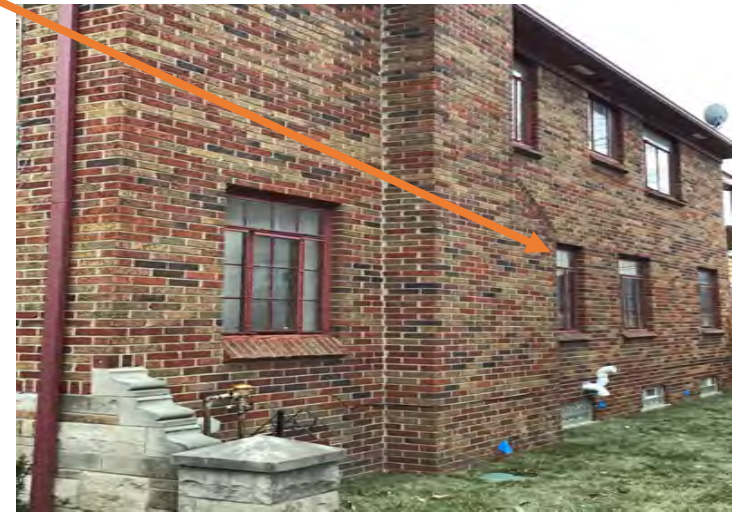
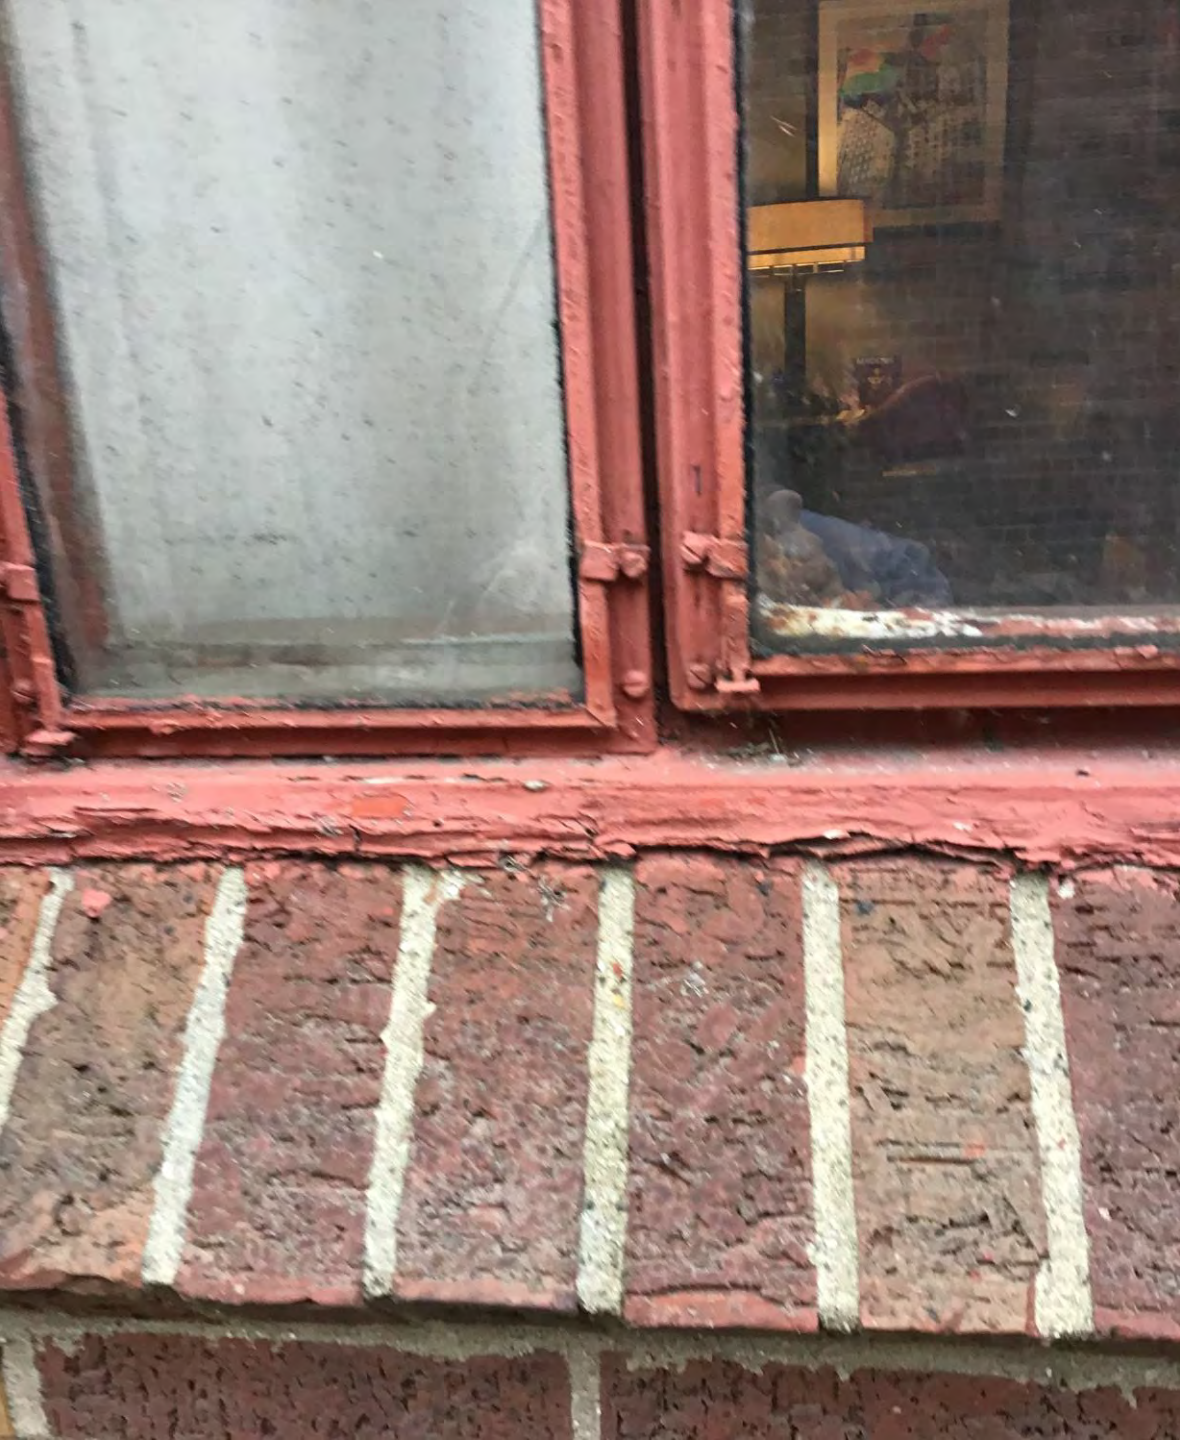
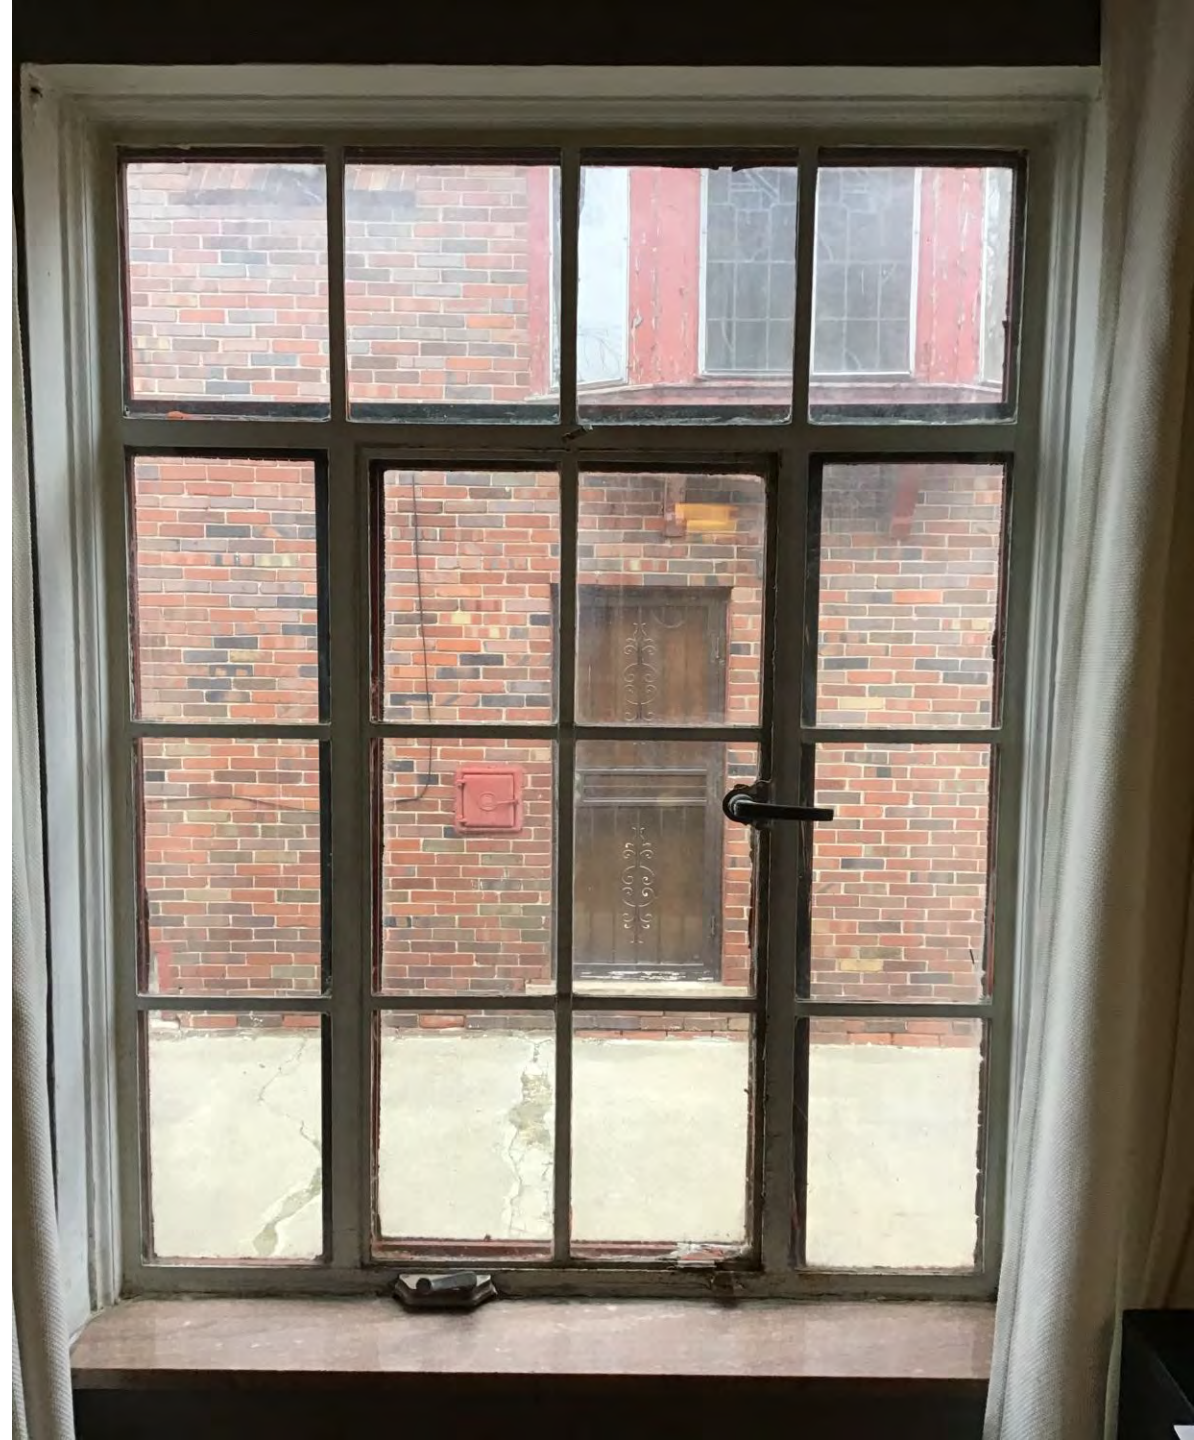
105

- Single Casement window
- Window is in Living room
- Window doesn't open
- Windowpane cracked
- Missing screen

**Window:** Casement, Single, Left Base Frame, 2" Brickmould / Traditional, Exterior Black, Interior Black, **Glass:** All Sash: High Performance SmartSun Glass, No Pattern, **Hardware:** Black, **Screen:** Fiberglass, Full Screen, **Grille Style:** Grilles Between Glass (GBG), **Grille Pattern:** All Sash: Colonial 4w x 4h, **Misc:** None
