**STAFF REPORT: FEBURARY 17, 2021 MEETING**

**APPLICATION NUMBER: 21-7091**

**ADDRESS: 19365 WARRINGTON**

**SCOPE OF WORK: REPLACE STEEL CASEMENT WINDOWS AS PROPOSED**

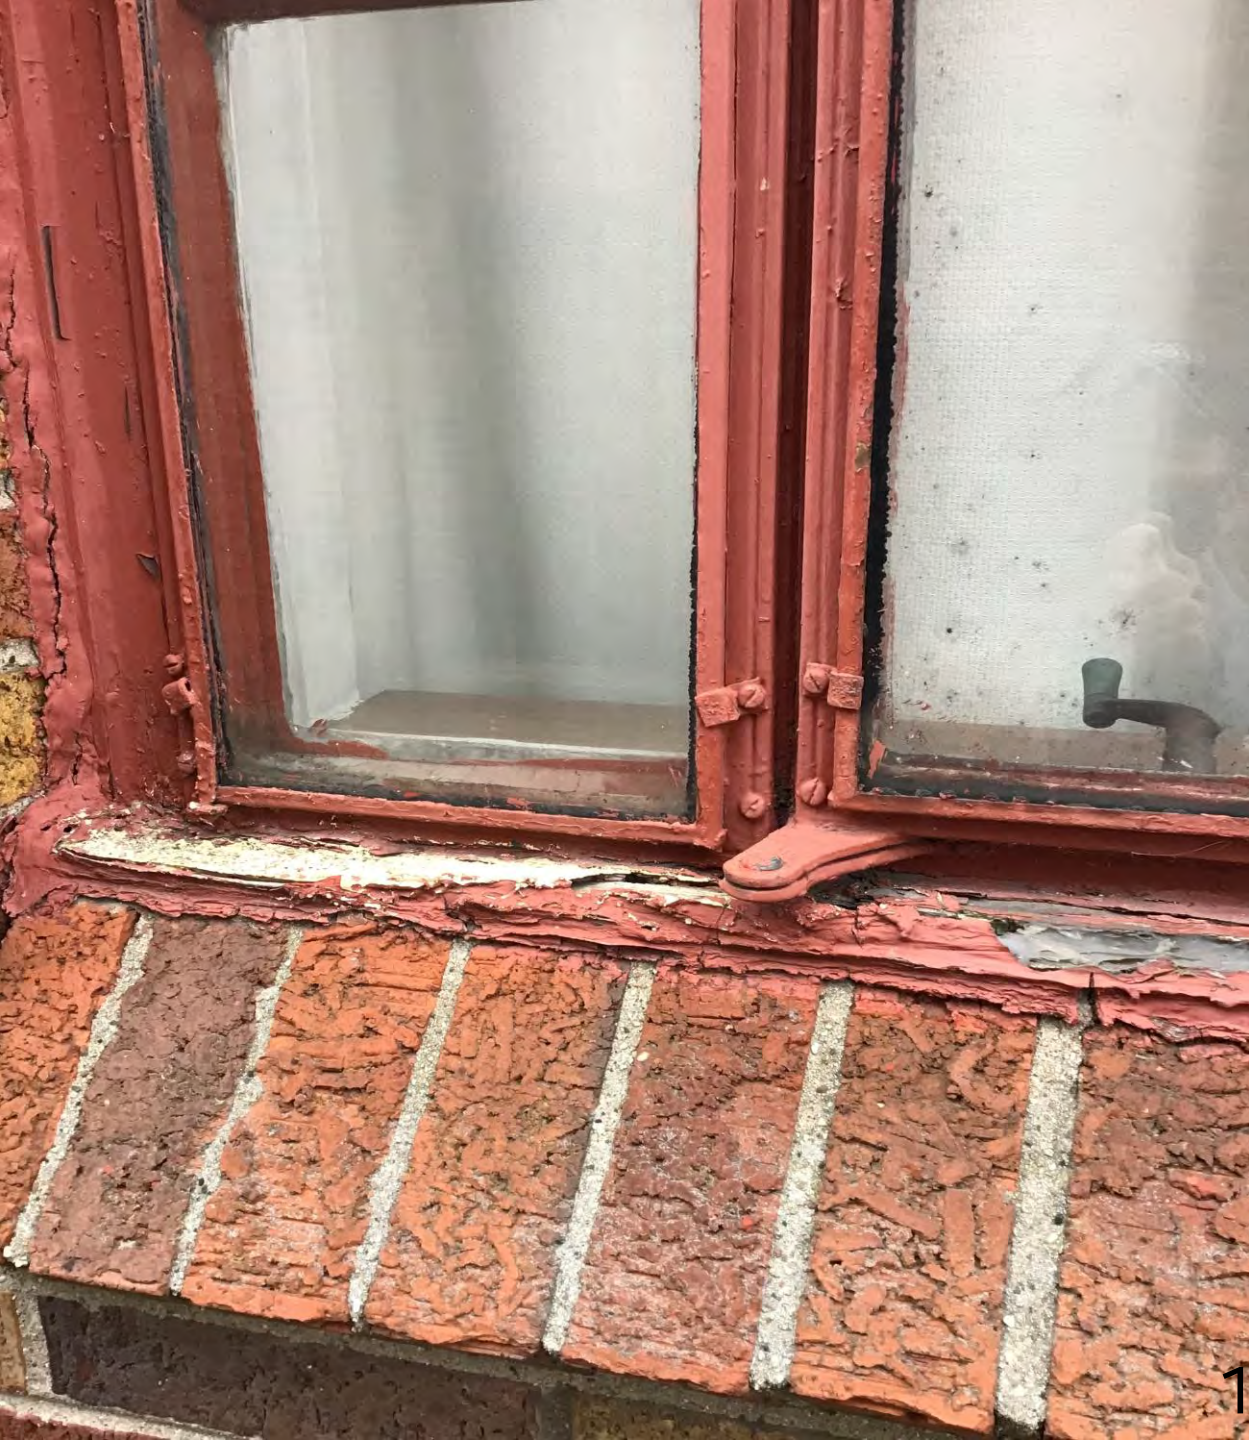
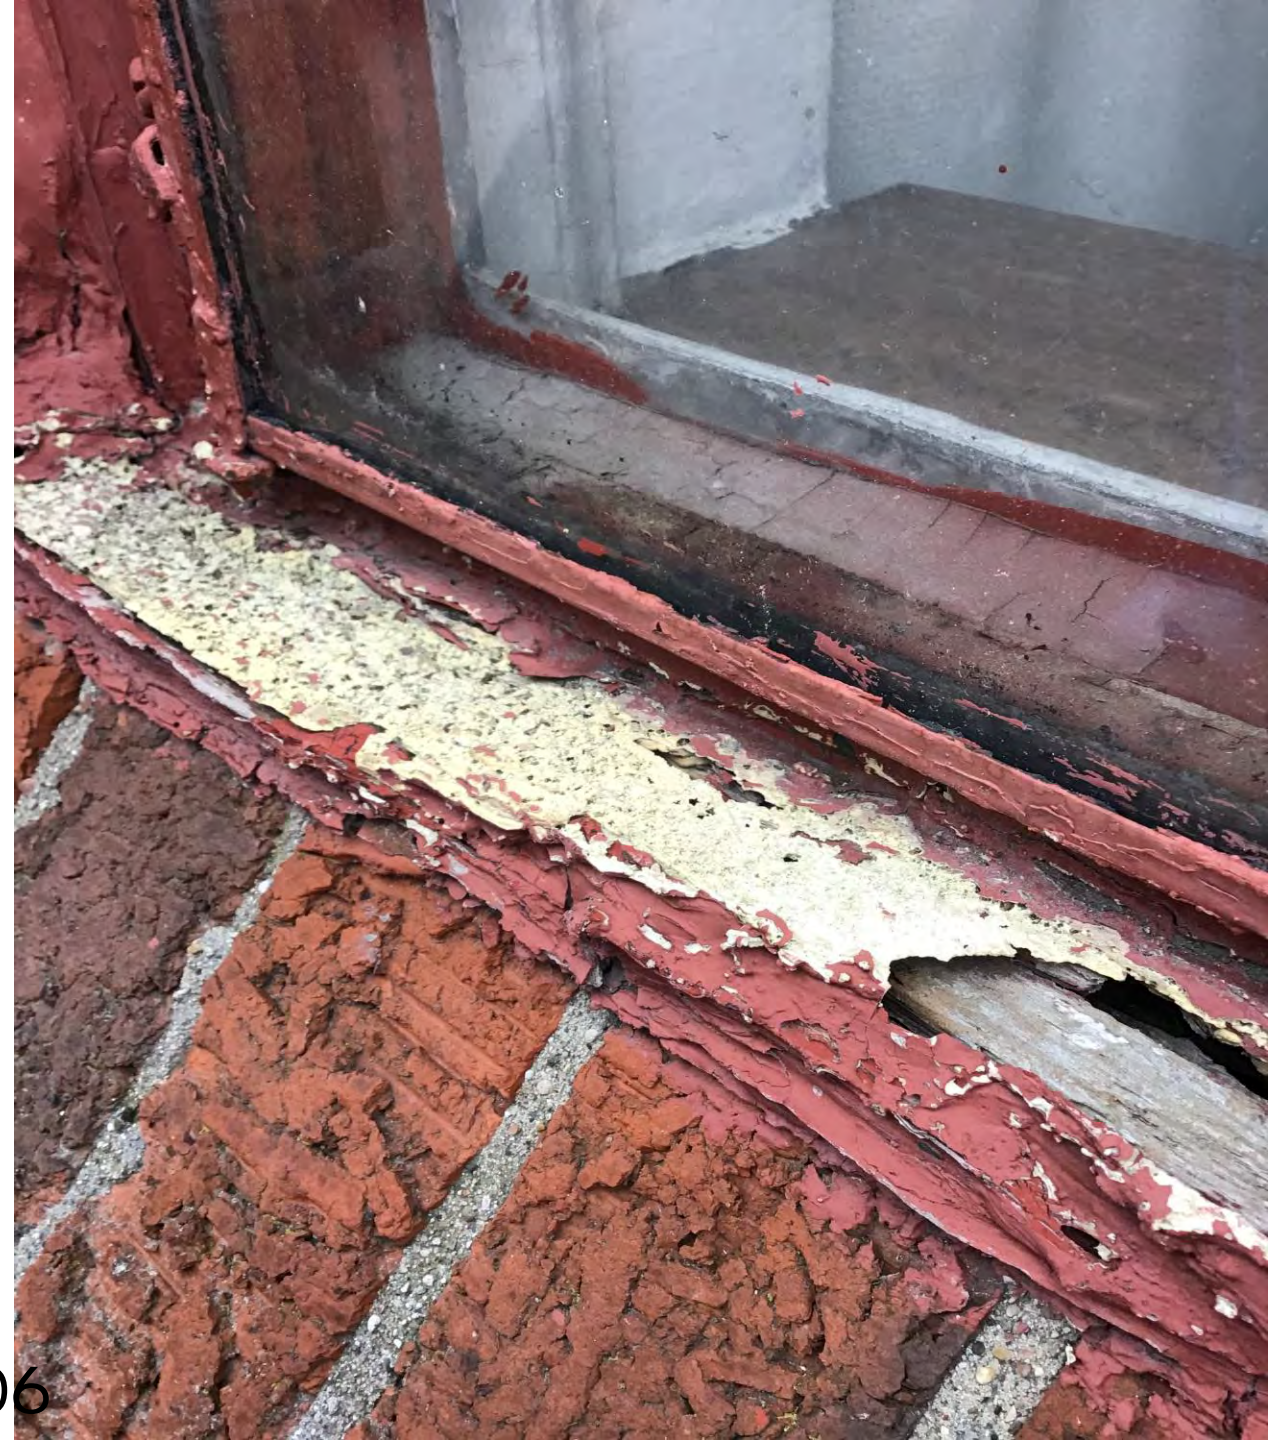
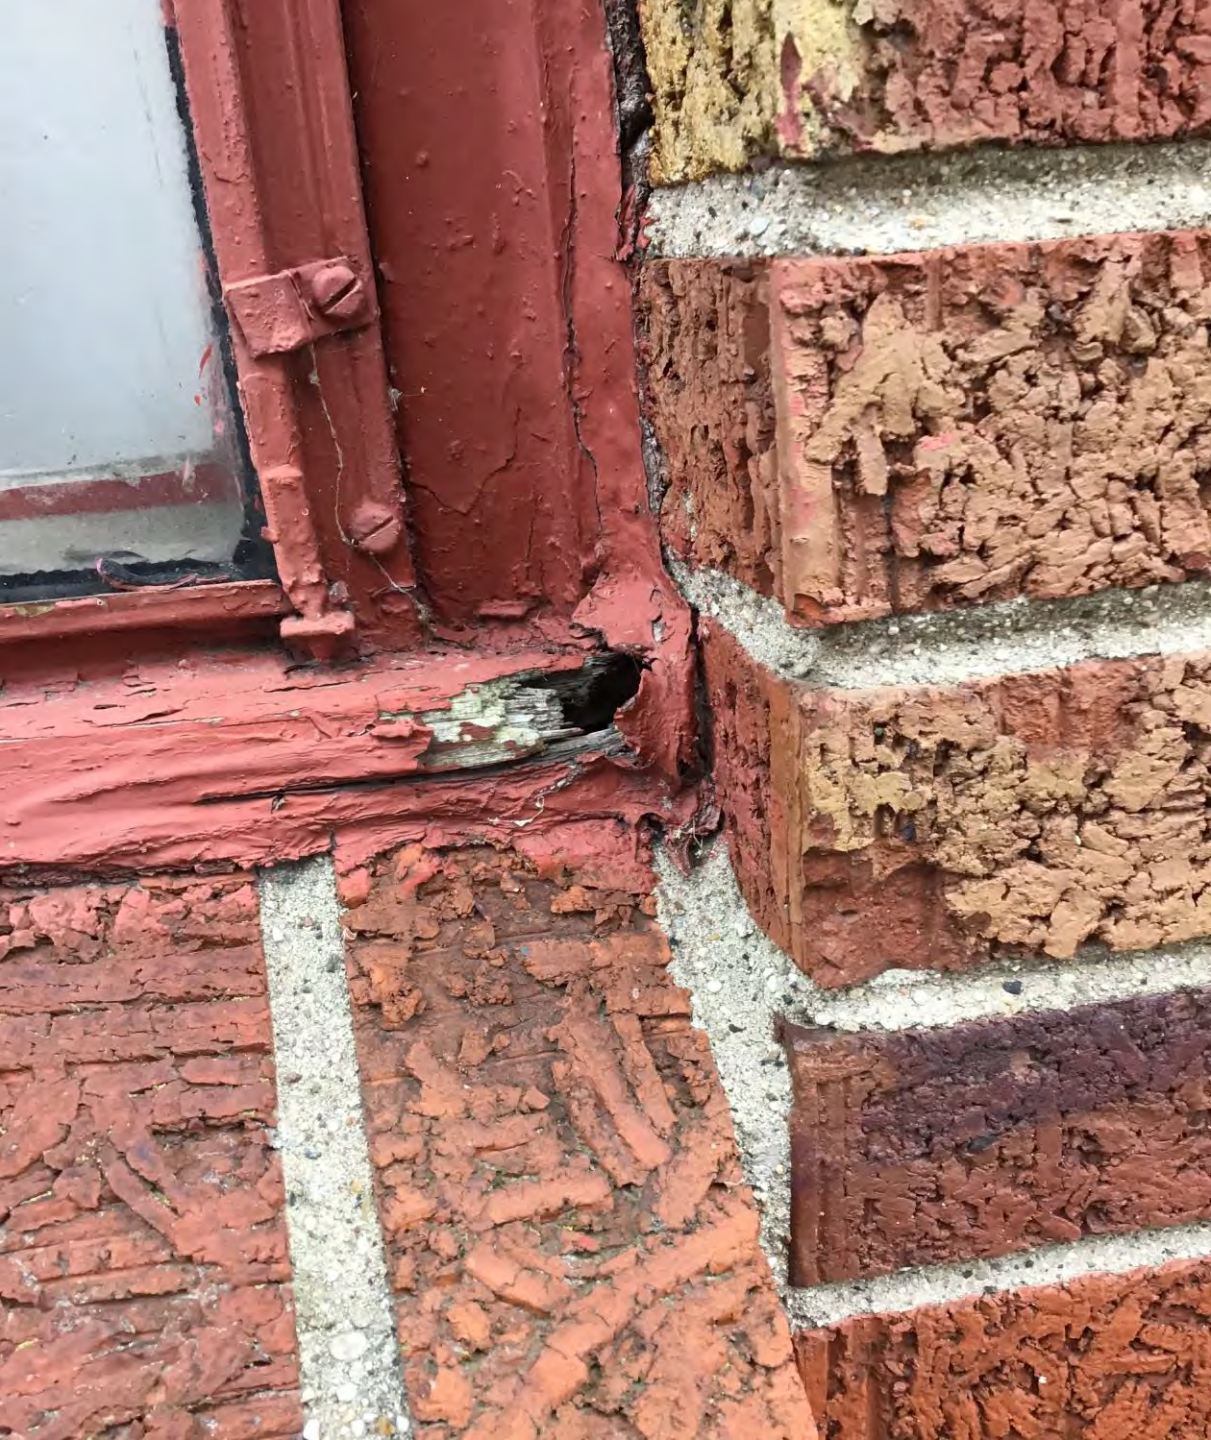
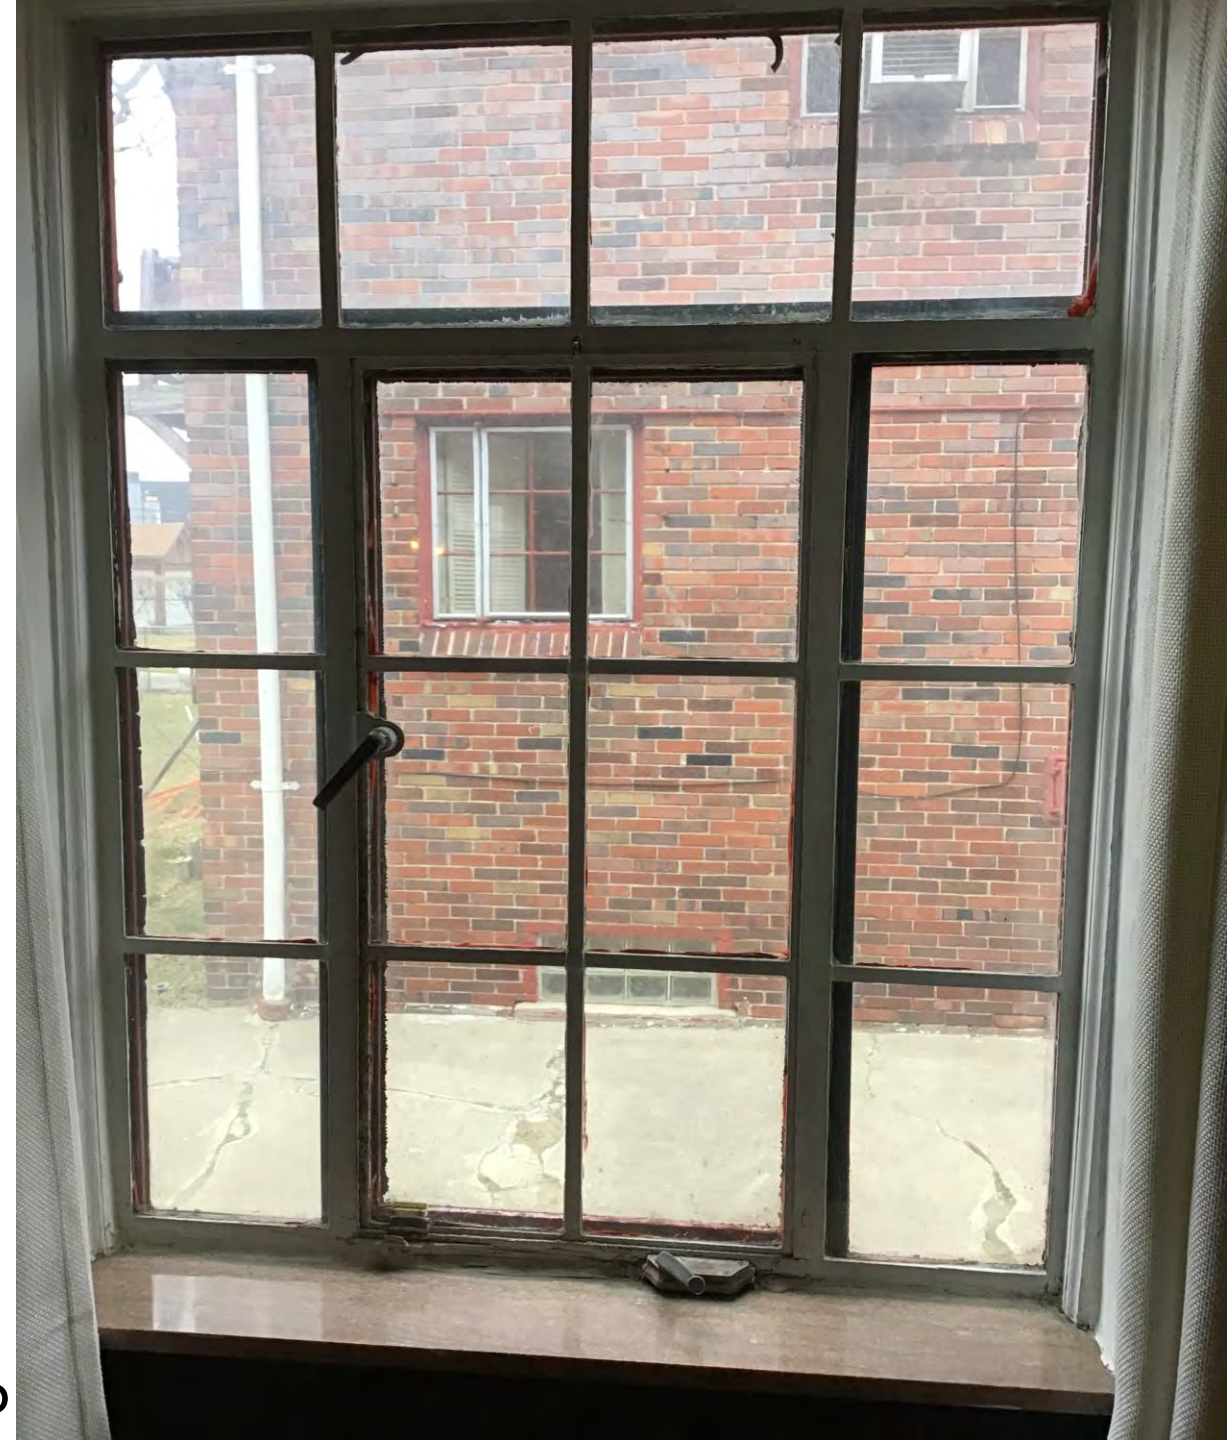
106

- Single Casement Window
- Window is in Dining room
- Window is hard to close if opened
- Exterior of window is rotting
- Screen missing

**Window:** Casement, Single, Left, Base Frame, 2" Brickmould / Traditional, Exterior Black, Interior Black, **Glass:** All Sash: High Performance SmartSun Glass, No Pattern, **Hardware:** Black, **Screen:** Fiberglass, Full Screen, **Grille Style:** Grilles Between Glass (GBG), **Grille Pattern:** All Sash: Colonial 4w x 4h, **Misc:** None

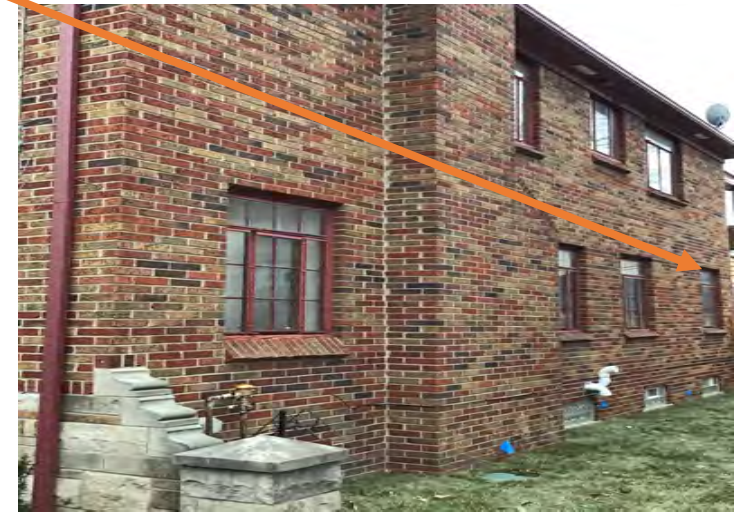
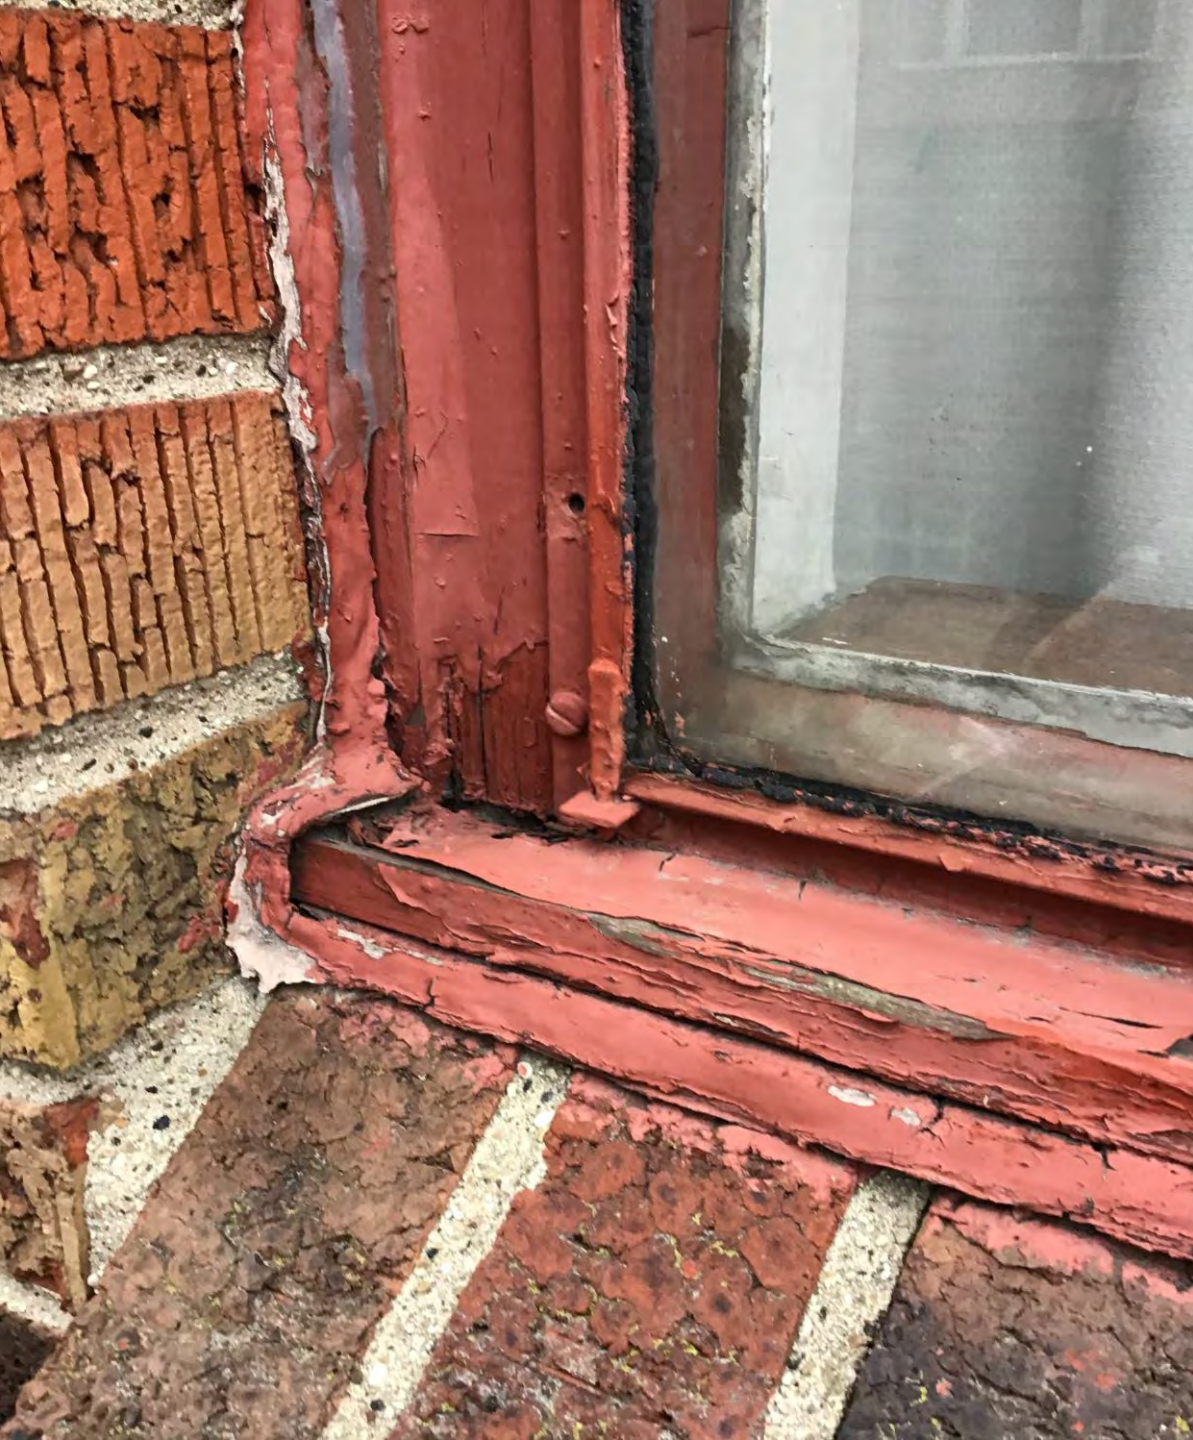
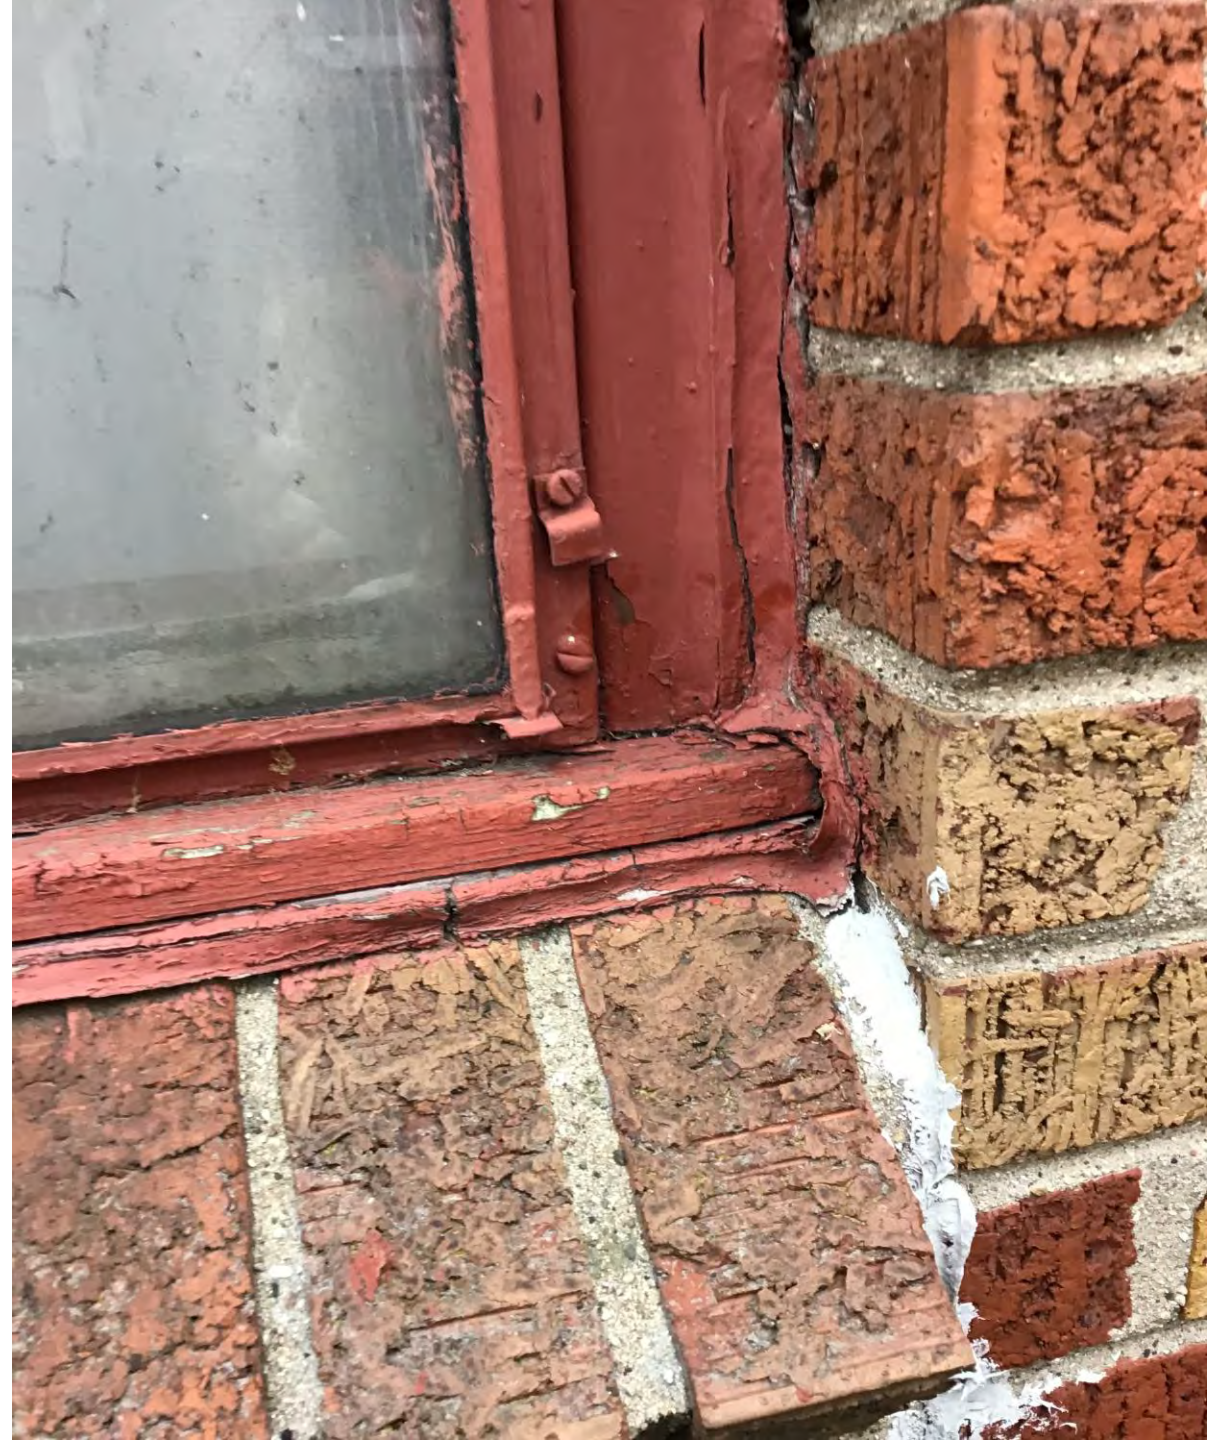
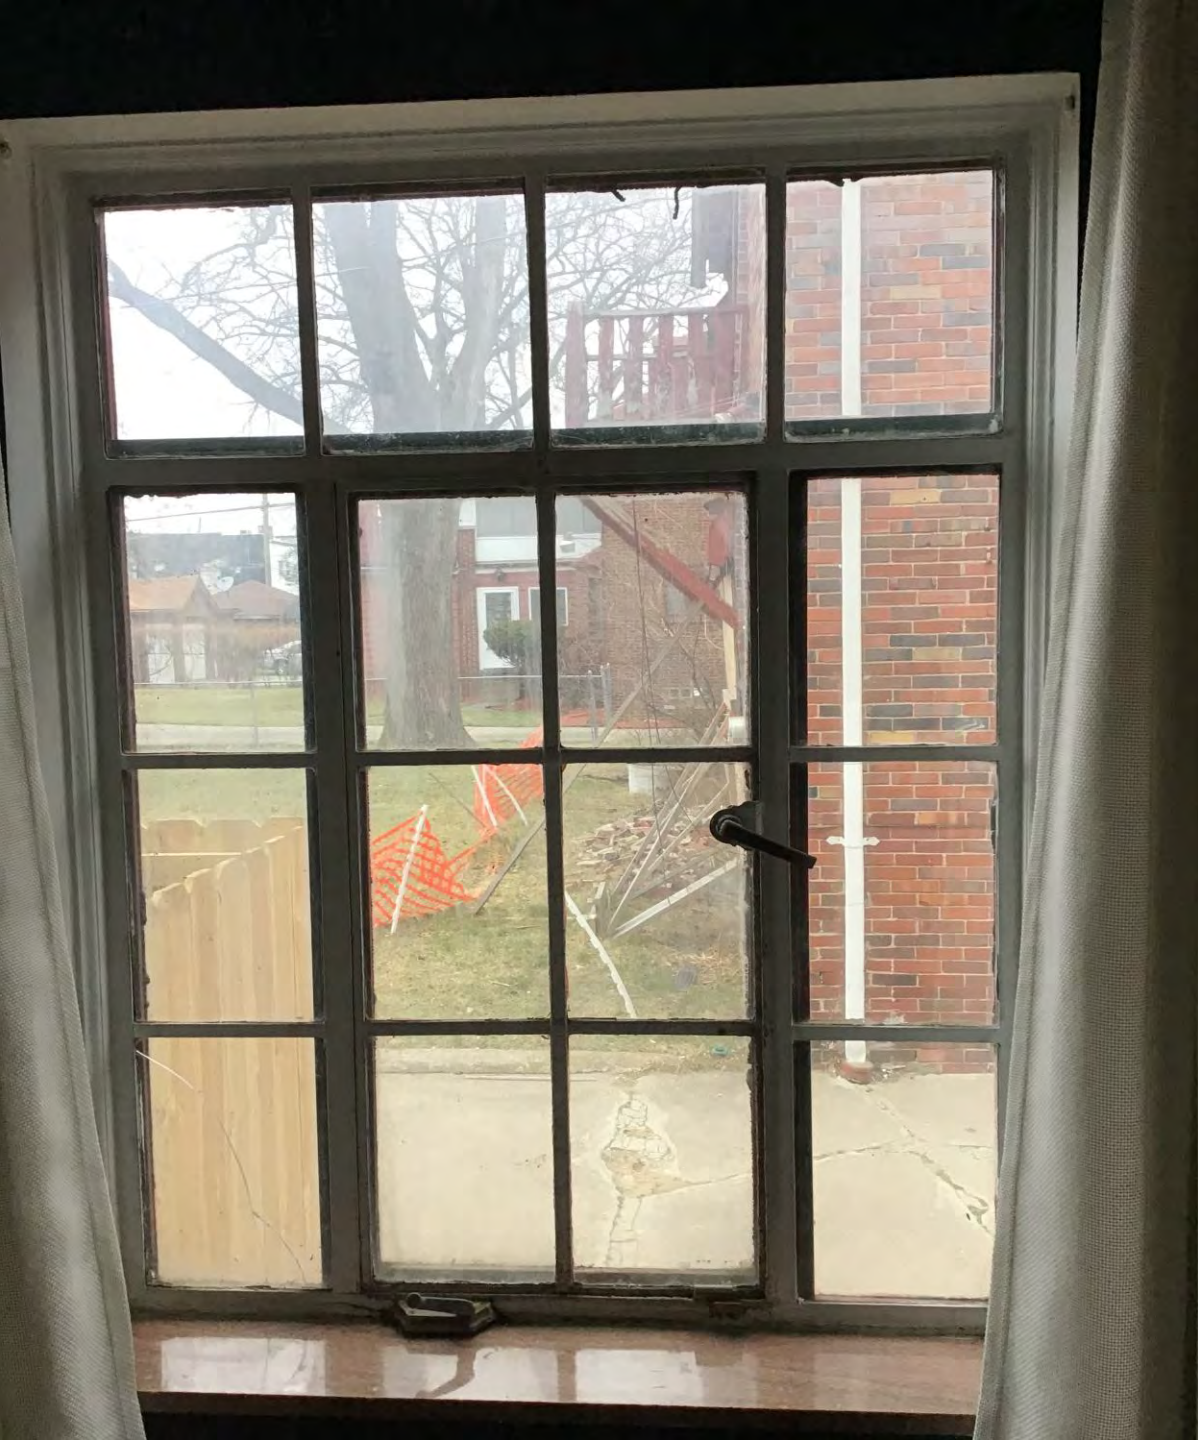
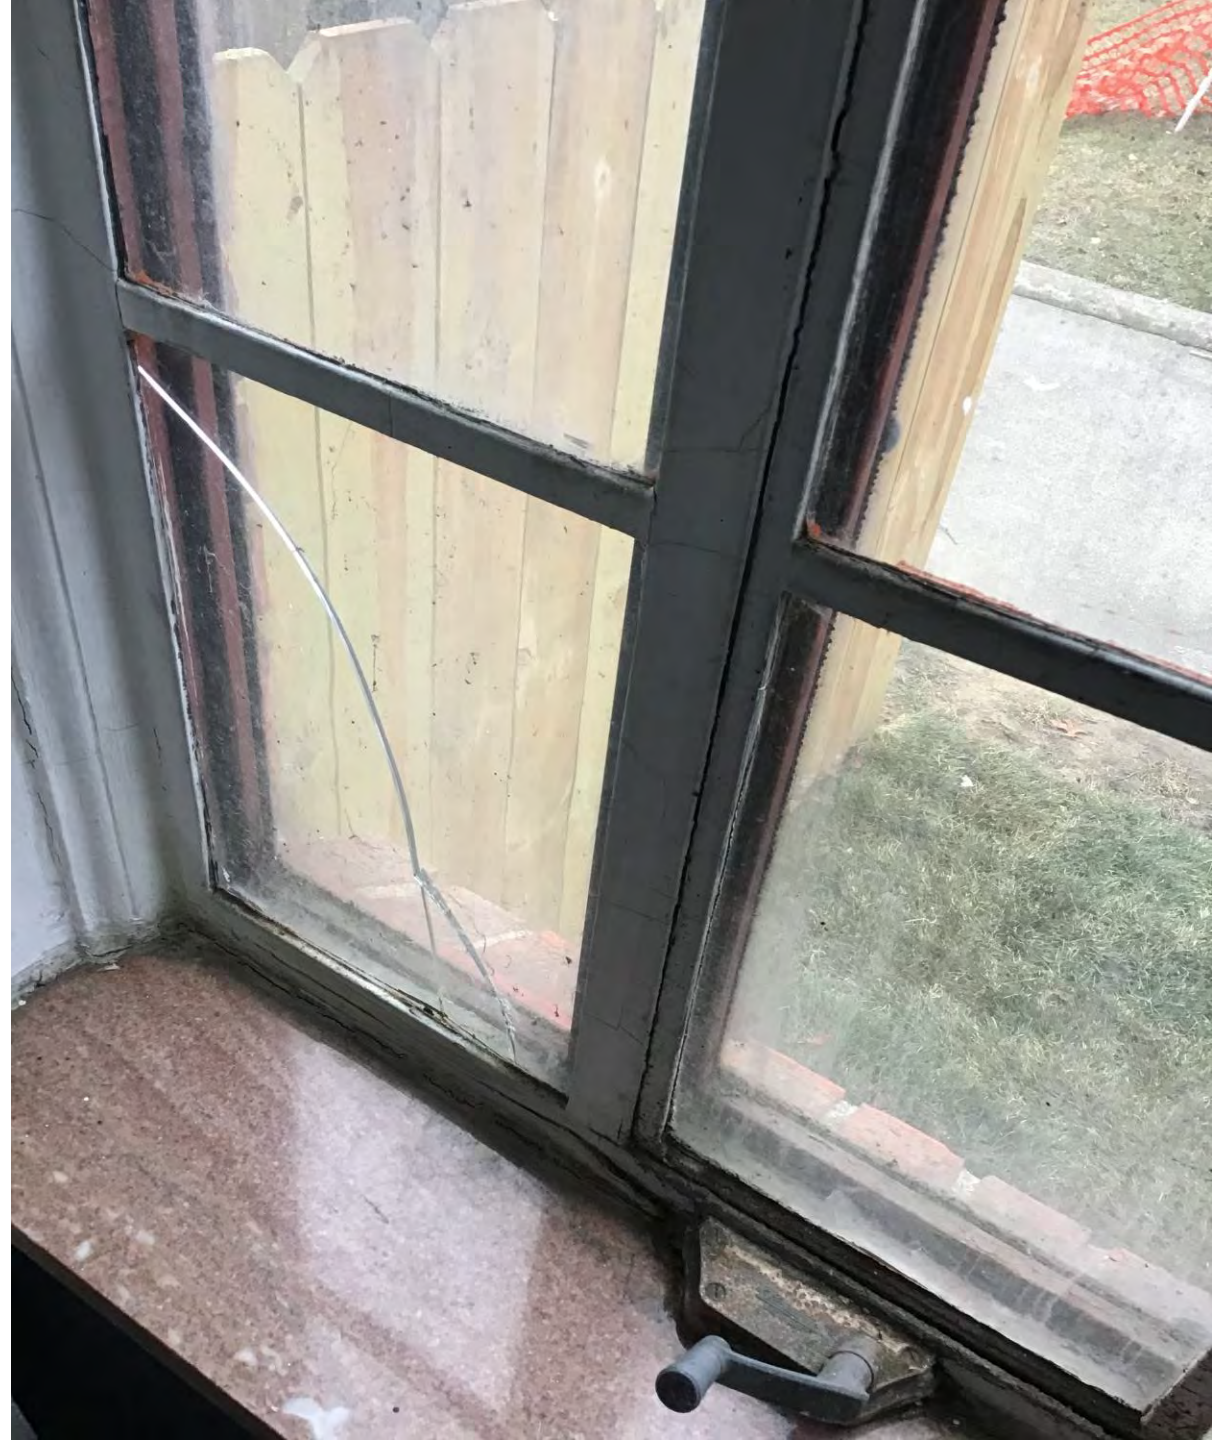
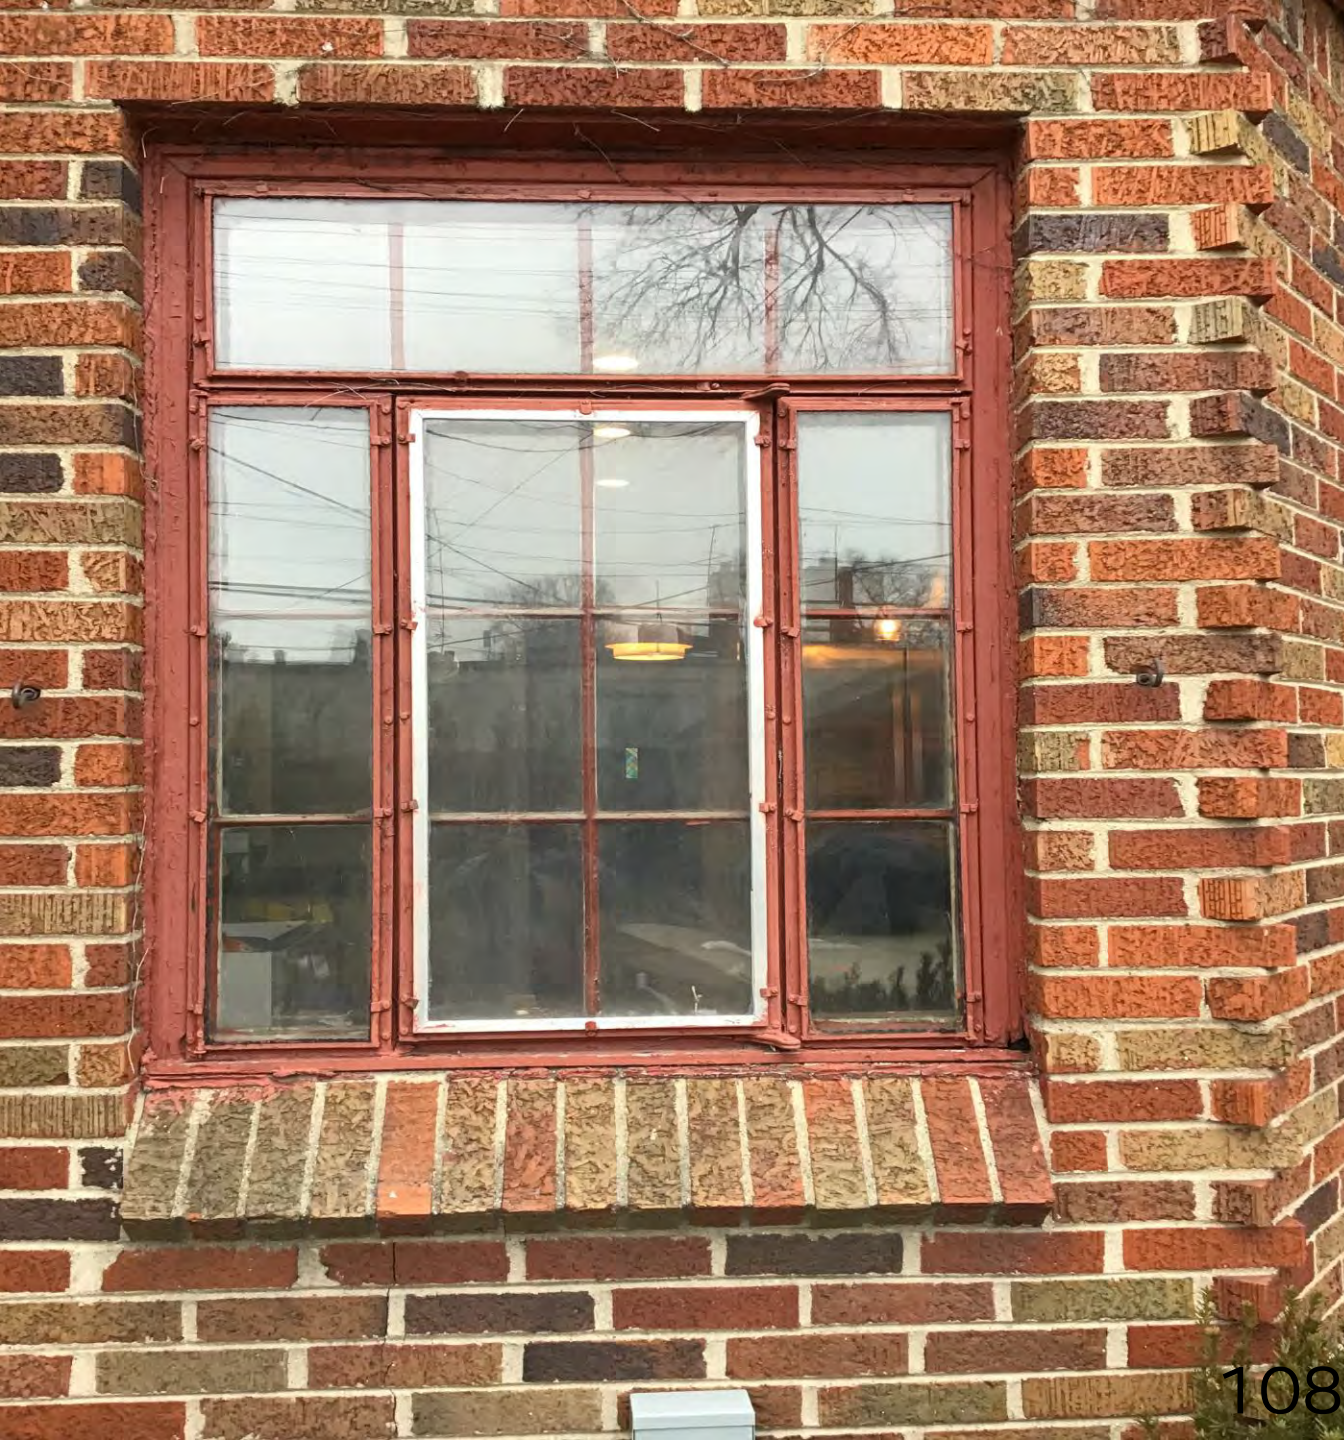
108

- Single Casement Window
- Window is in Dining room
- Window is hard to close if opened
- Windowpane cracked
- Screen missing
