**STAFF REPORT: FEBURARY 17, 2021 MEETING**

**APPLICATION NUMBER: 21-7091**

**ADDRESS: 19365 WARRINGTON**

**SCOPE OF WORK: REPLACE STEEL CASEMENT WINDOWS AS PROPOSED**

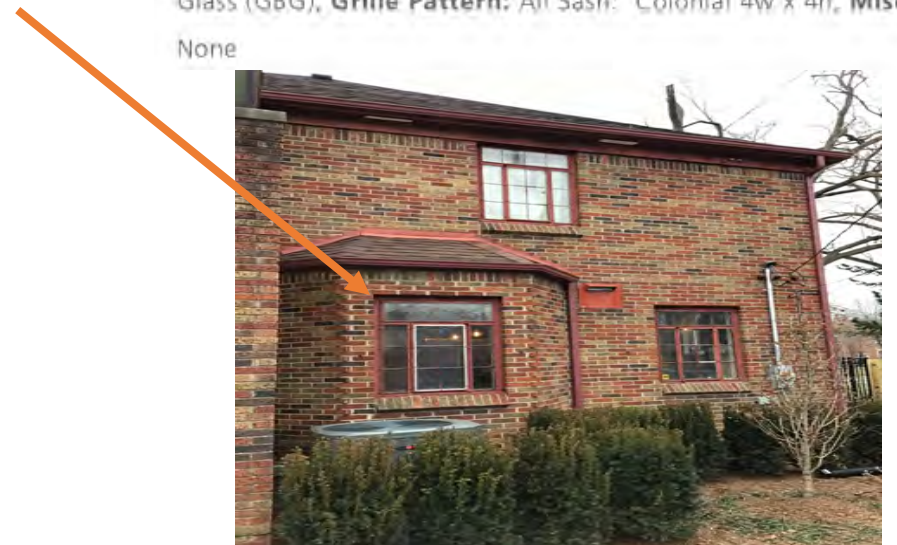
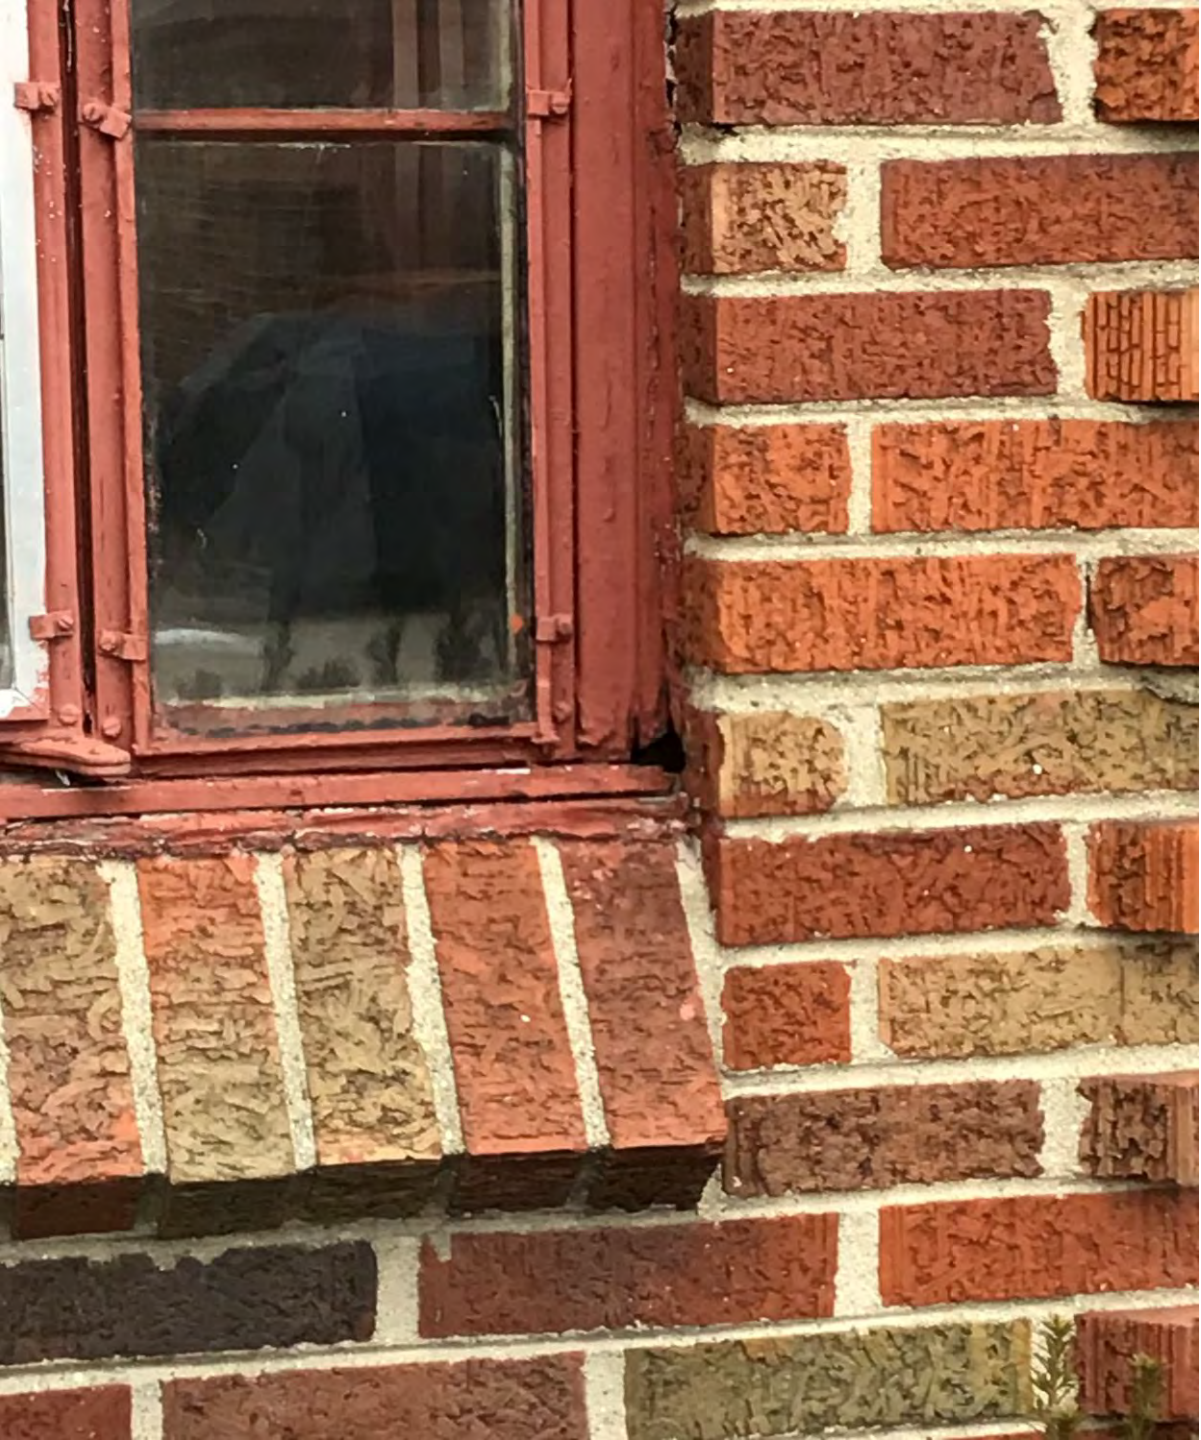
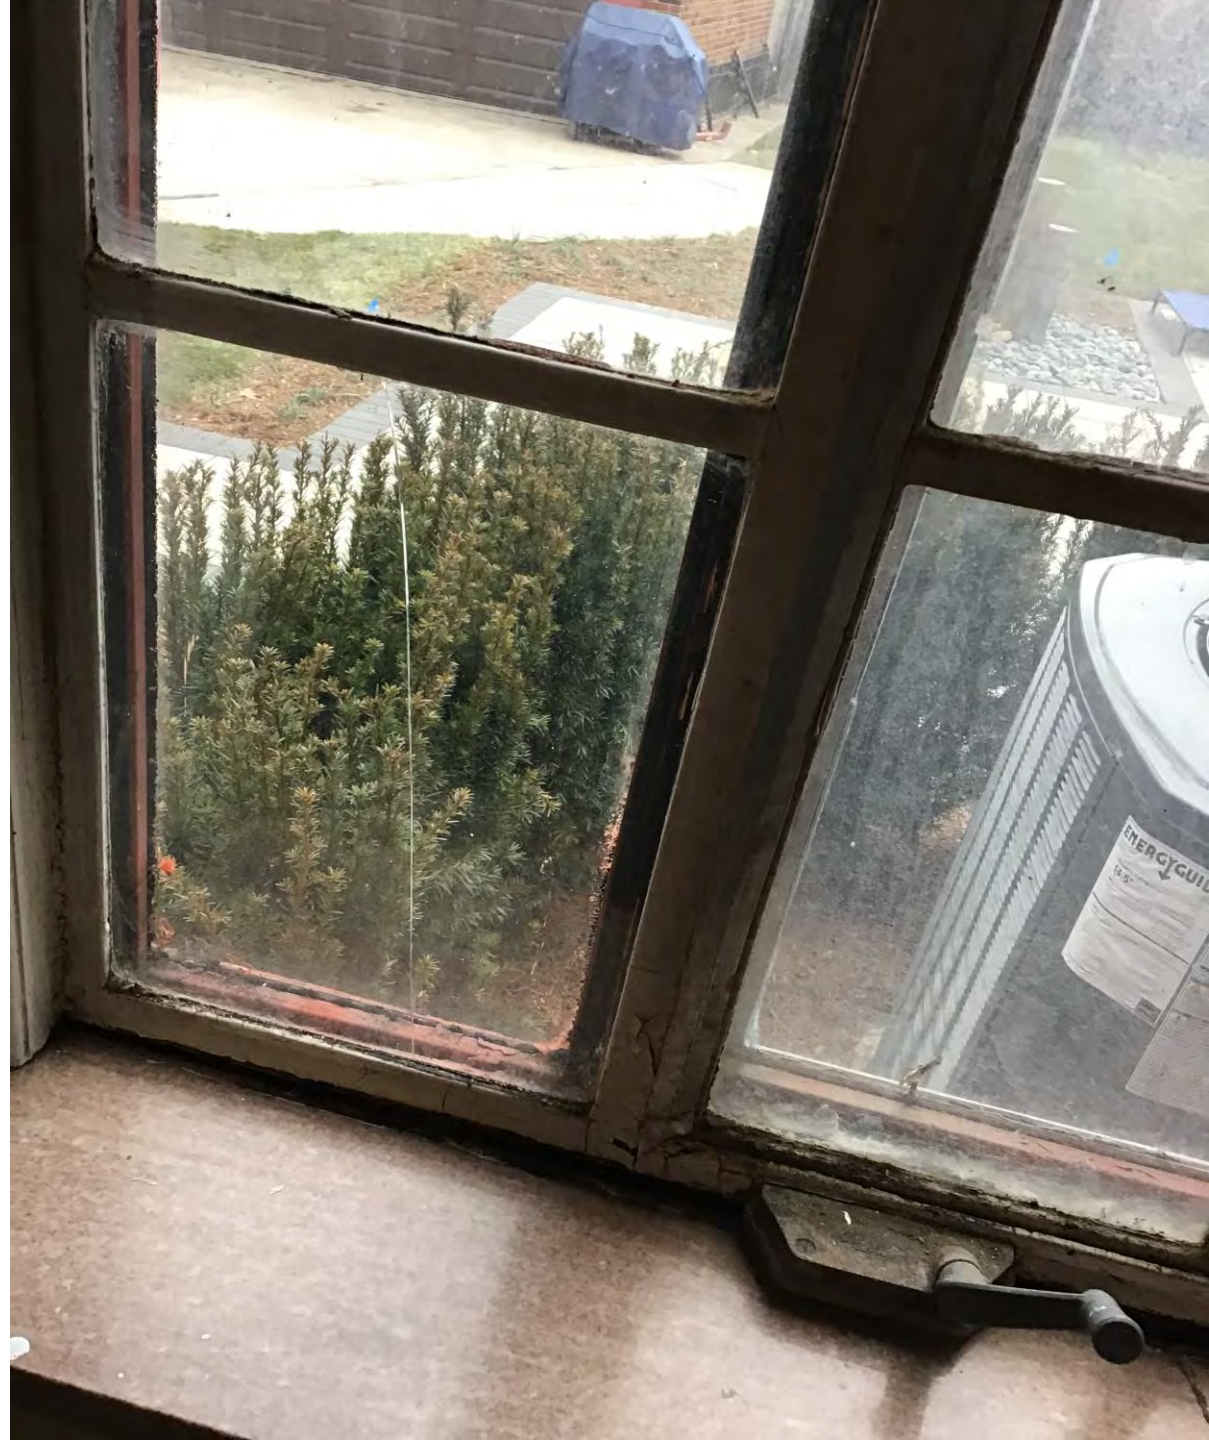
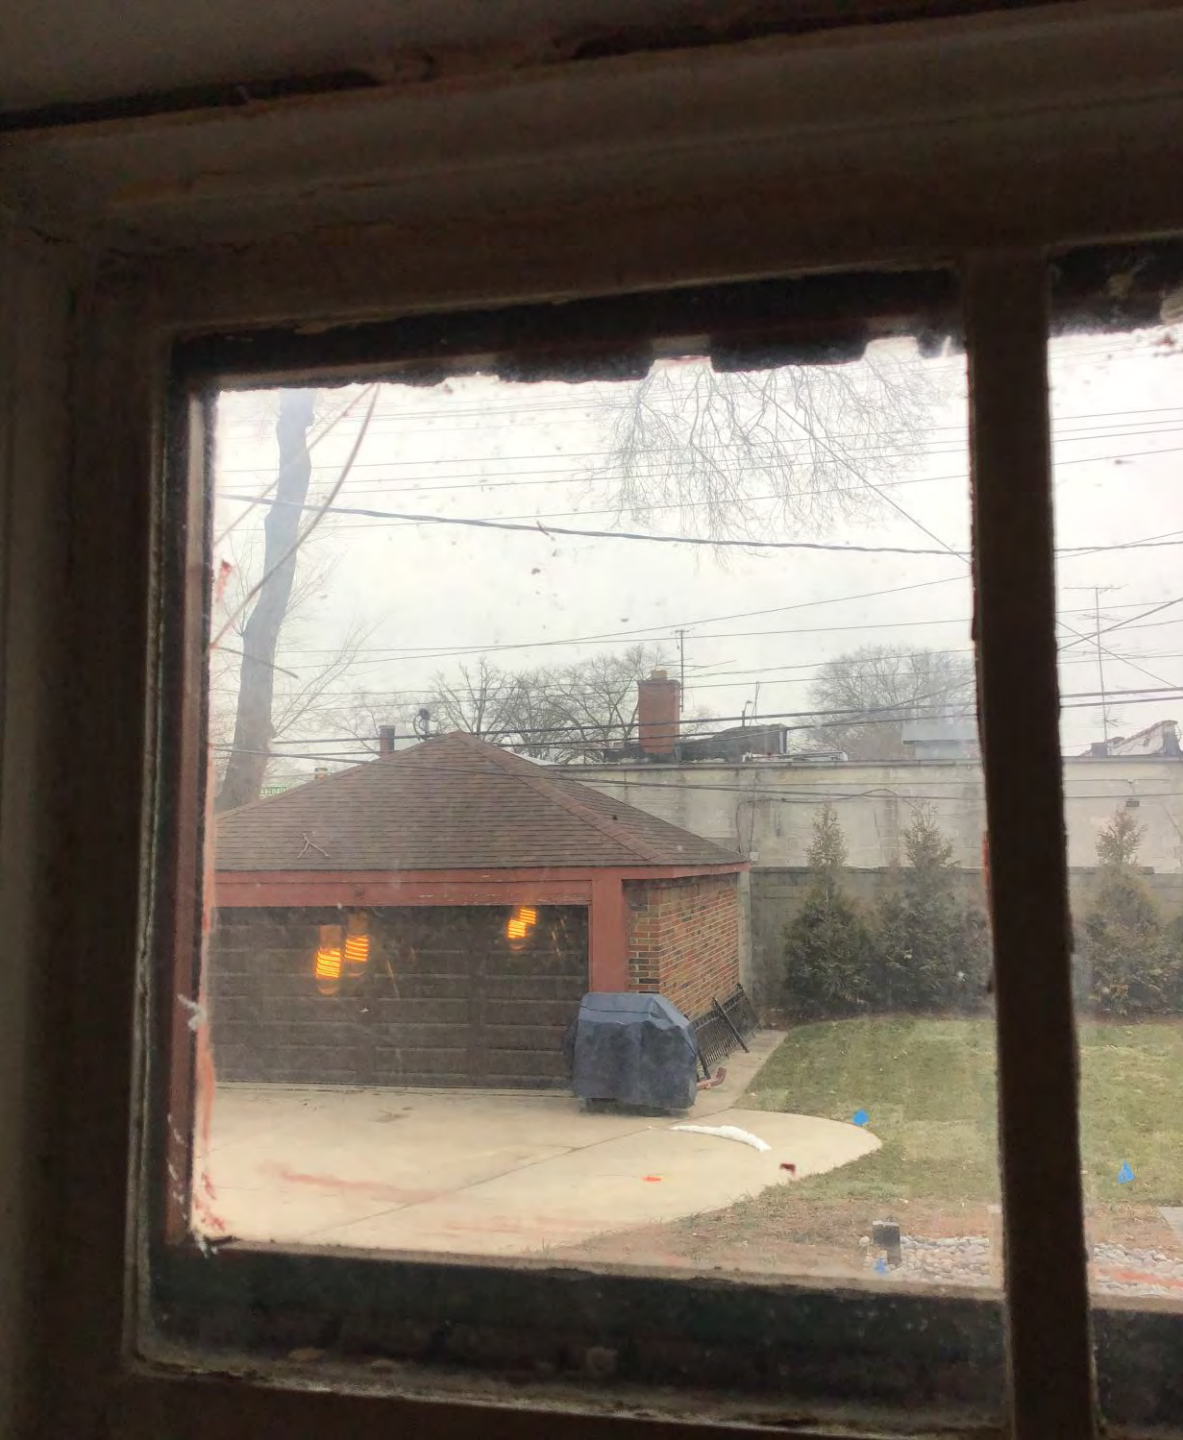
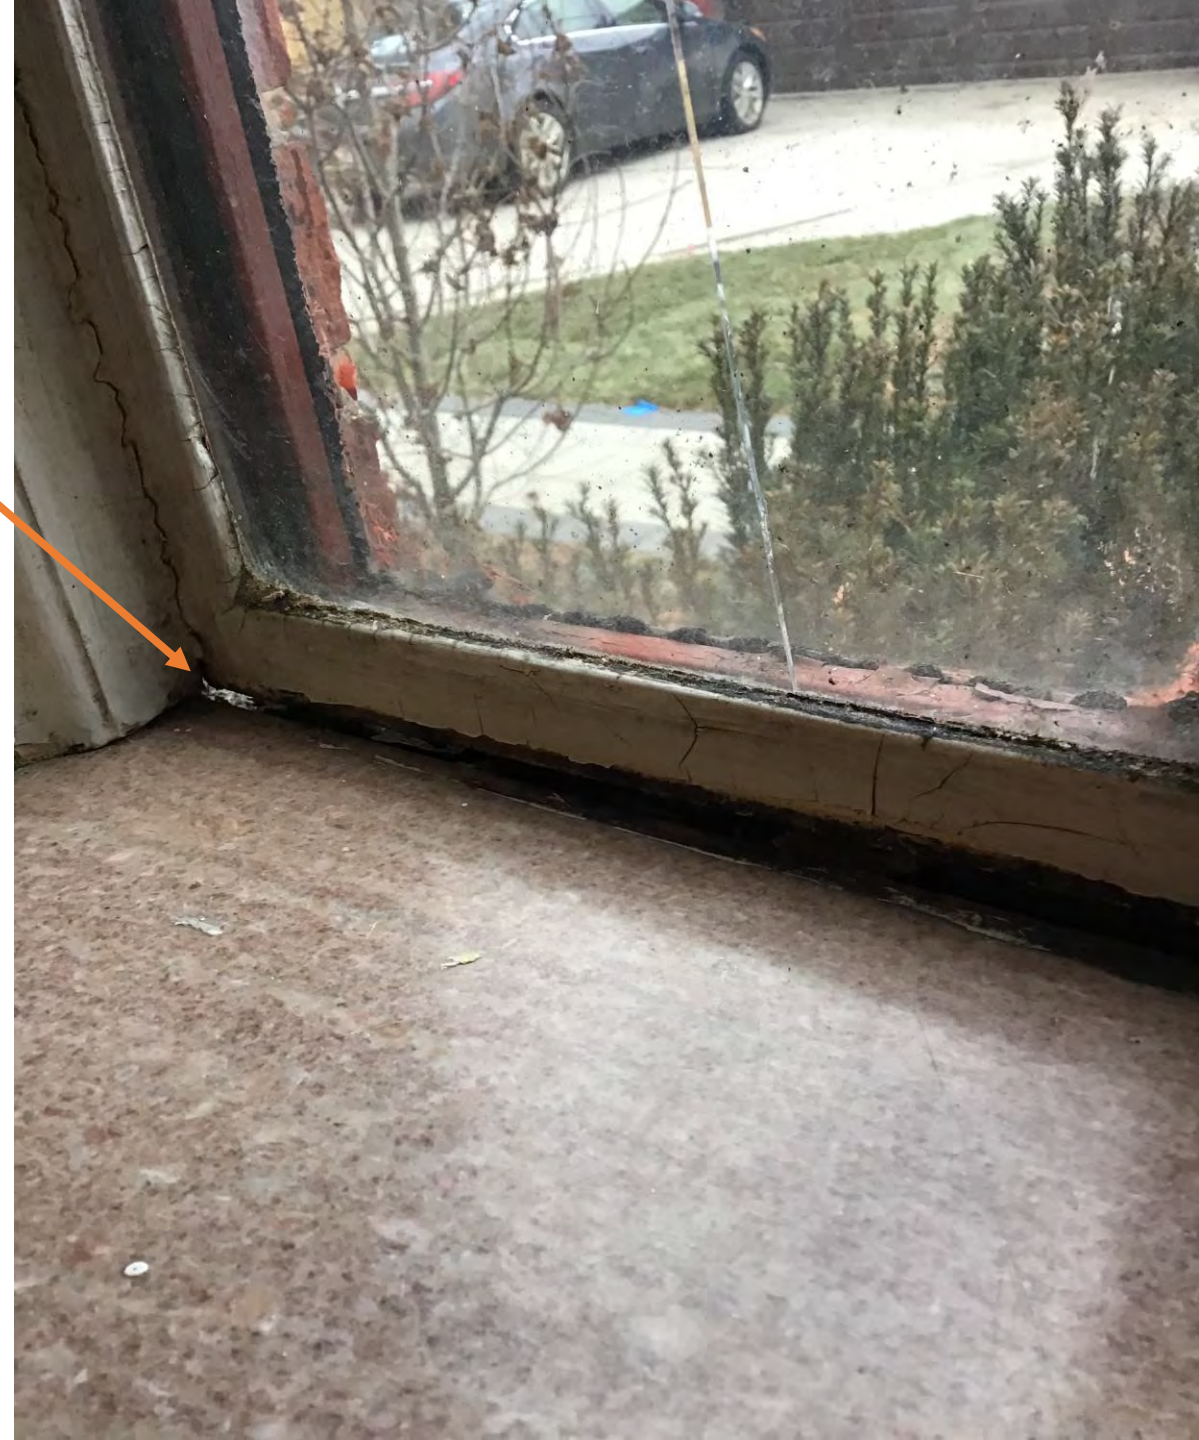
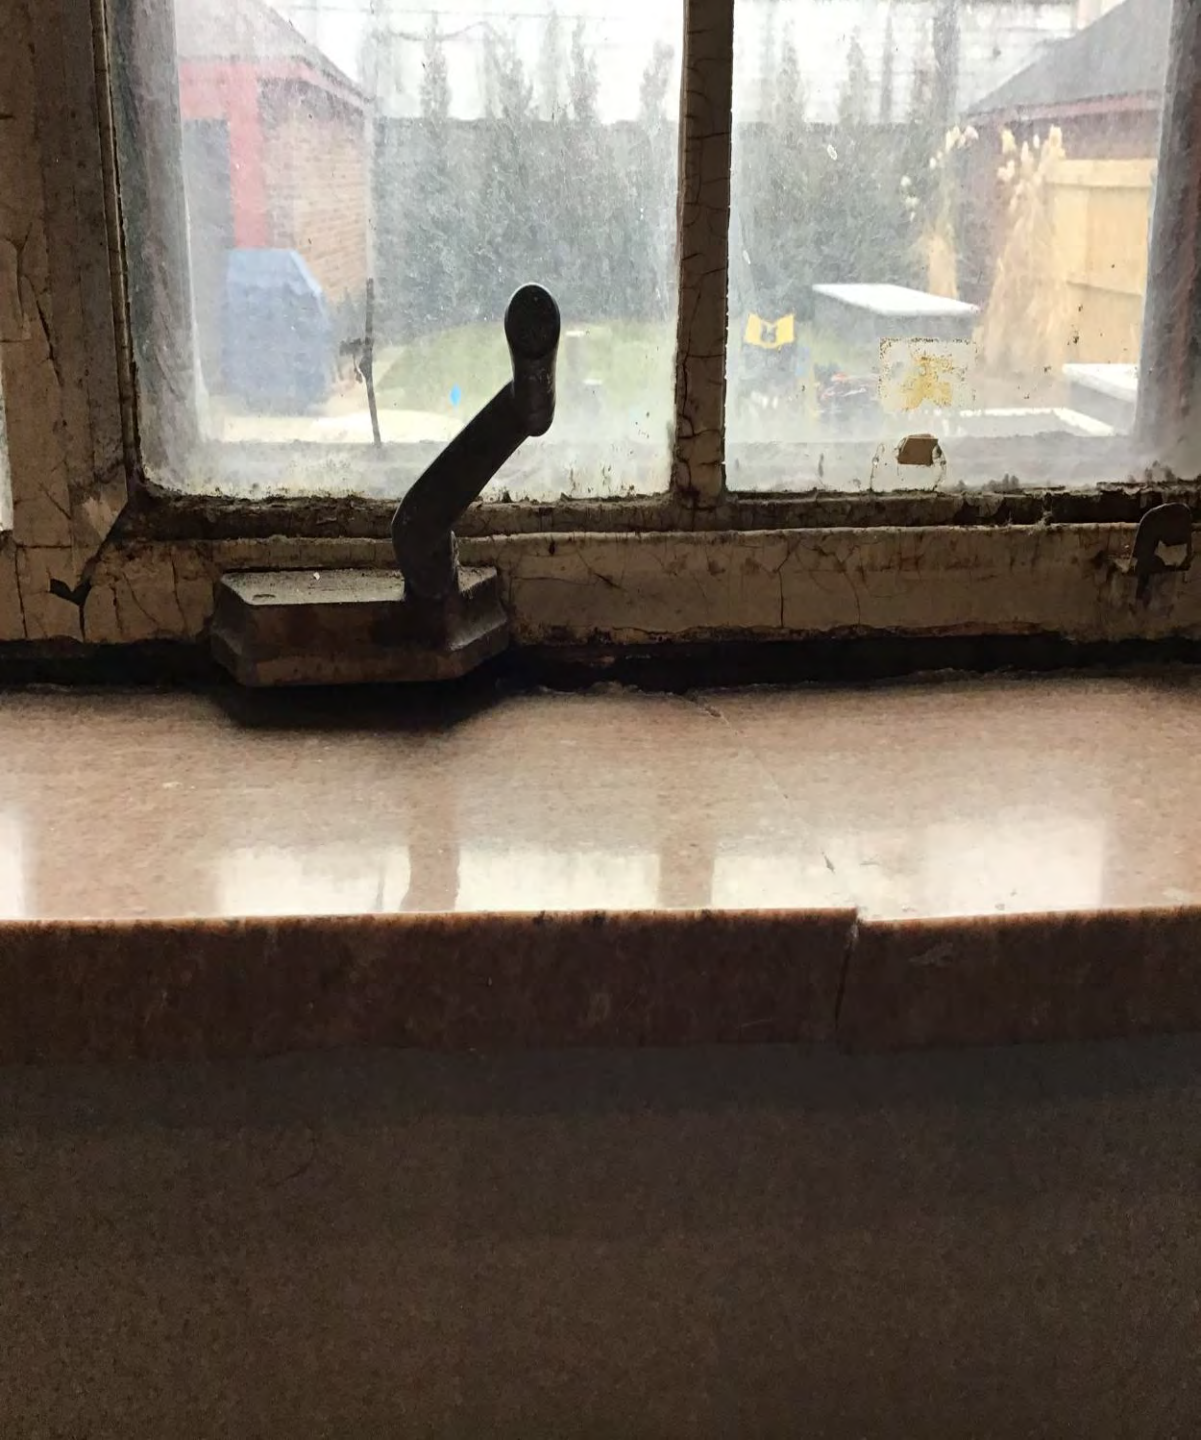
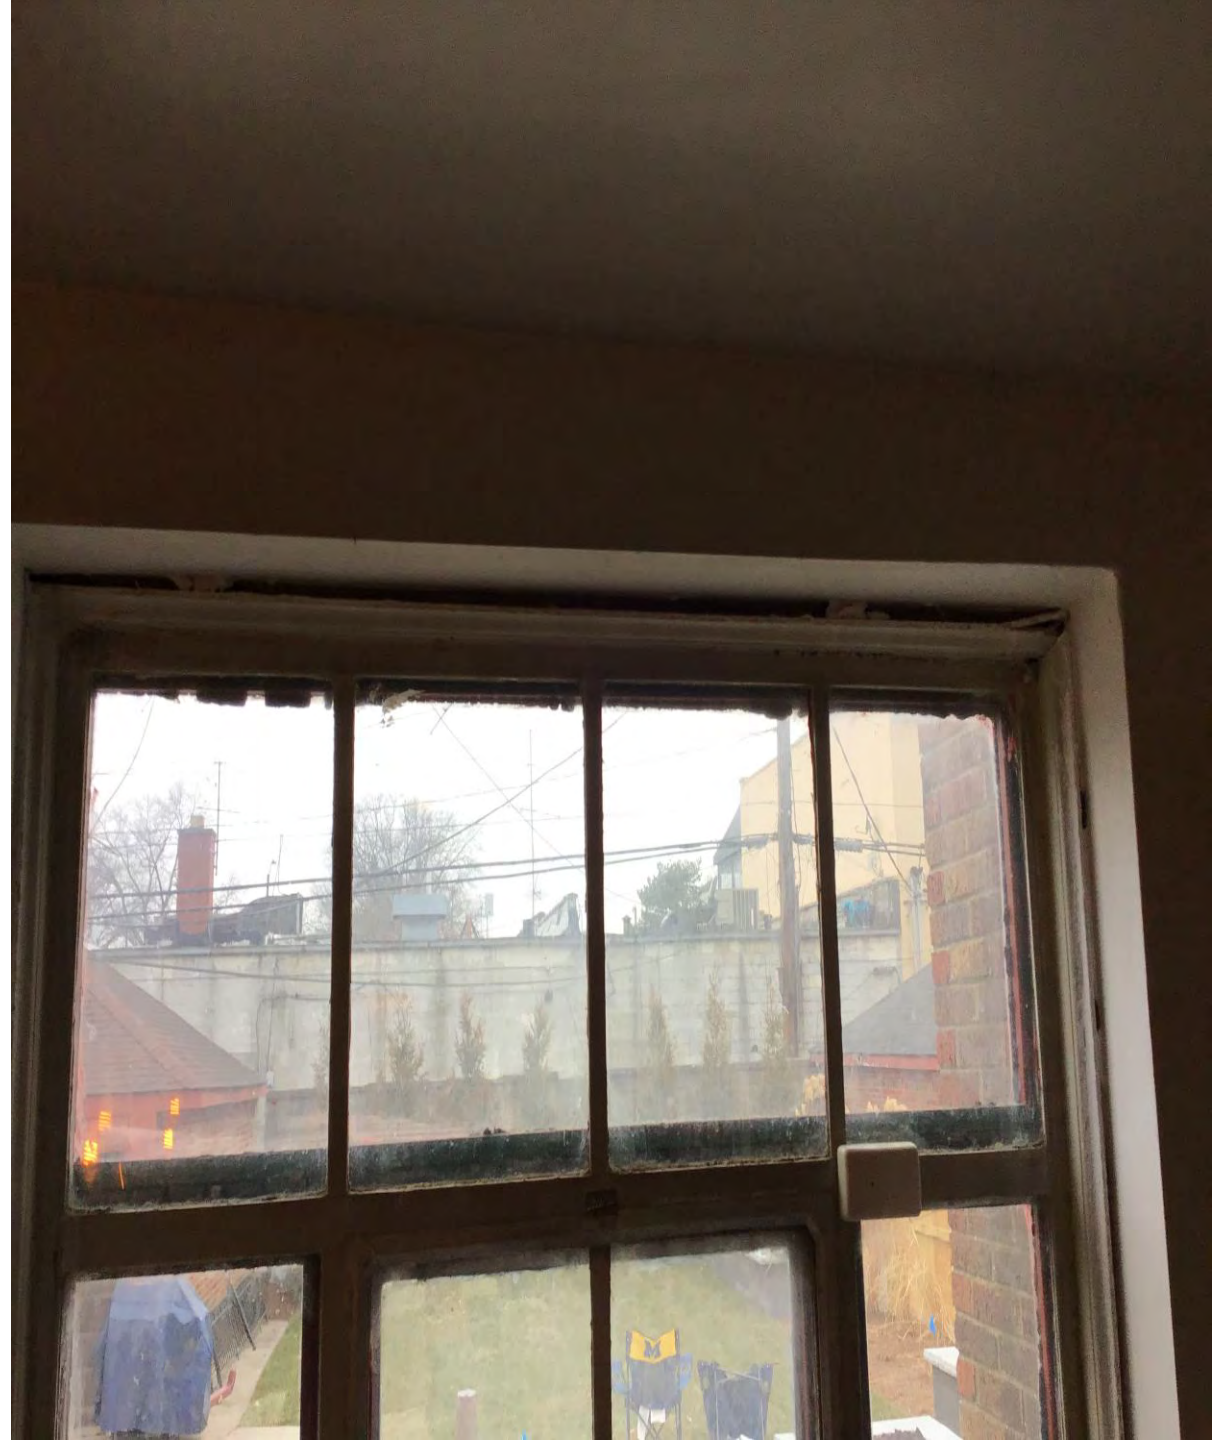
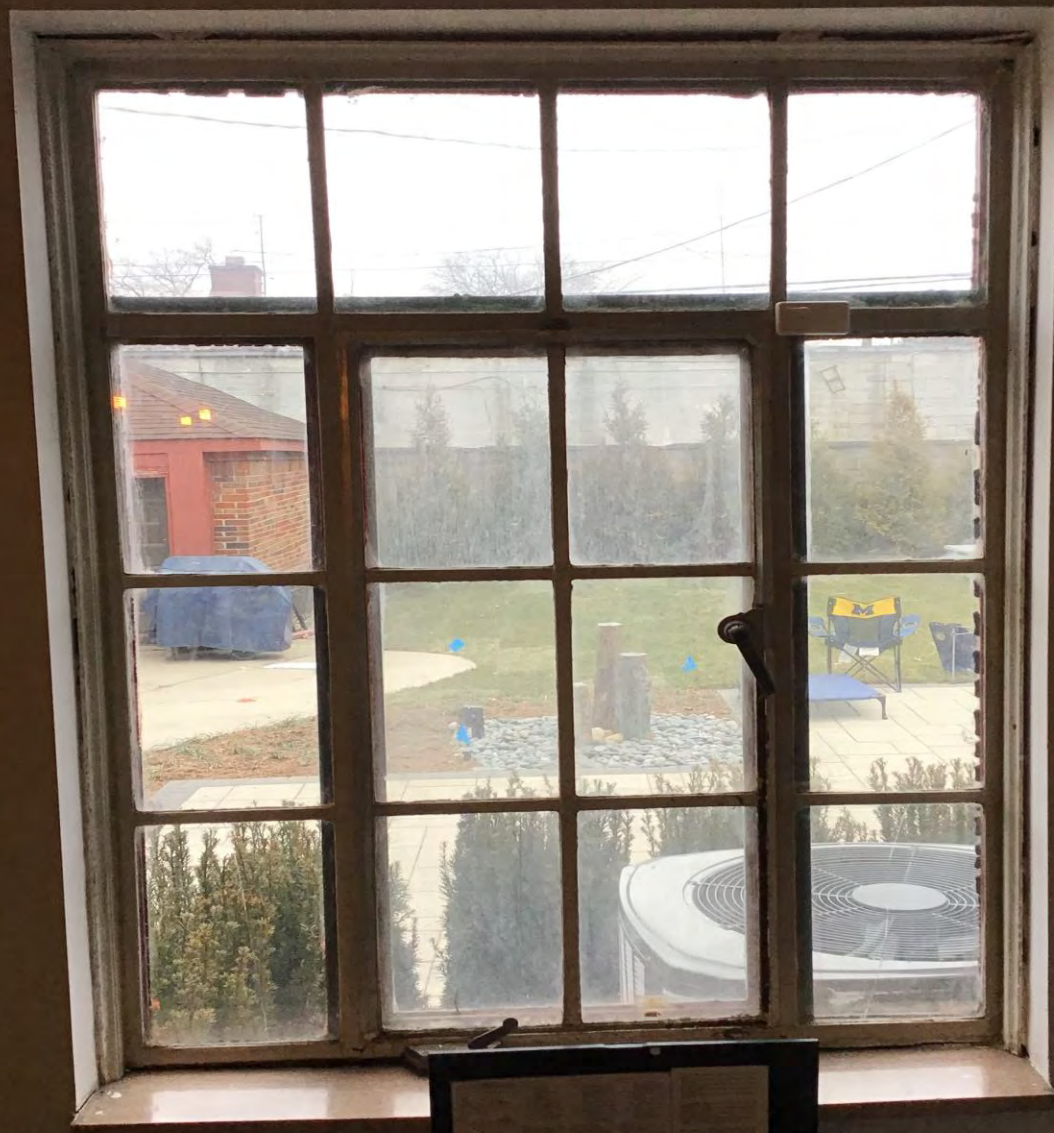
## WINDOW OPENING 108

- Single Casement Window
- Window is in Kitchen
- Window doesn't open
- Exterior sill is rotted, can see through
- Interior sill is cracked
- Windowpane cracked
- Screen missing
