**STAFF REPORT: FEBURARY 17, 2021 MEETING**

**APPLICATION NUMBER: 21-7091**

**ADDRESS: 19365 WARRINGTON**

**SCOPE OF WORK: REPLACE STEEL CASEMENT WINDOWS AS PROPOSED**

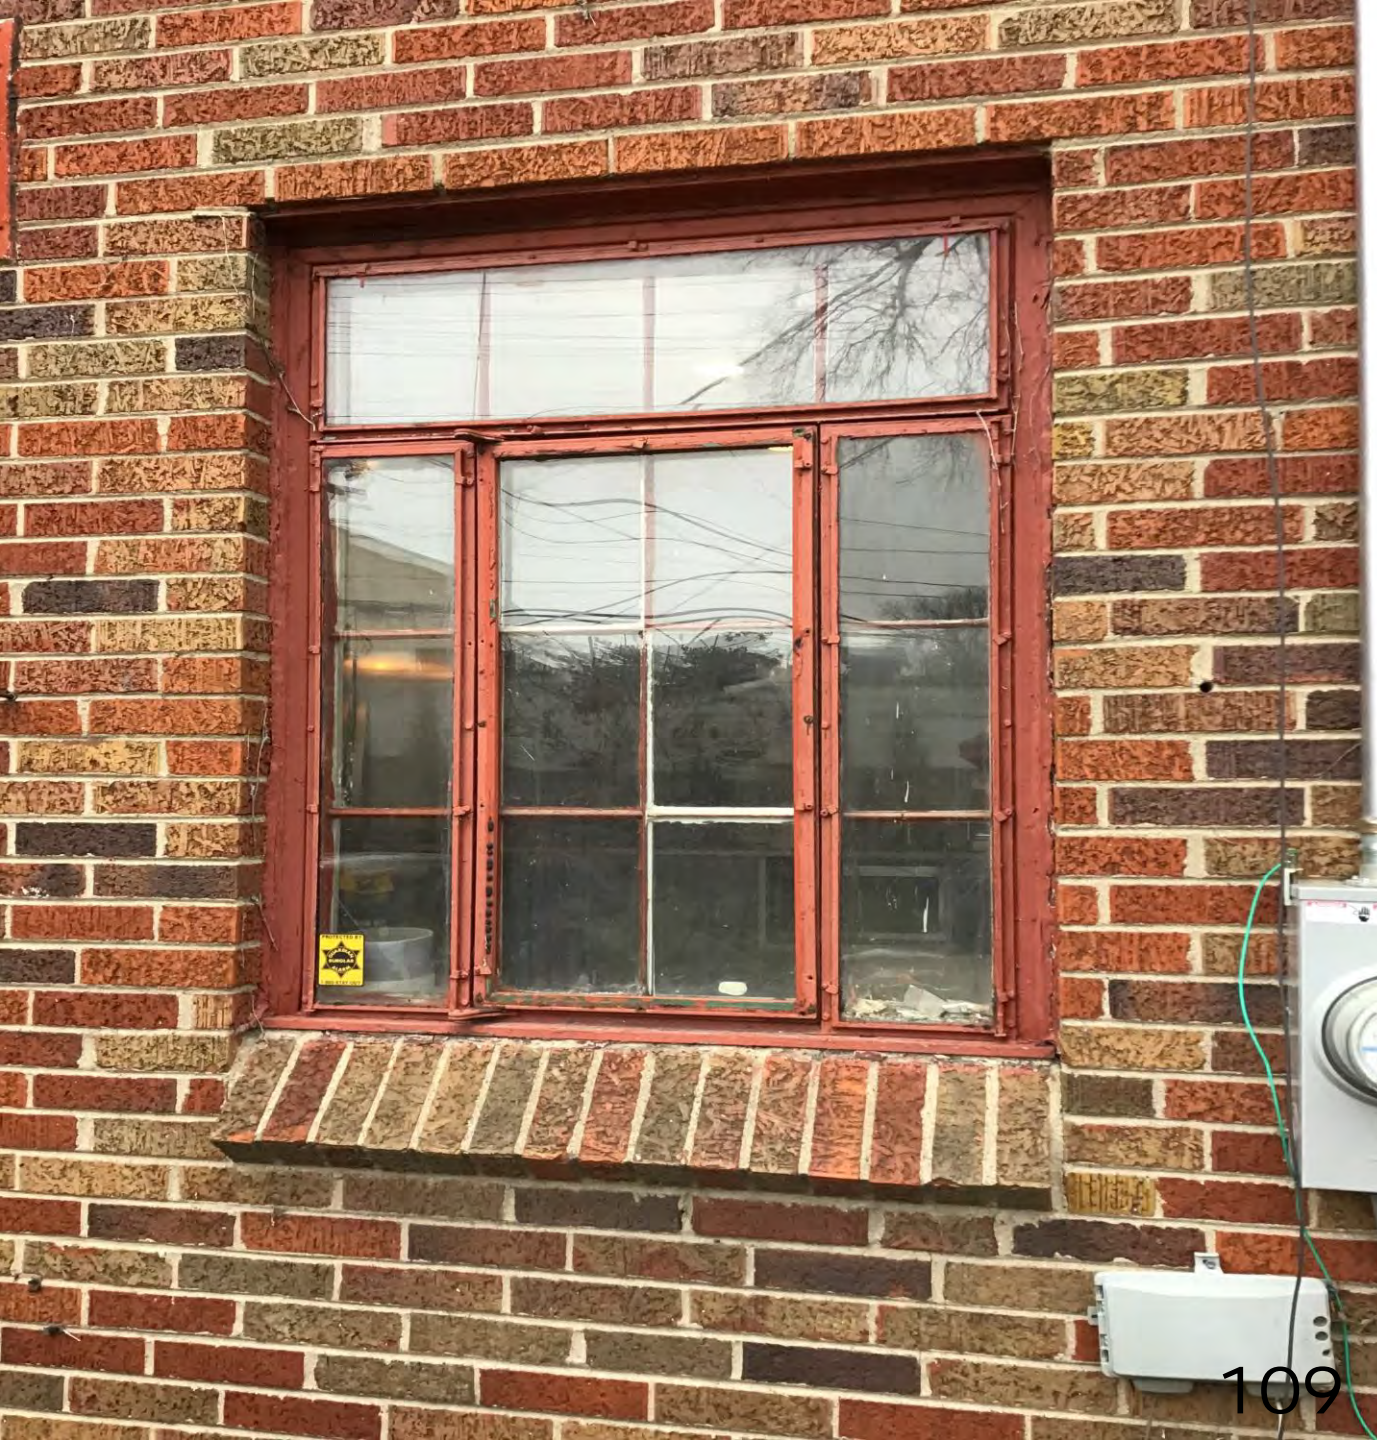
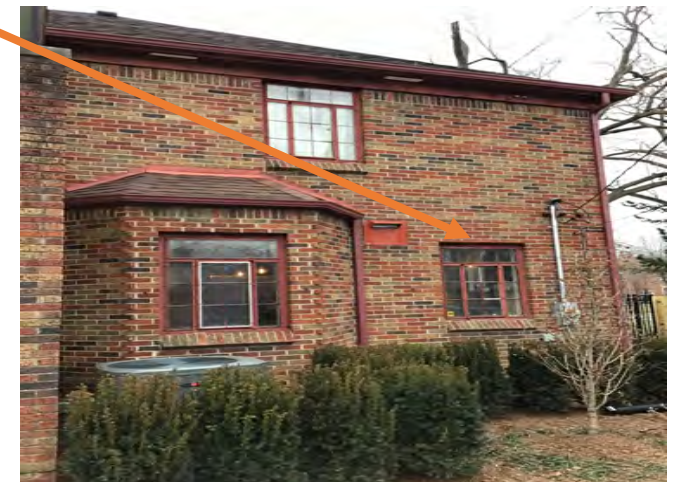
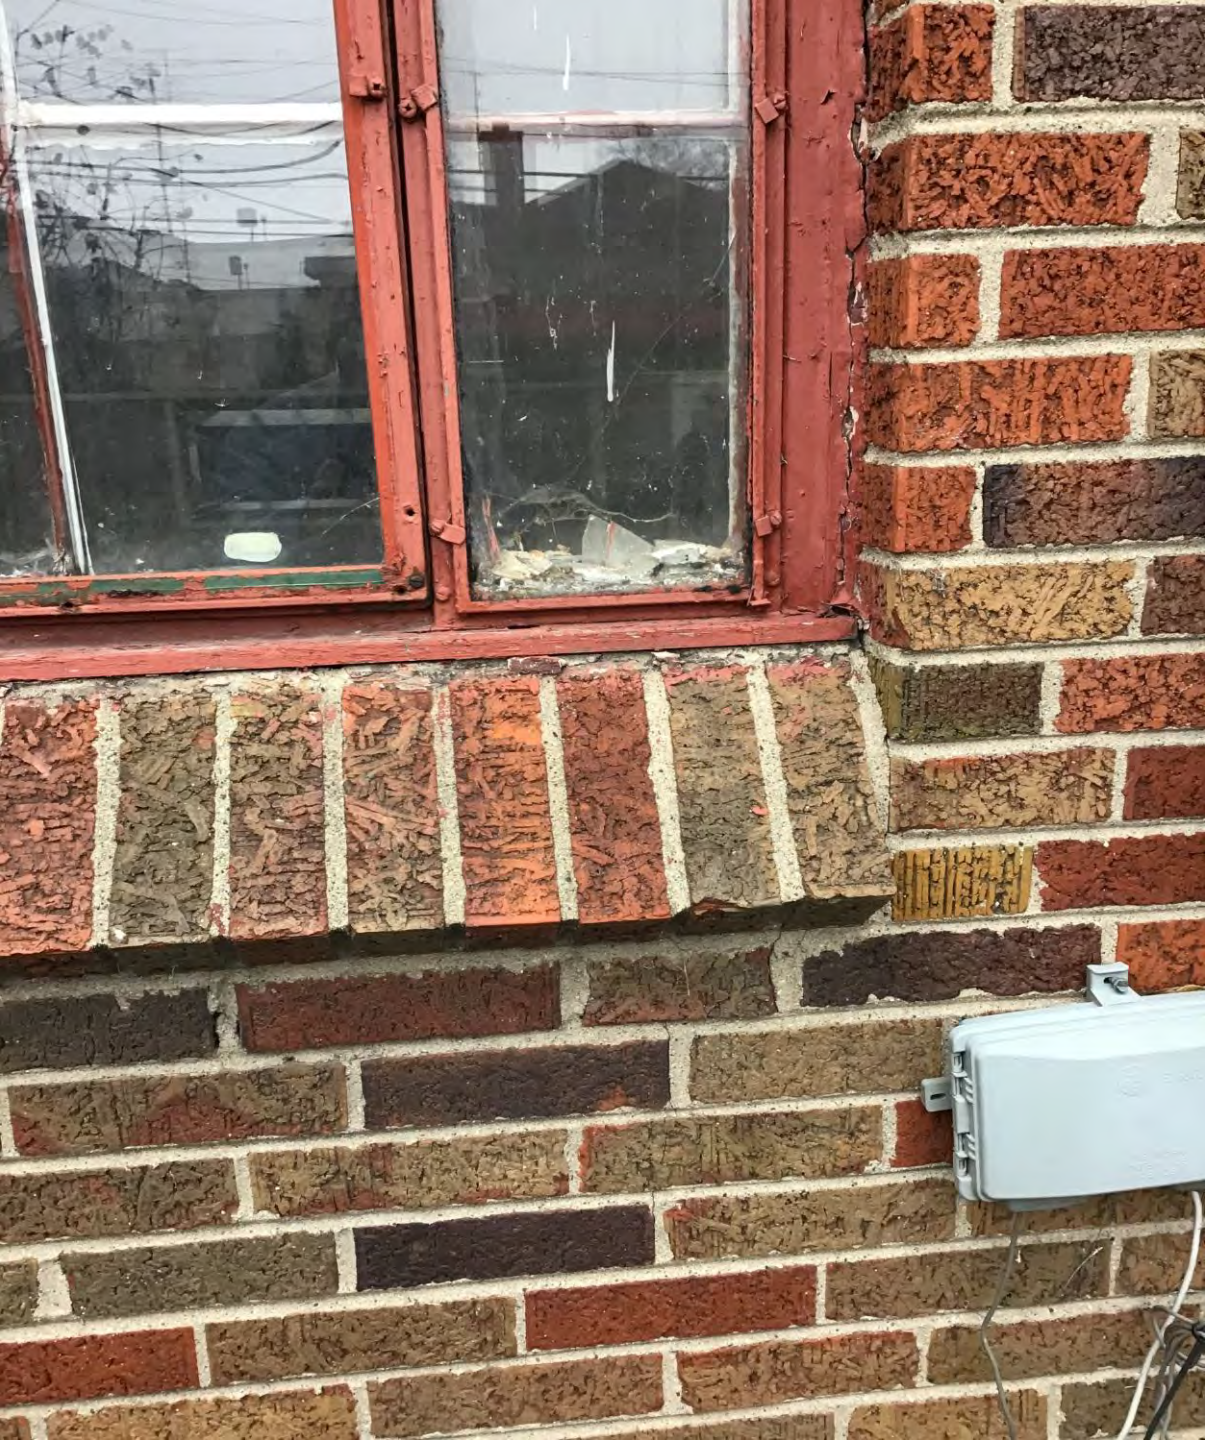
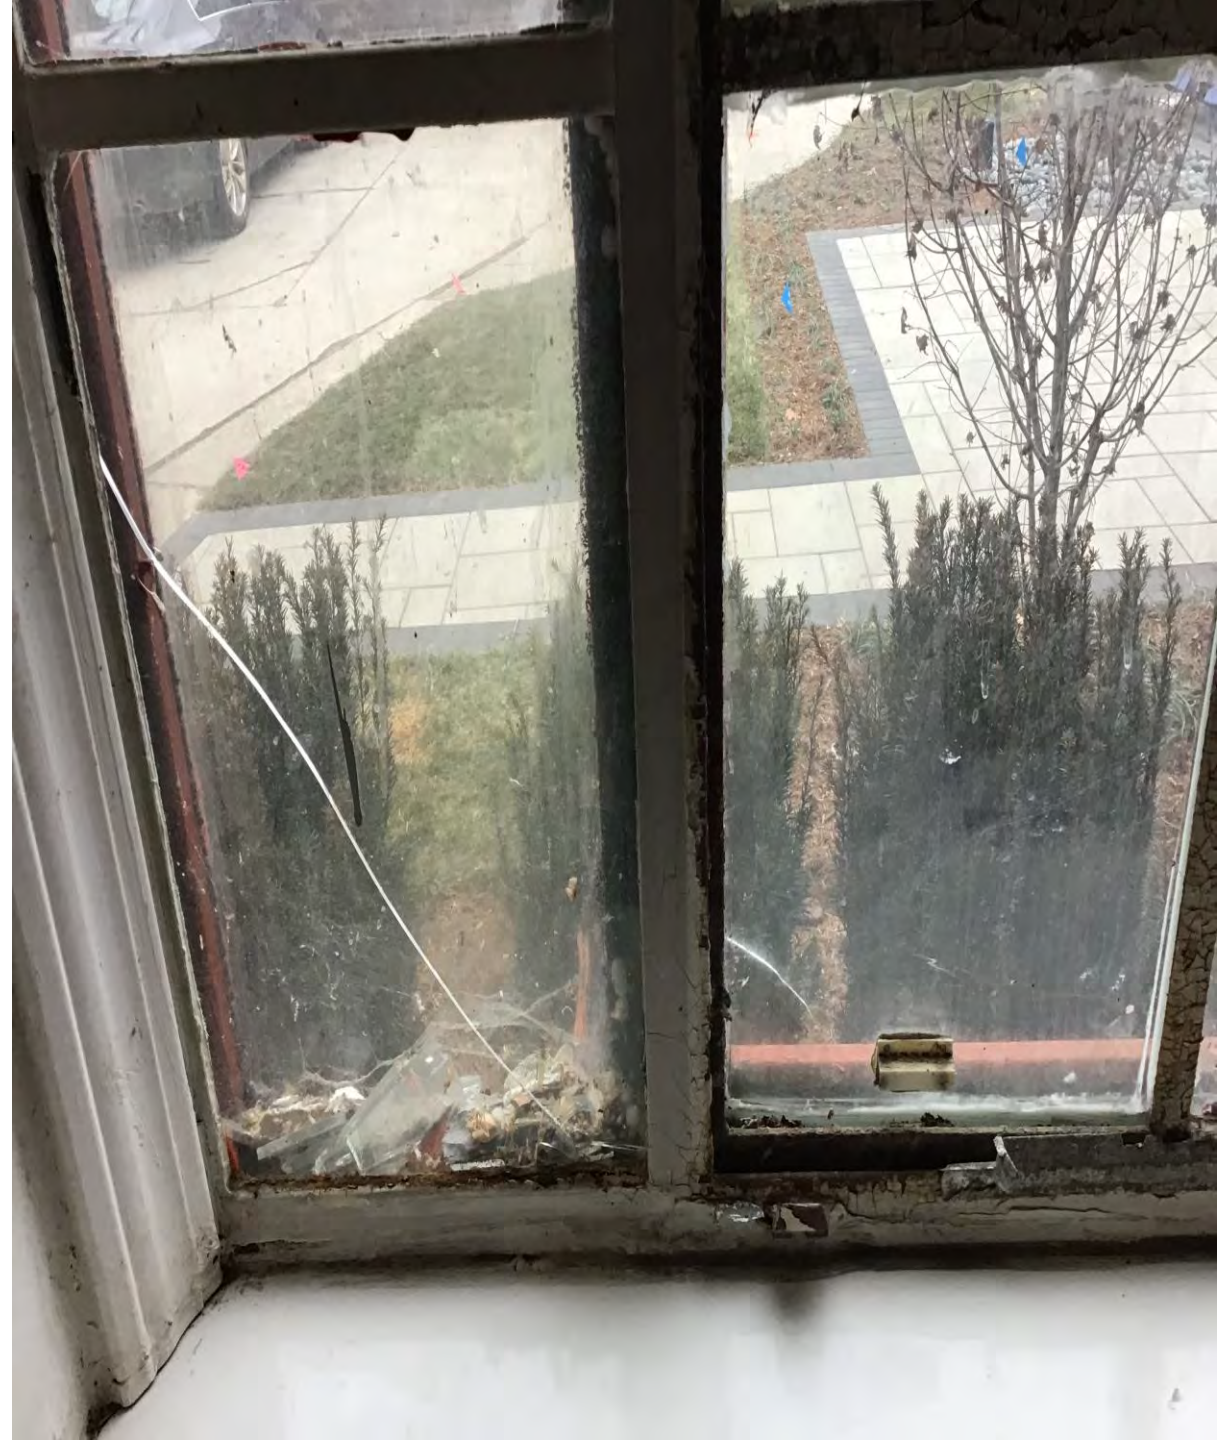
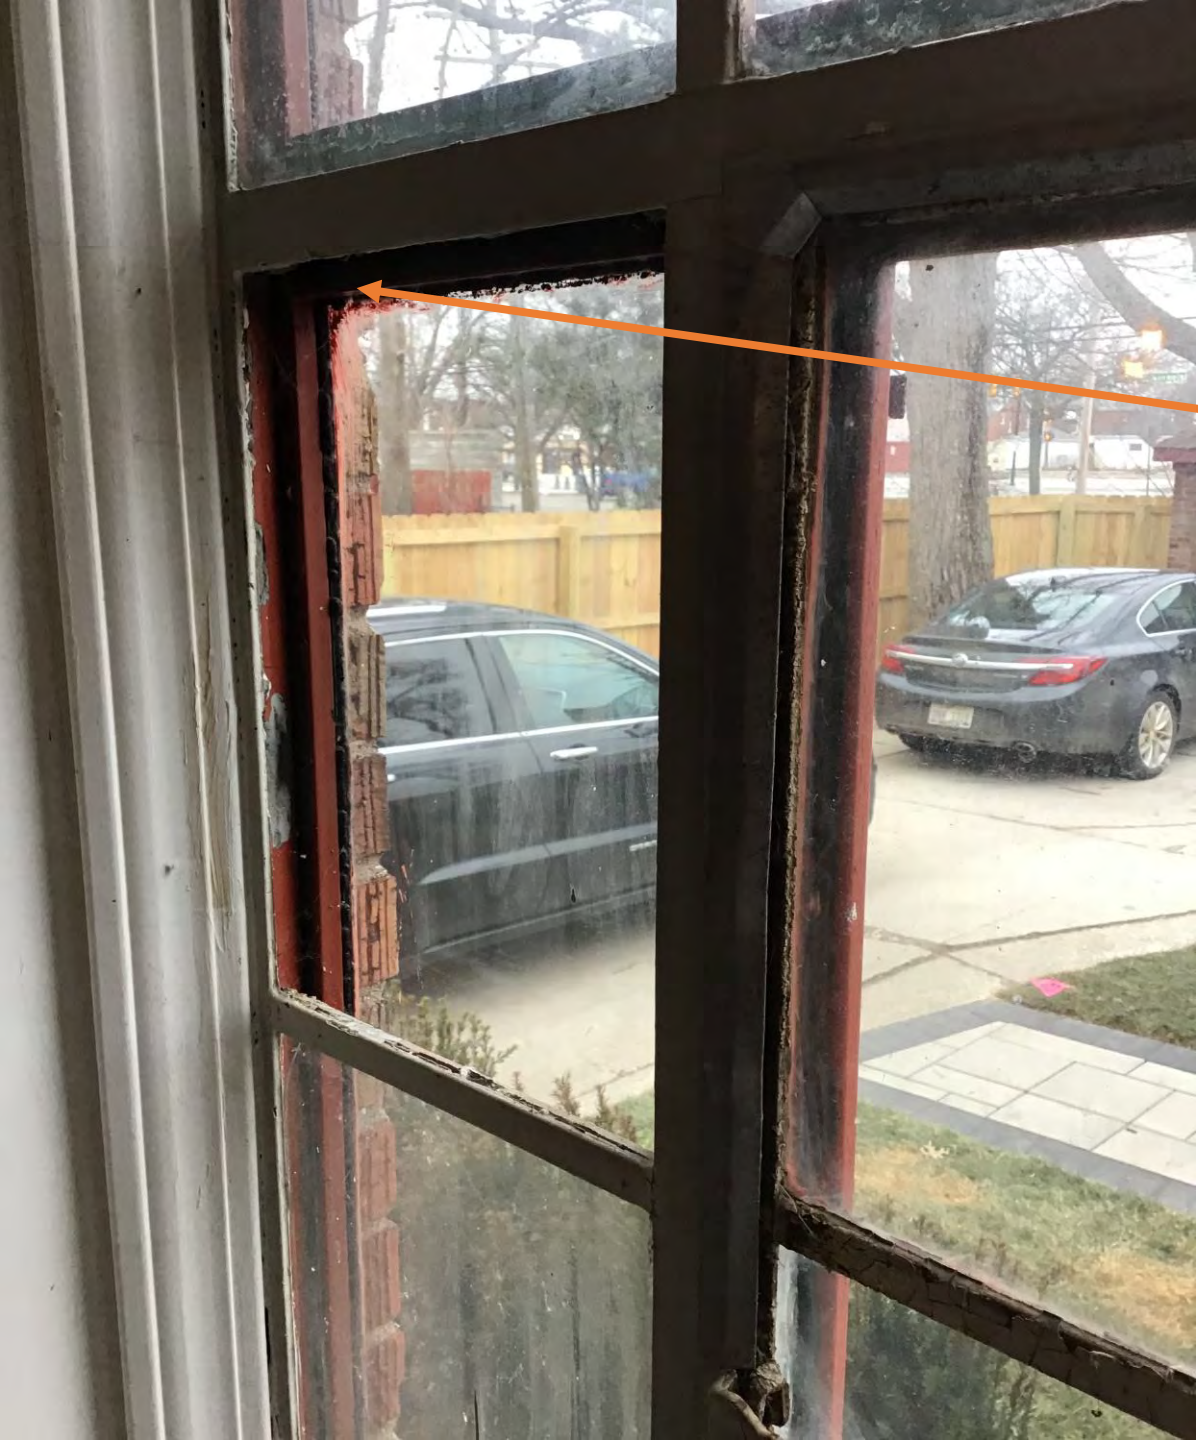
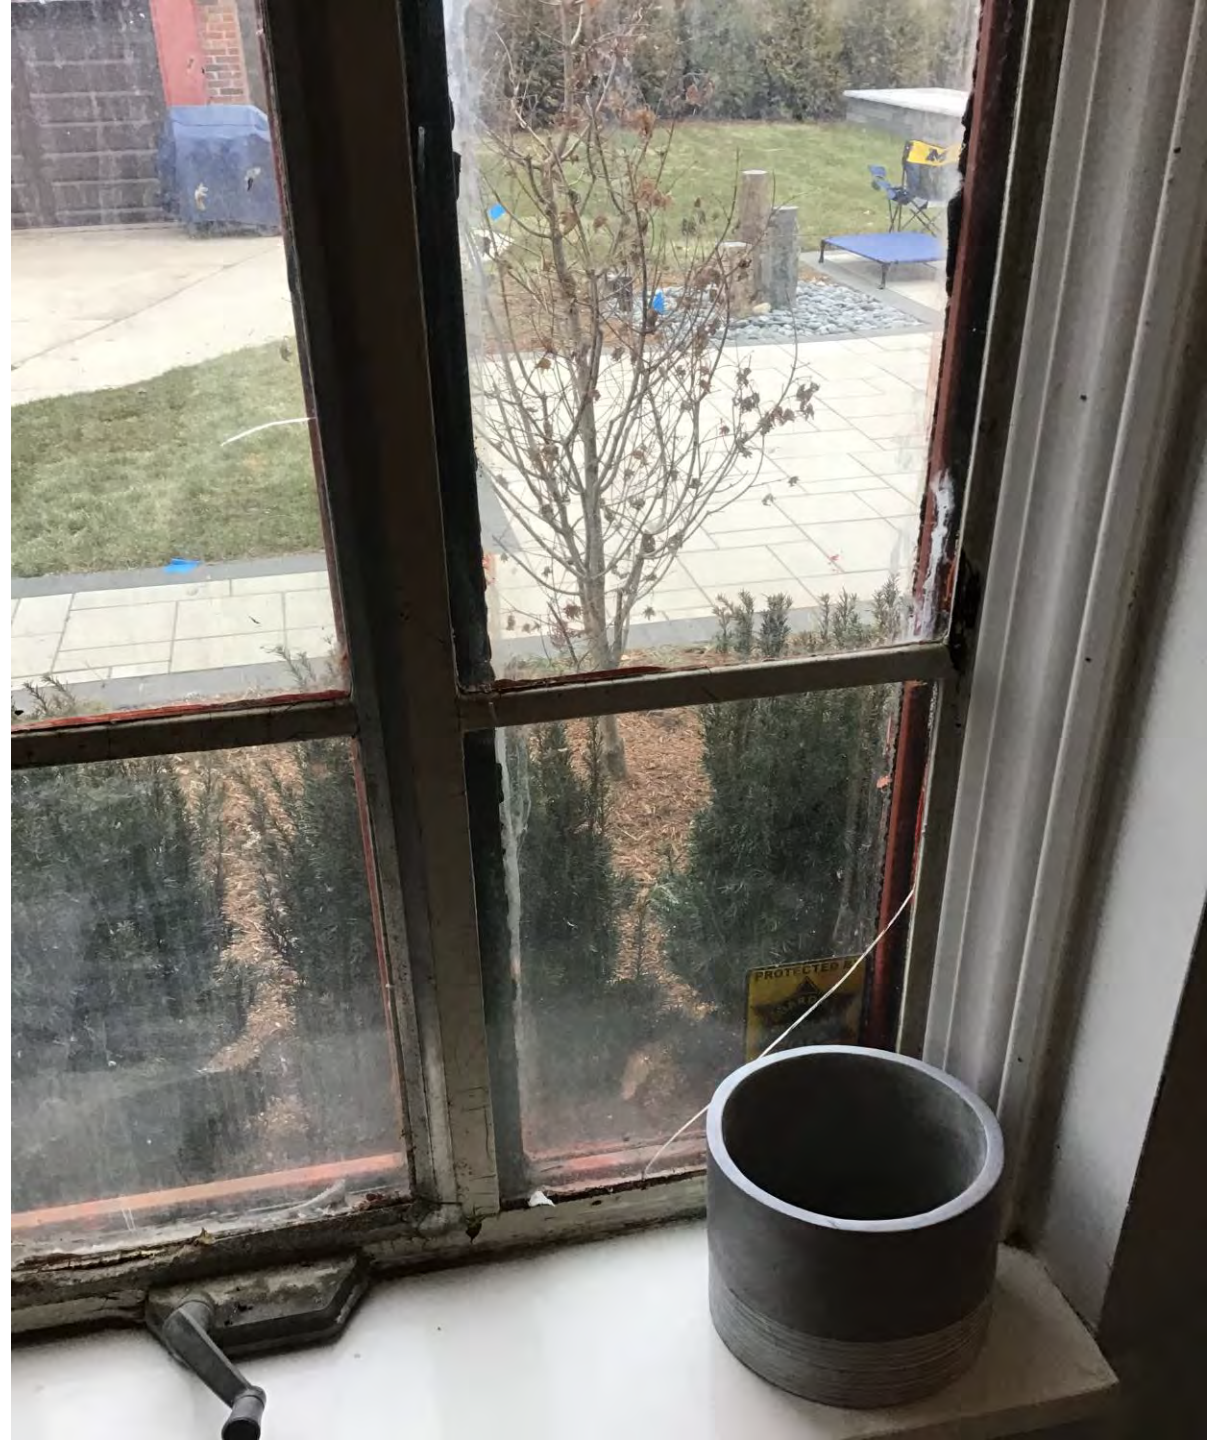
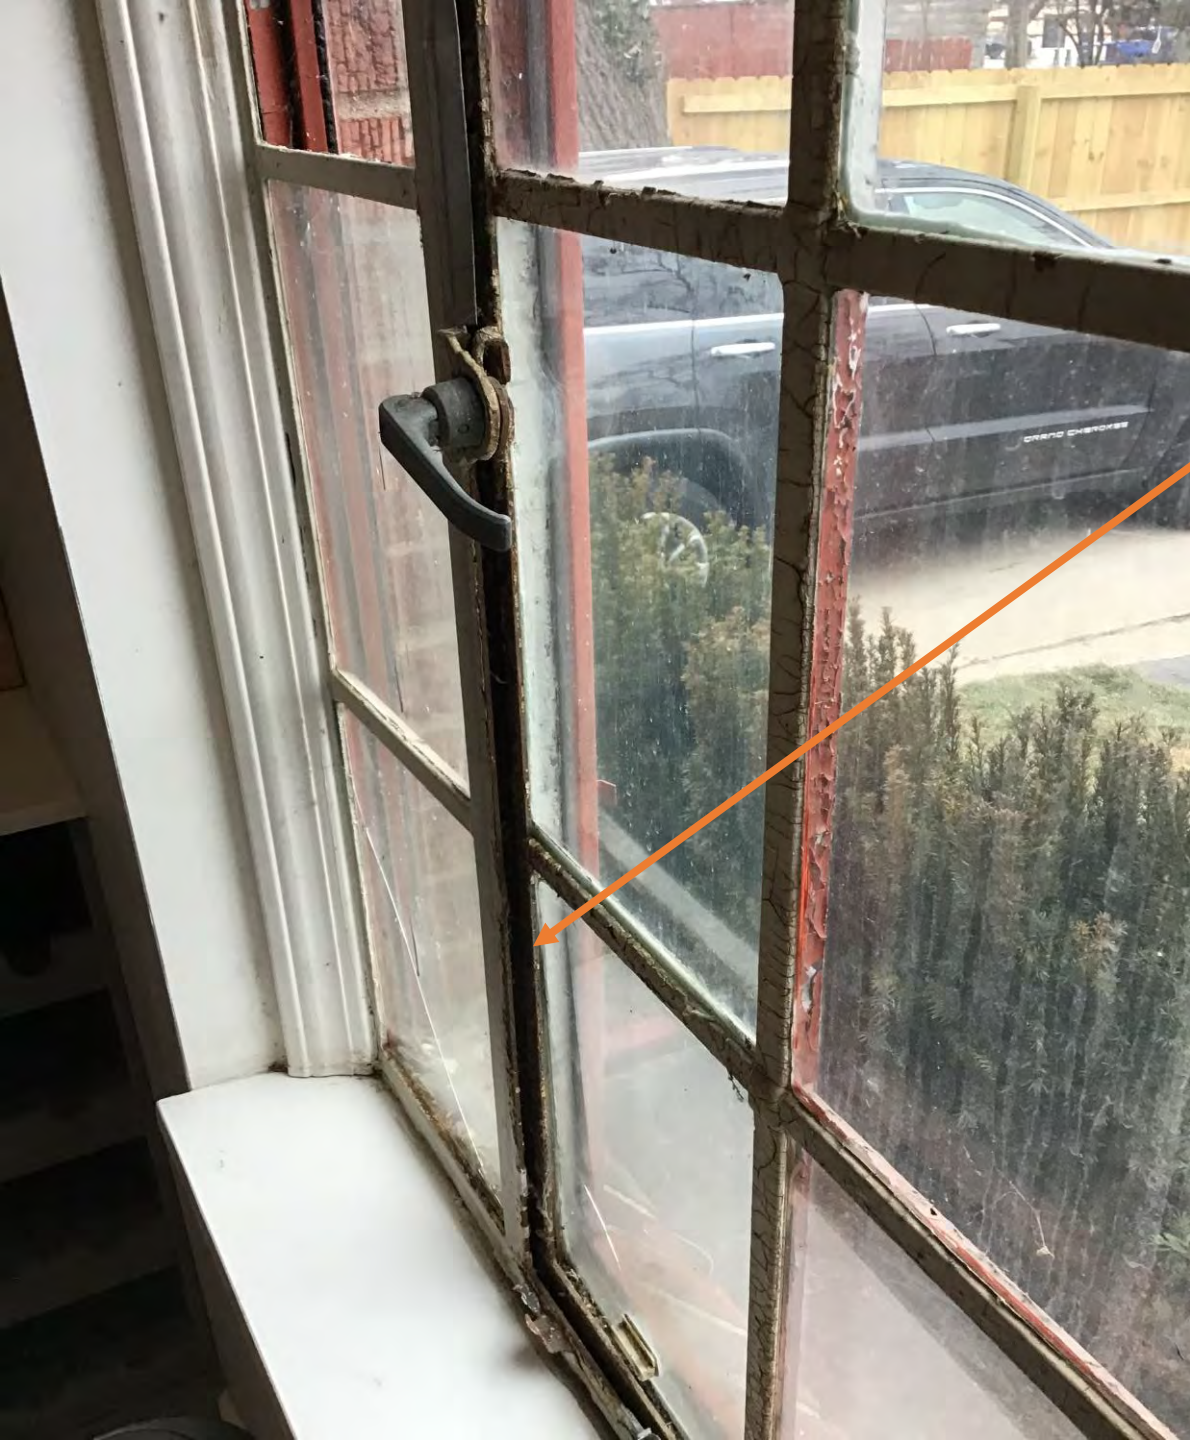
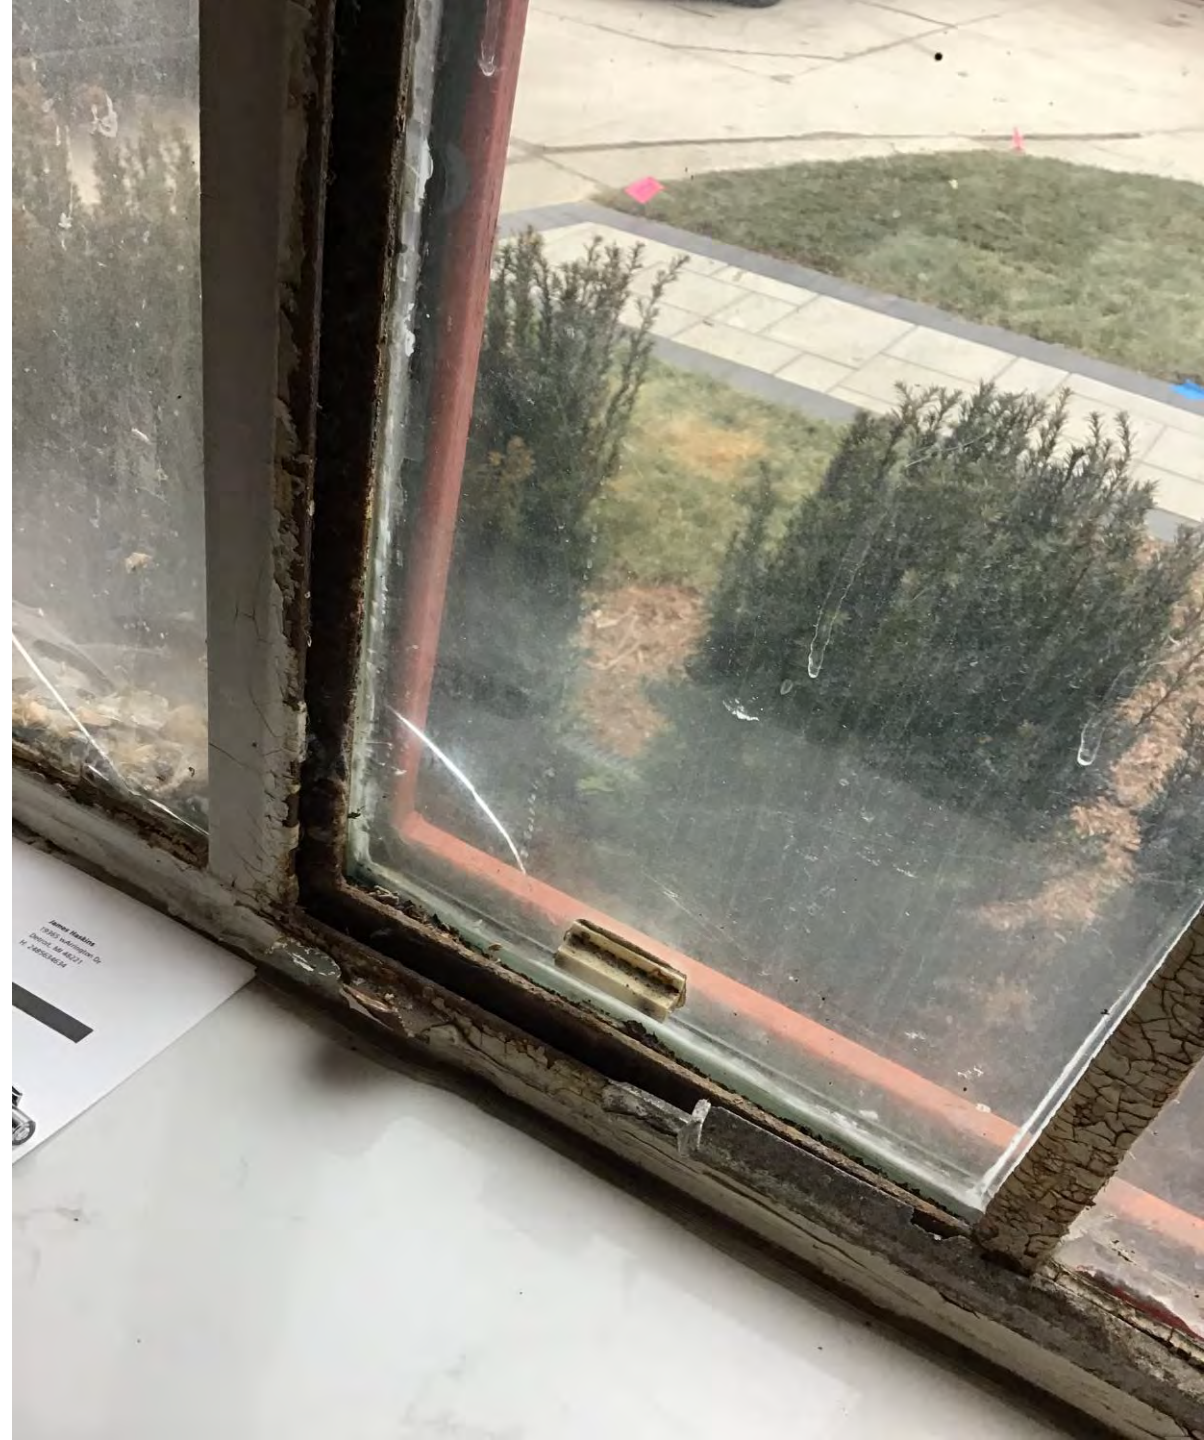
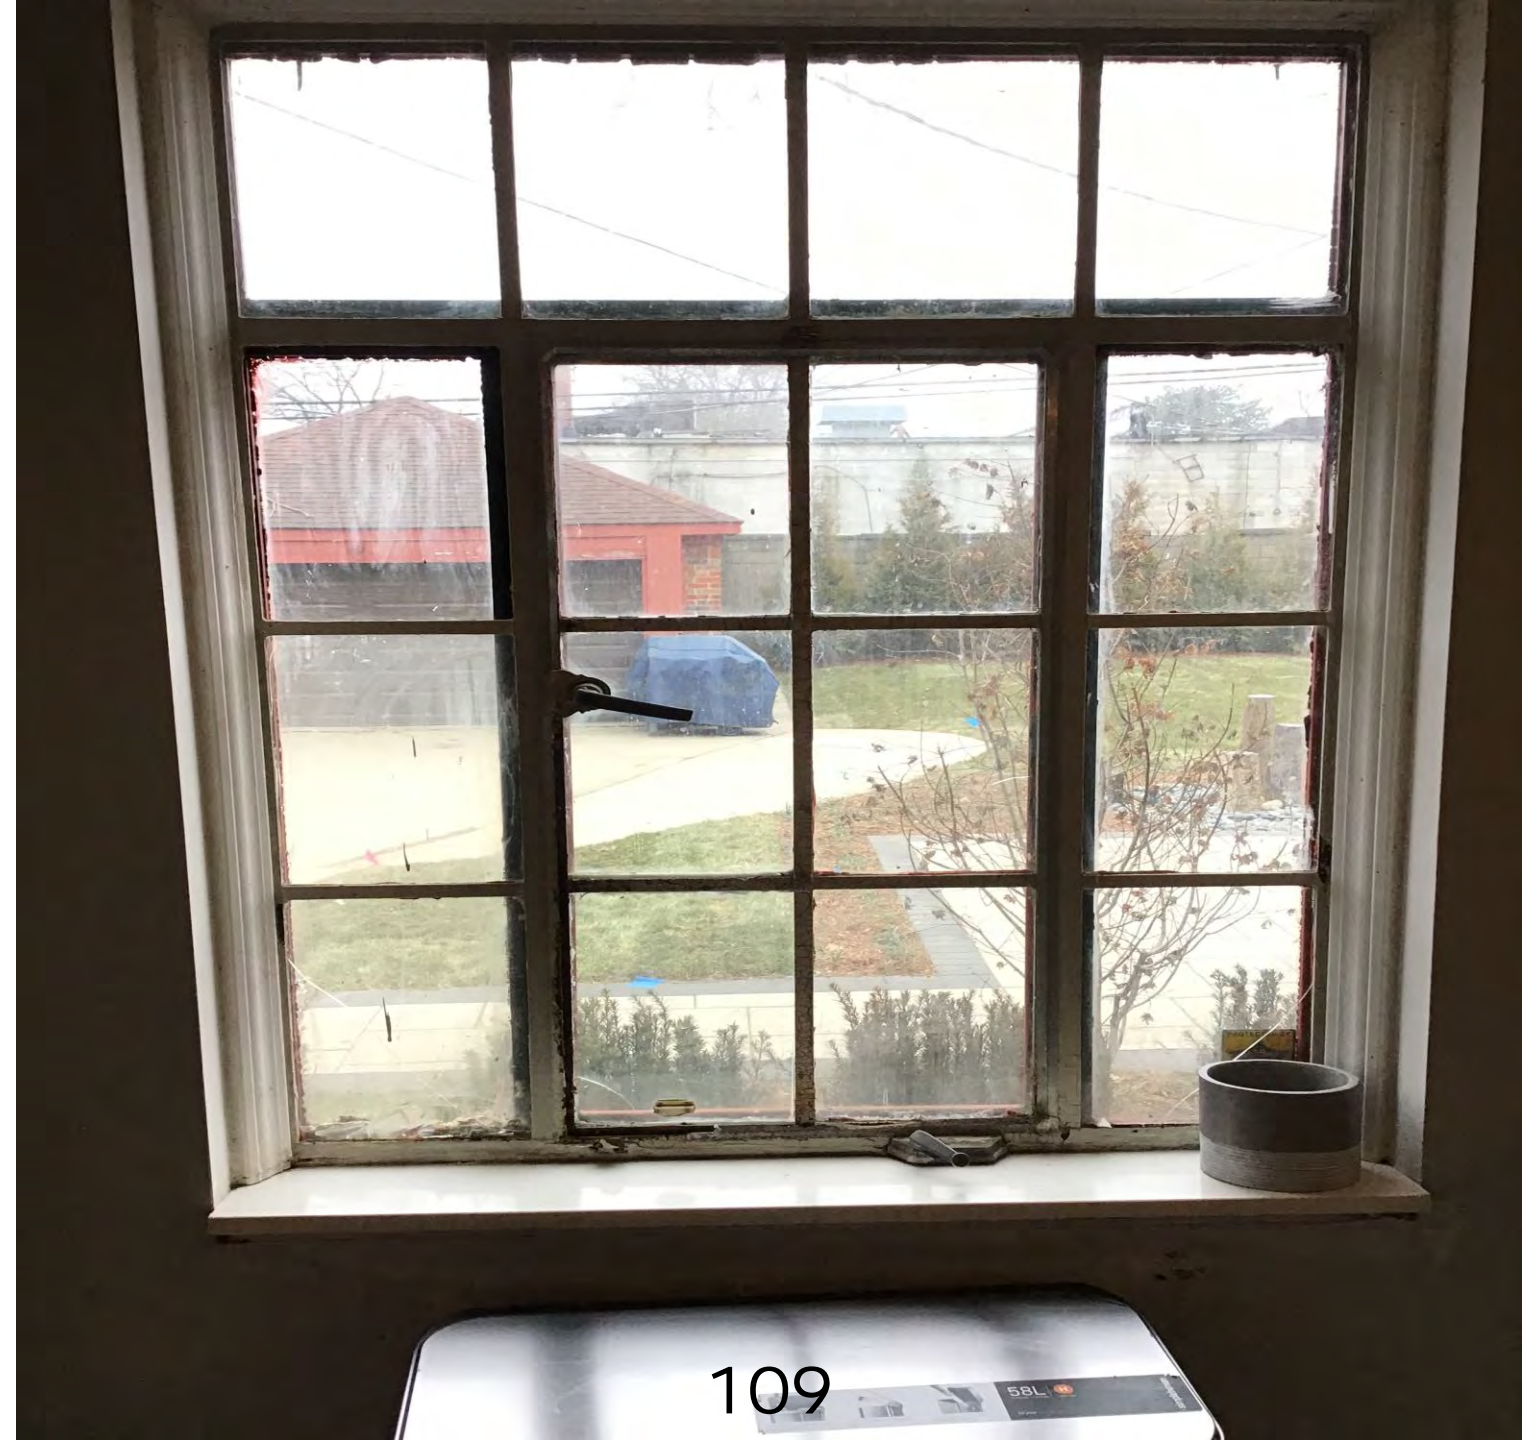
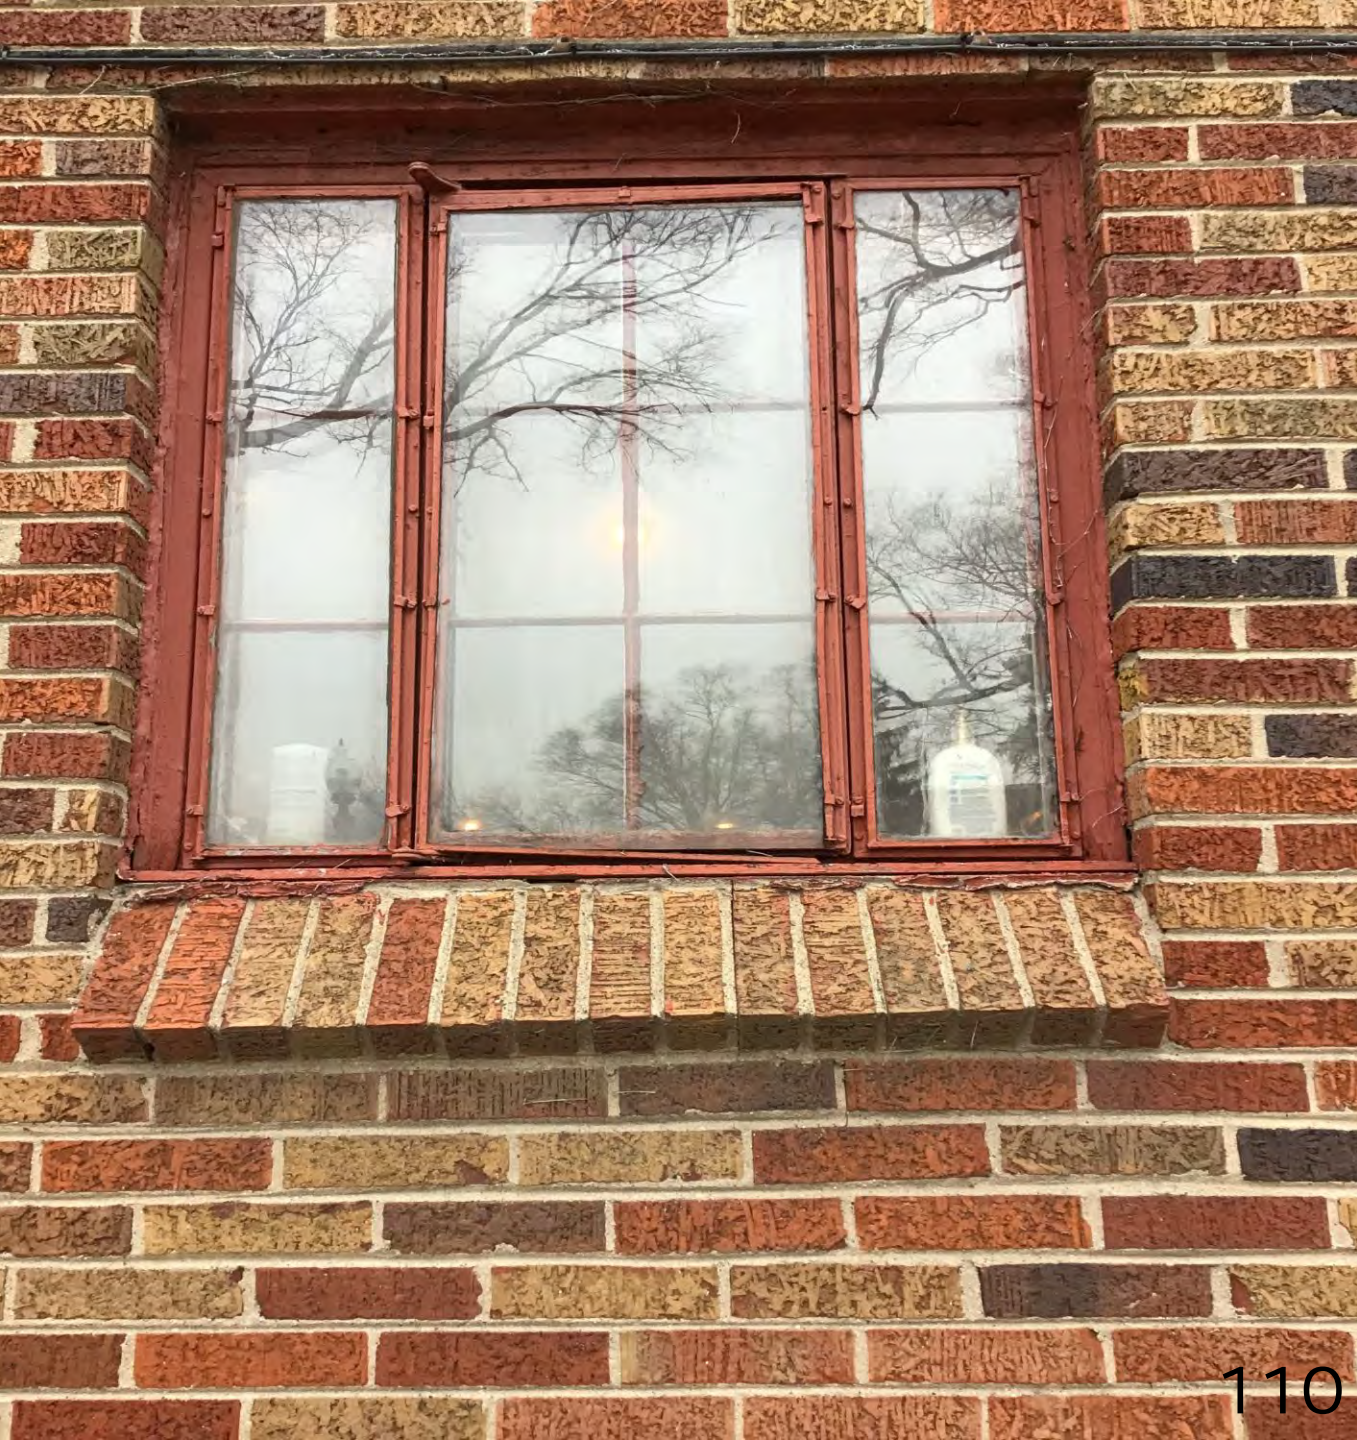
## WINDOW OPENING 109 Kitchen - Back of House

- Single Casement Window
- Window is in Kitchen
- Window won't open
- Broken and cracked windowpanes

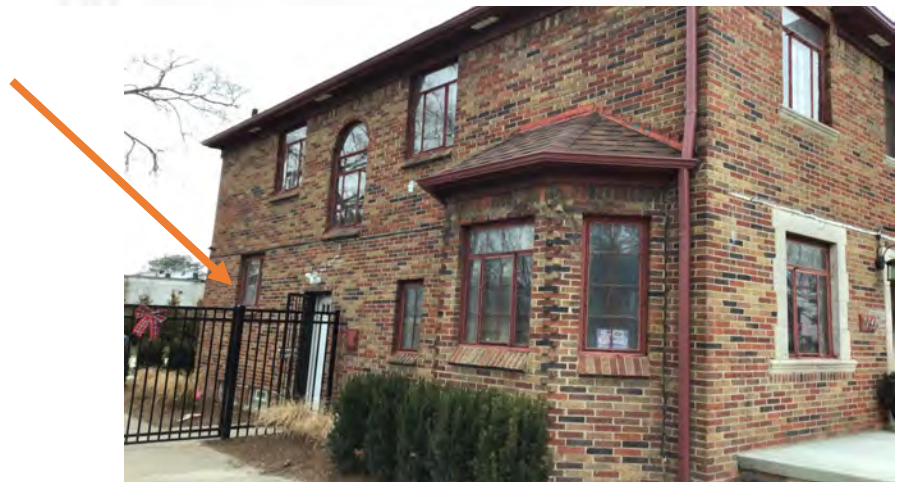
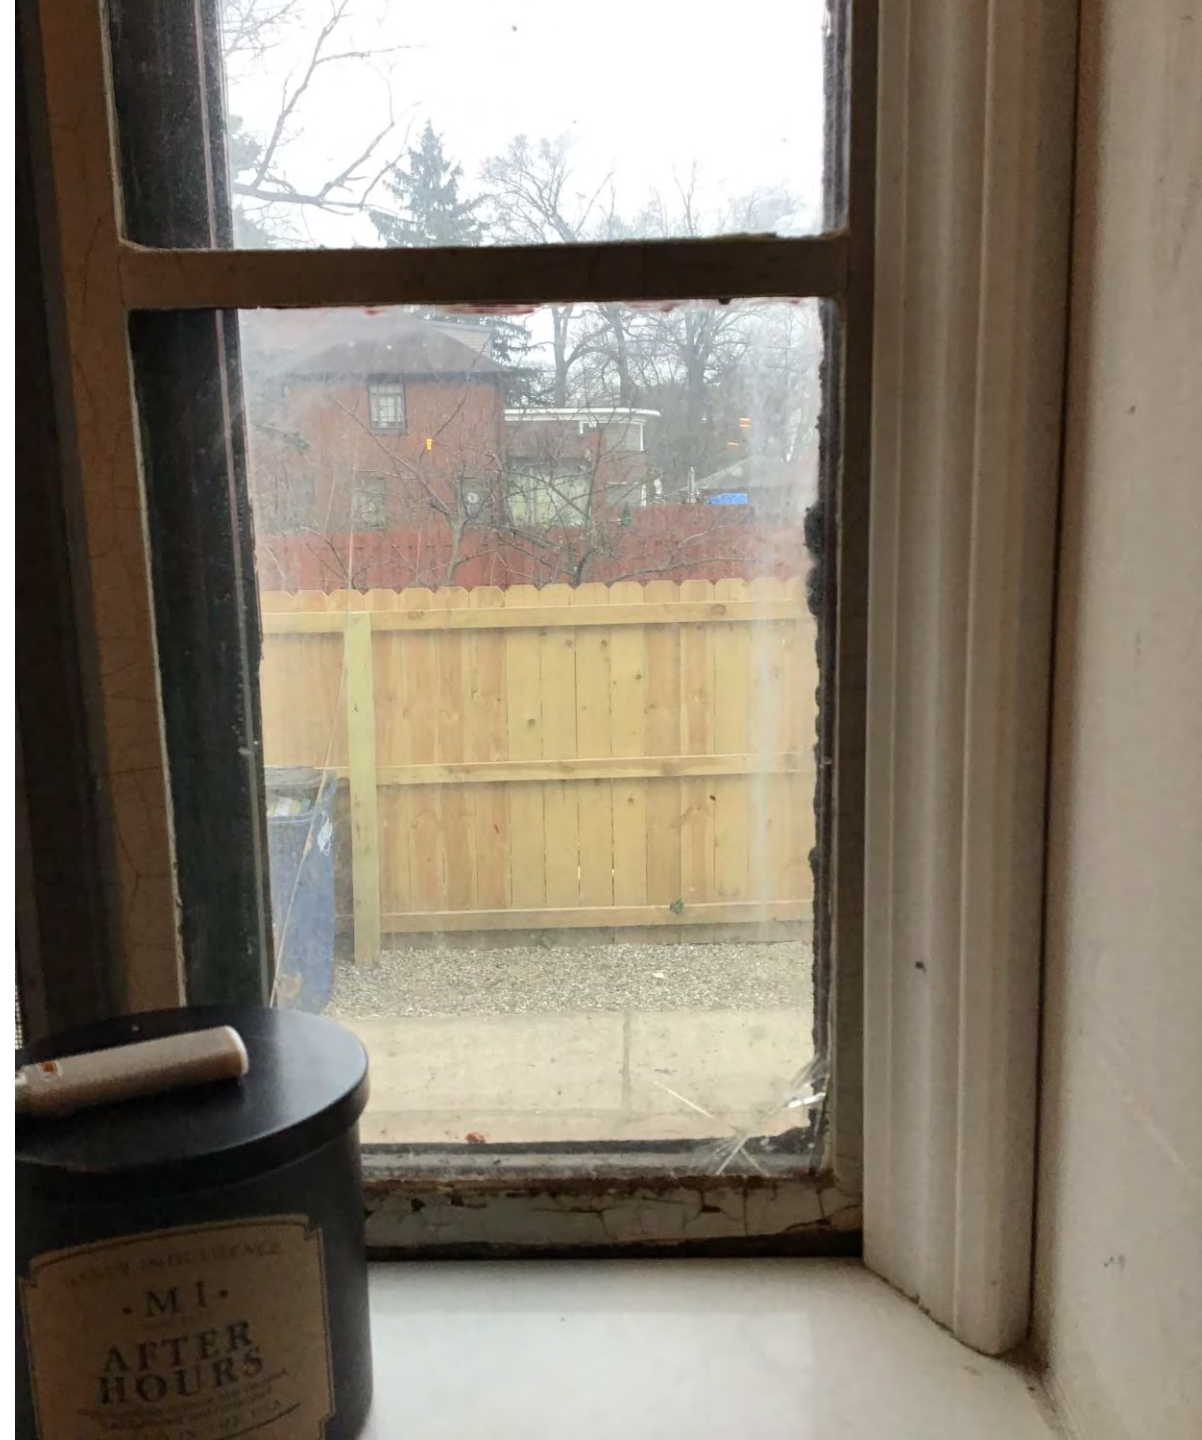
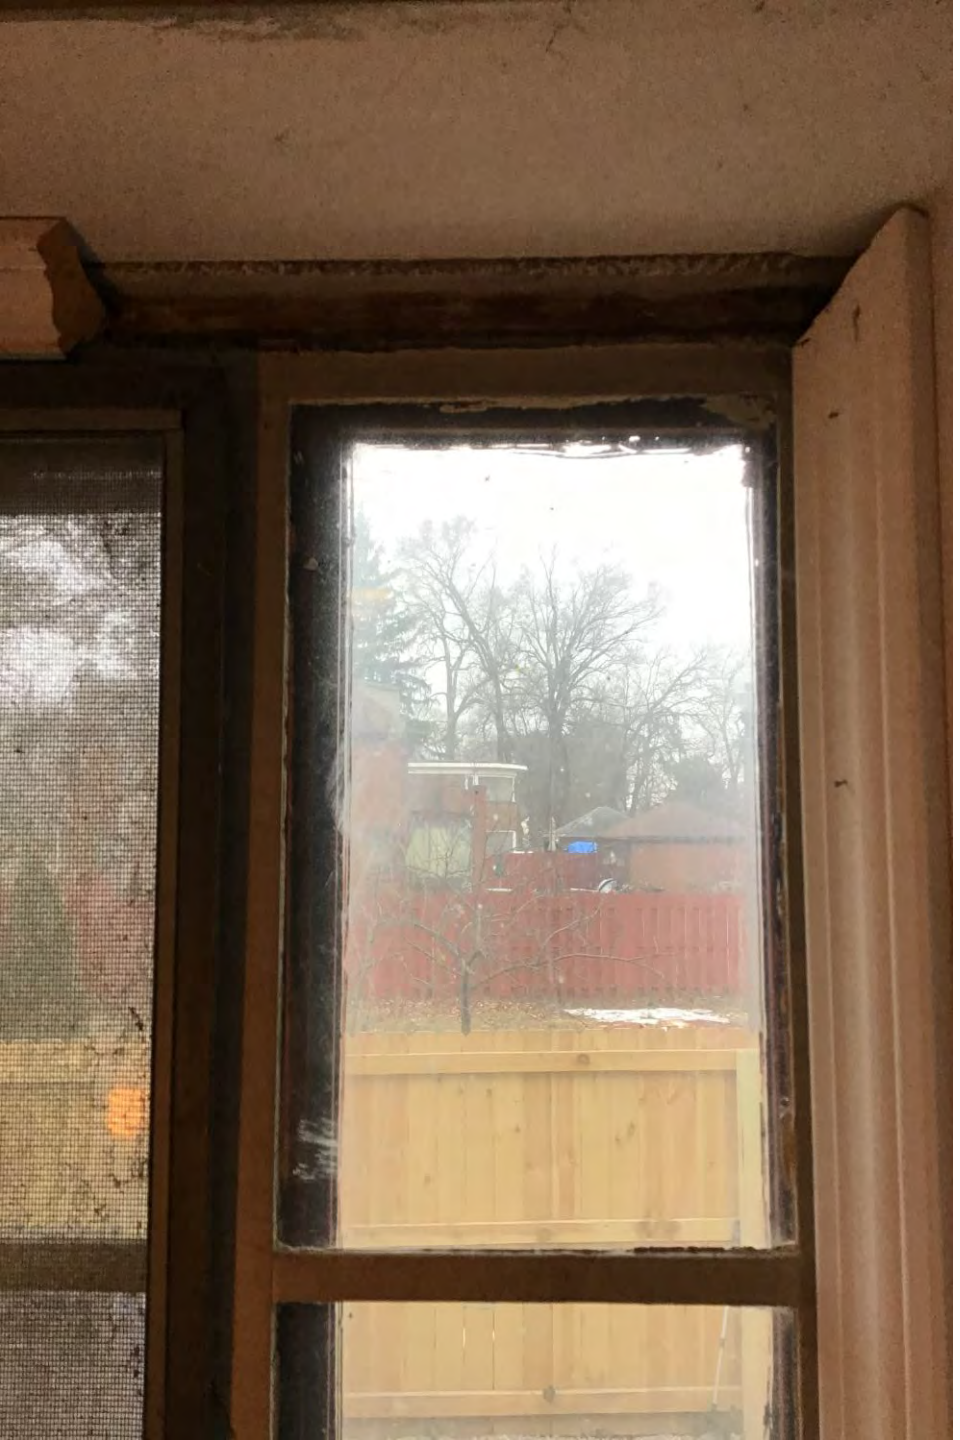
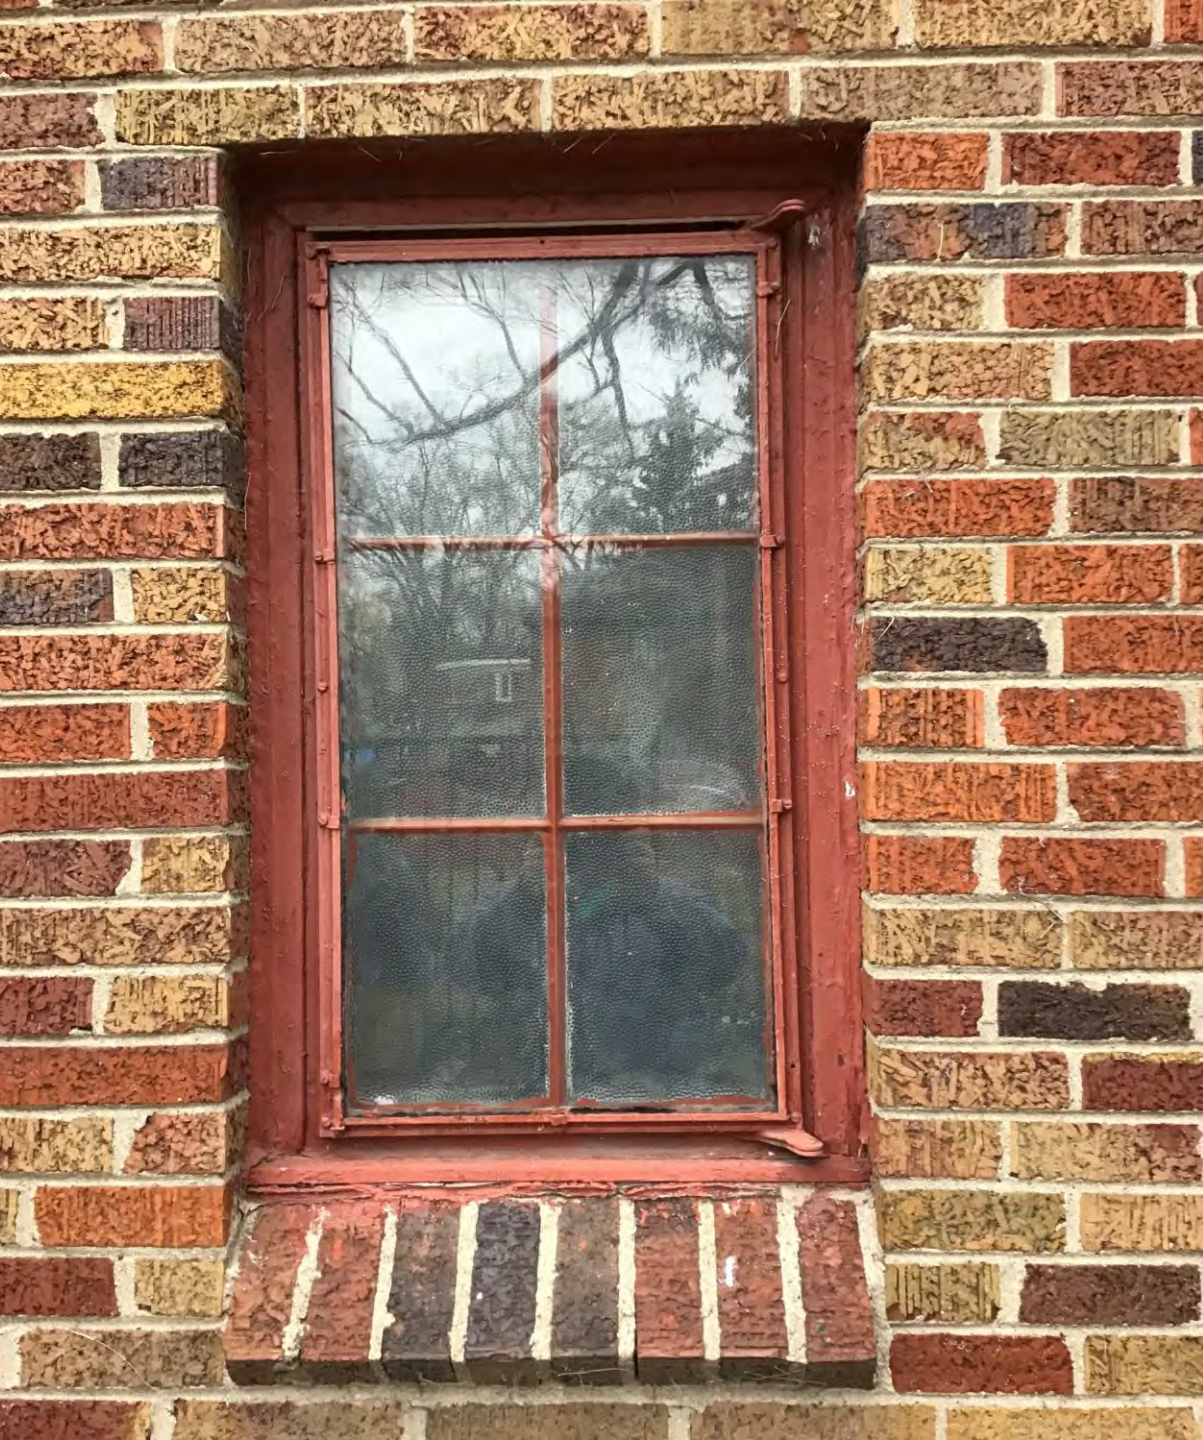
## WINDOW OPENING 110

- Single Casement Window
- Window is in Kitchen
- Window won't open
- Exterior of window showing signs of rotting around frame and exterior window shows breakage
- Interior casing is missing/broken
