**STAFF REPORT: FEBURARY 17, 2021 MEETING**

**APPLICATION NUMBER: 21-7091**

**ADDRESS: 19365 WARRINGTON**

**SCOPE OF WORK: REPLACE STEEL CASEMENT WINDOWS AS PROPOSED**

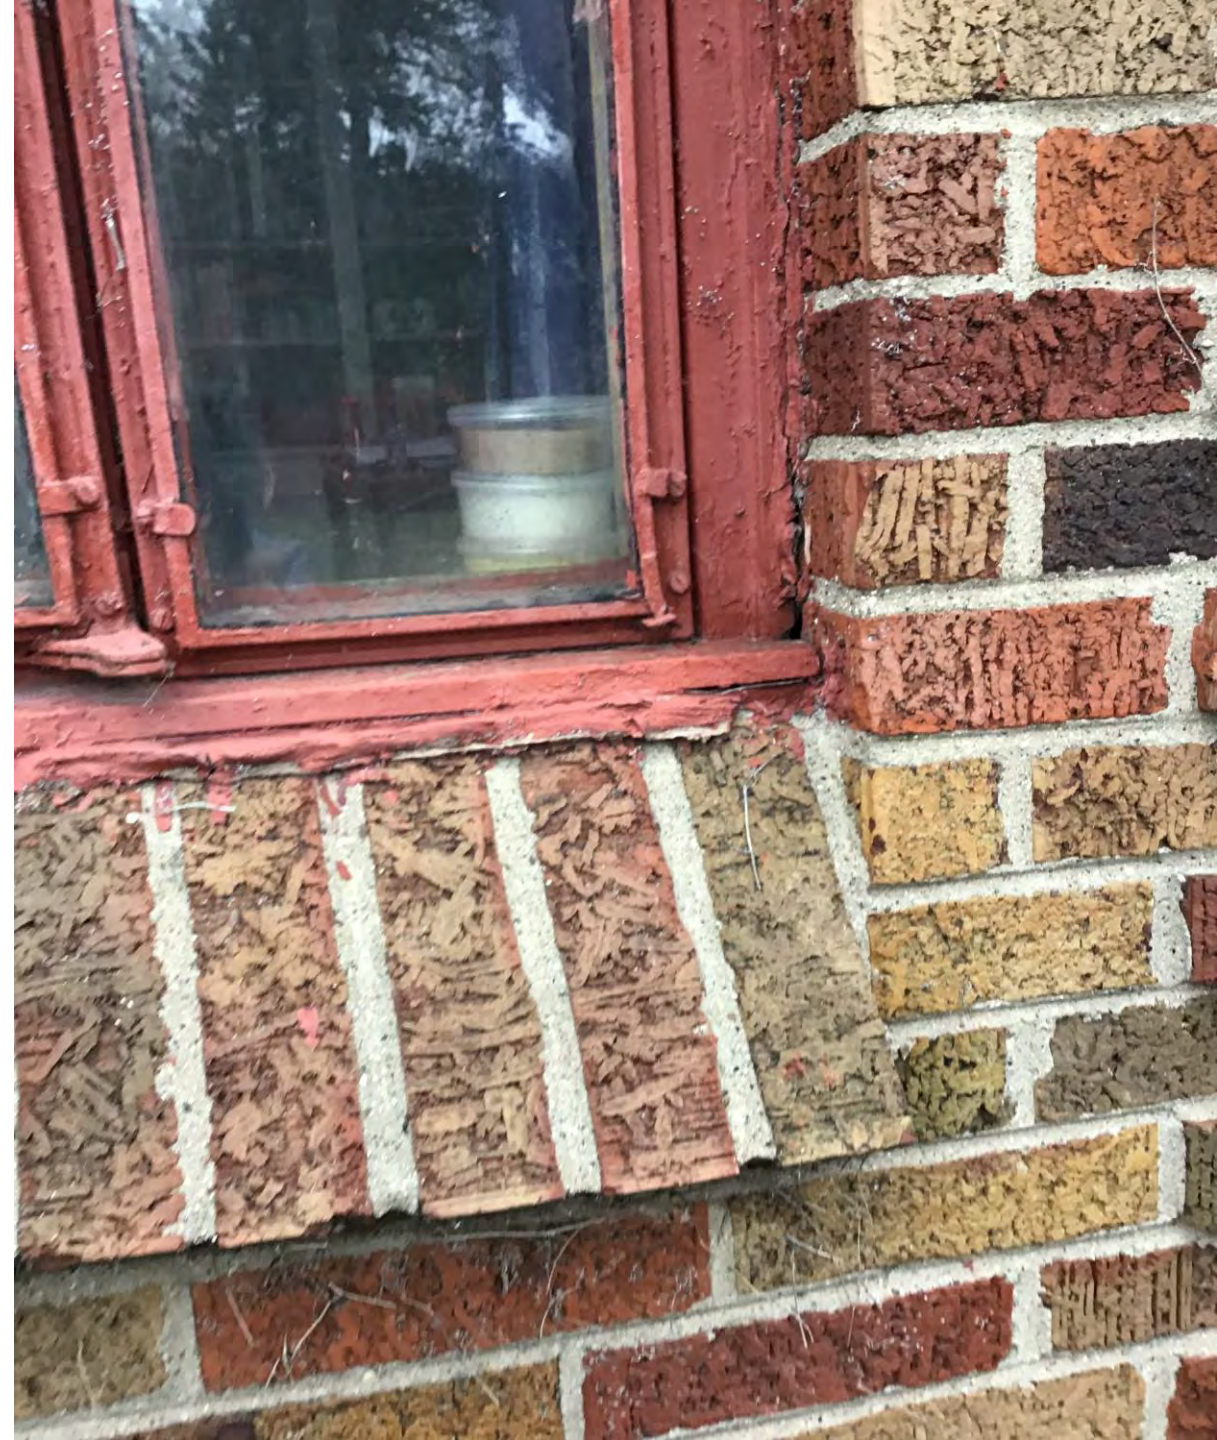
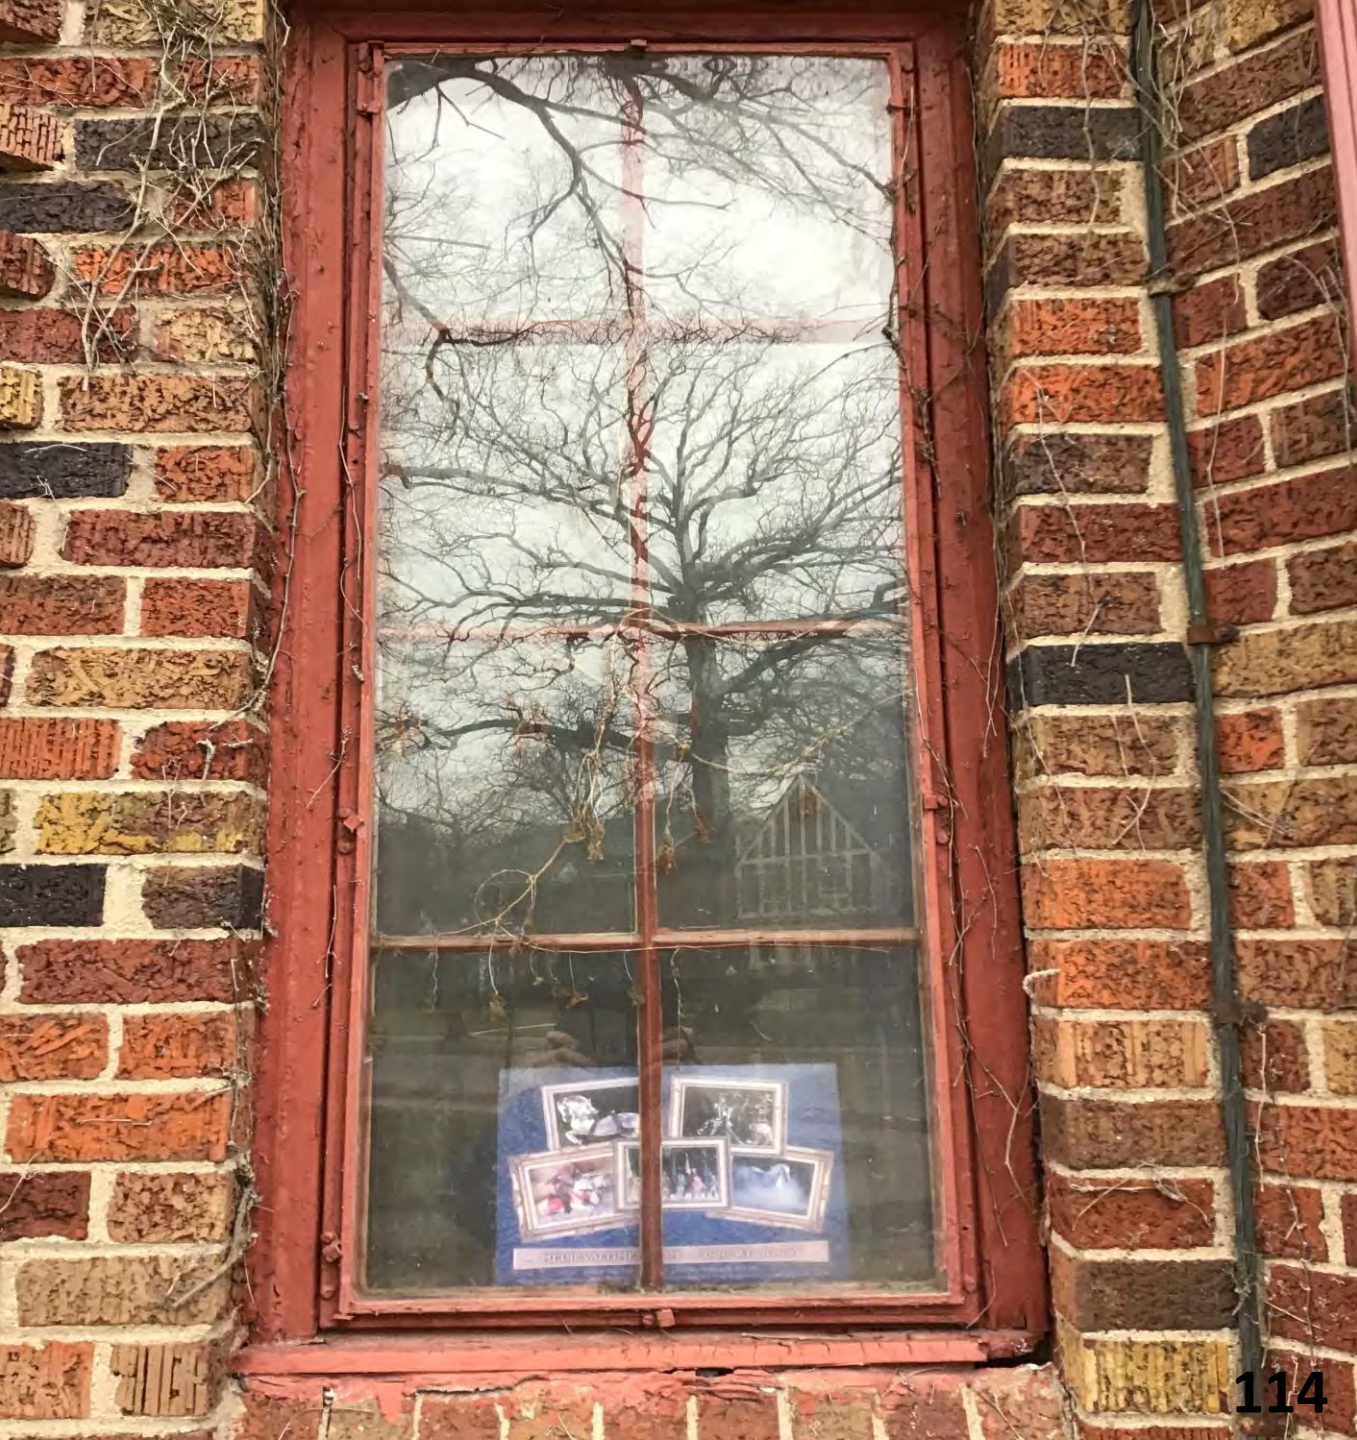
## WINDOW OPENING 114 Office - Left side of House

- Fixed window – Steel casement
- Window is in an office
- Ivy stuck between window and storm
- Exterior of window showing signs of rotting around frame
