**STAFF REPORT 02/17/2021 MEETING**

**APPLICATION NUMBER: #21-7098**

**ADDRESS: 4221 CASS (STUBER AND STONE BUILDING)**

**SCOPE: REPLACE WINDOW AT NORTH/SIDE ELEVATION, SECOND STORY; REPLACE CONCRETE LINTELS**

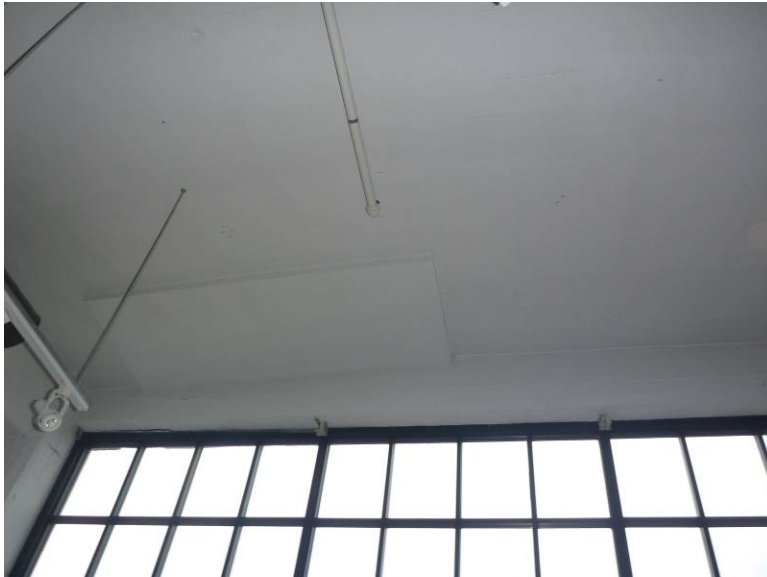
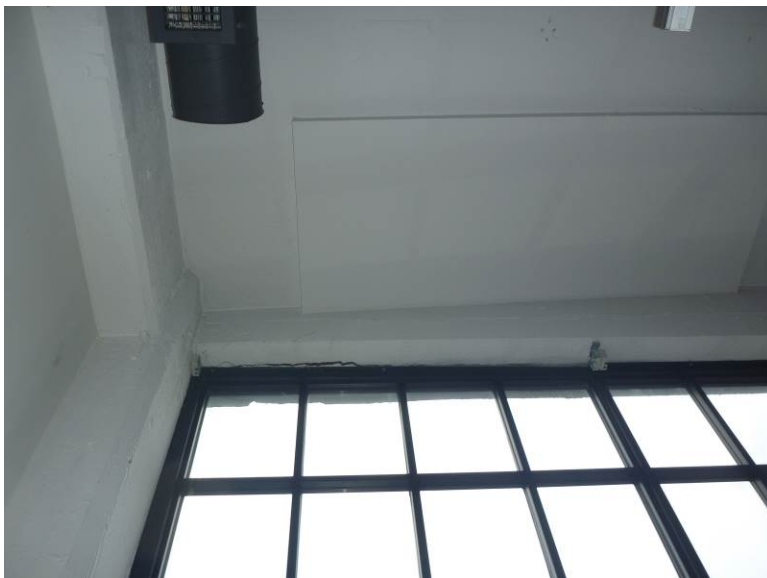
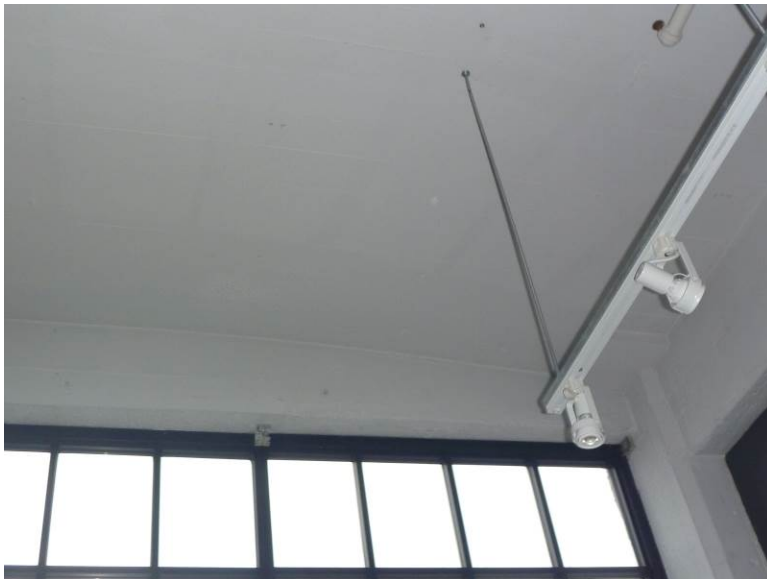
Photo No. 1 – Unit 300

Unit #300 was visually inspected from the interior and hammer sounded from the exterior. During the survey, we noted severe deterioration at the entire bottom of the beam (above the window), with moderate damage observed at the surrounding concrete members (beam below window and adjacent column 300/400). This includes widespread cracking and spalling concrete. Large crack separation at bottom of beam. No steel reinforcement was visible but it should be assumed that the crack has developed from steel corrosion and a structural repair is required. Pullman recommends fixing these areas to eliminate falling debris hazards (both inside and outside) and the potential for growth of the deteriorated areas.

Item No.1:      There is cracking/spalling at the bottom of the beam over the window.

Refer to Photos No. 1, 2 & 3
