**STAFF REPORT:** 4/14/2021 MEETING

**APPLICATION NUMBER:** 21-7172

**ADDRESS:** 791 SEMINOLE

**SCOPE:** REHABILITATE HOME; REPLACE WINDOWS & REPIAR AND REPLCE SIDING AND TRIM

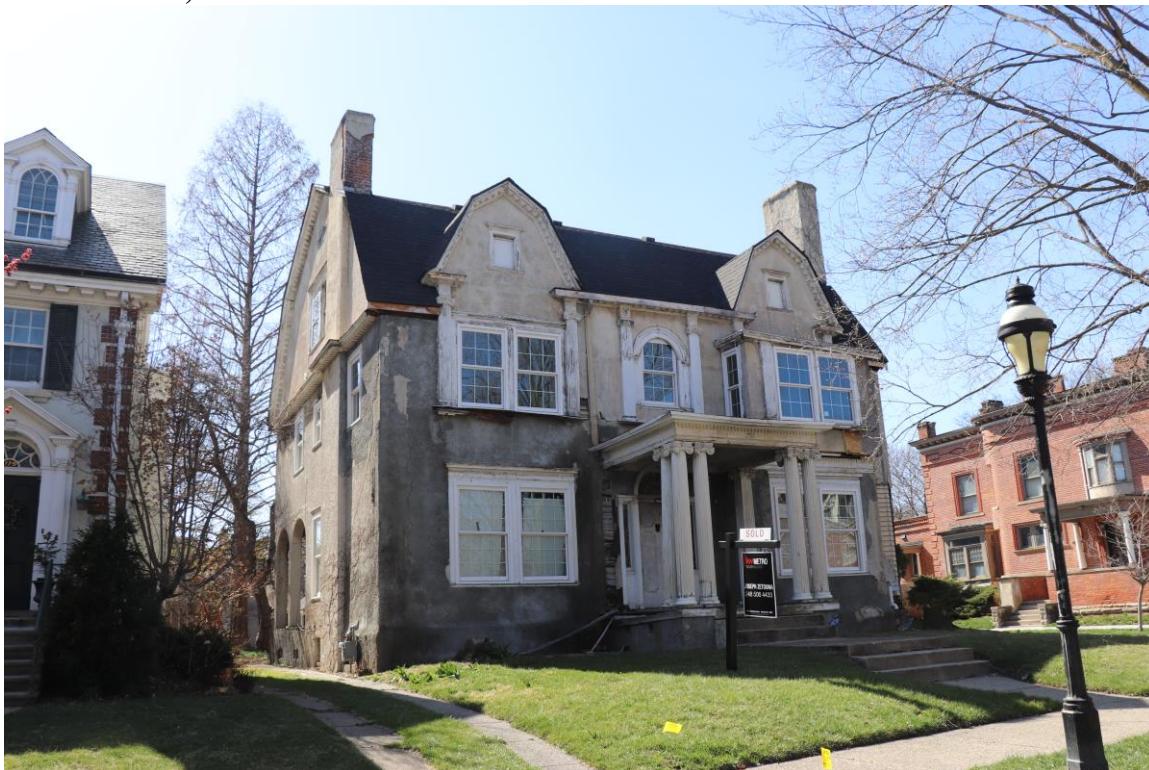
### **791 Seminole, current conditions**

The building located at 791 Seminole, sits at a prominent location, at the northeast corner of Seminole Street and E. Lafayette Street, within the Indian Village historic district. The building was constructed in 1898-1899 and designed for Dr. Andrew Biddle by the architectural firm Rogers & MacFarlane. The 2 ½ story, Dutch Colonial Revival-style home displays a gambrel-roof main mass with a rear, lower intersecting gambrel-roof wing. Asphalt shingles were recently added to the roof surface. Decorative detailing includes dentils at the soffit, the fluted Ionic columns at the first-story front porch, and the Ionic pilasters at the second story story's brick mould. Exterior walls are primarily clad with stucco, although large portions of the stucco at the south, north, and west elevations have been removed and replaced with unpainted/unfished plywood/oriented strand board (OSB). Unpainted OSB is also visible at the fascia and soffit. Windows are currently wood, double-hung units with grids between the glass. Note that a number of the windows have been improperly installed/are smaller than their respective openings and plywood has been installed to enclose the gap. Much of the original wood window trim/brickmould A hipped-roof garage with cedar-shake clad exterior walls is to the rear of the home.

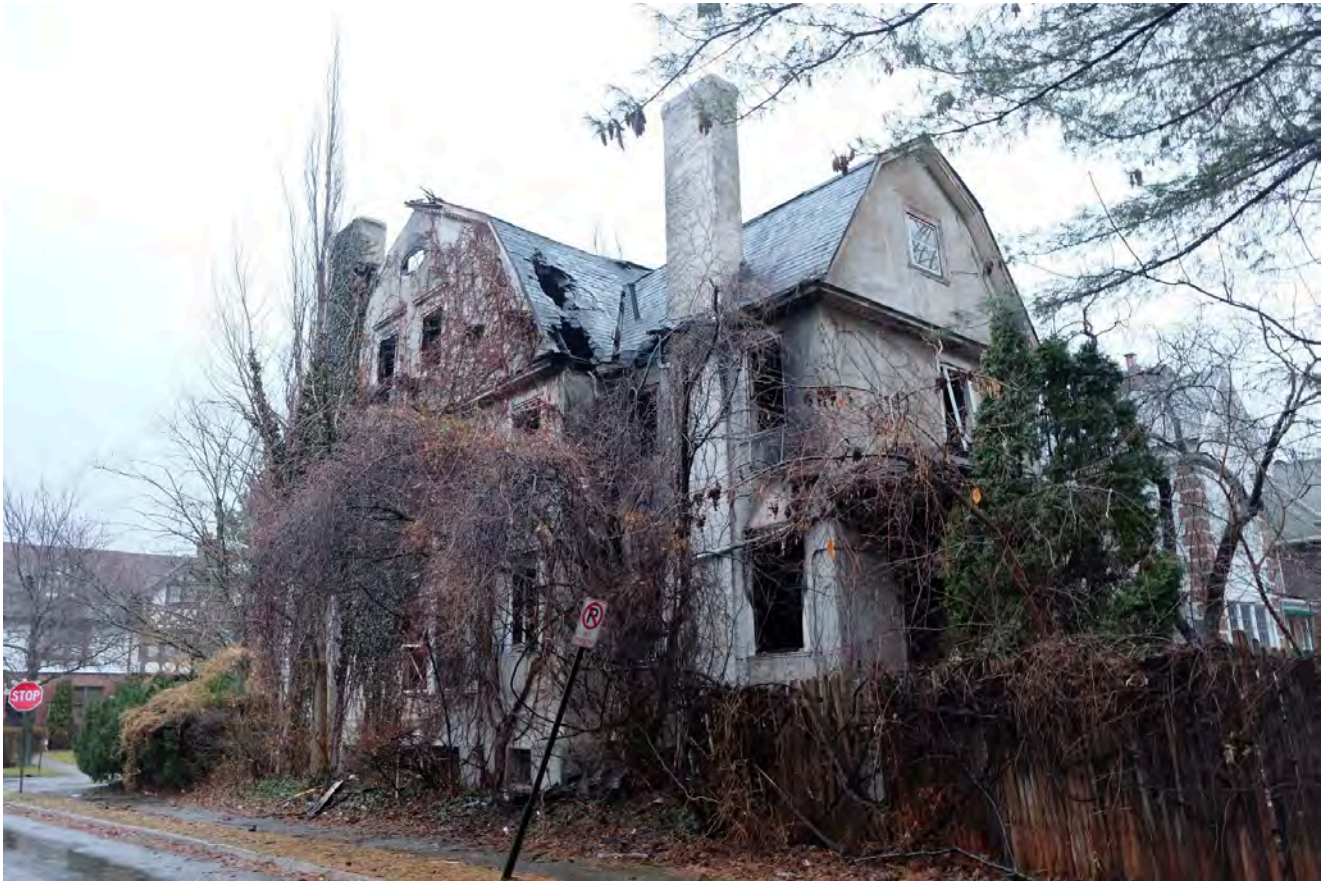
FEBRUARY 21, 2018

- Please note that this property caught fire/burned on 2/22/2018. As reported by the Detroit Building, Safety, Engineering, and Environmental Department (BSEED), the fire was concentrated in the rear wing of the property, leading to extensive damage to the interior and the roof at that location. A review of the photos of the property which were submitted to staff immediately after the fire indicates that the then owner boarded up the windows.

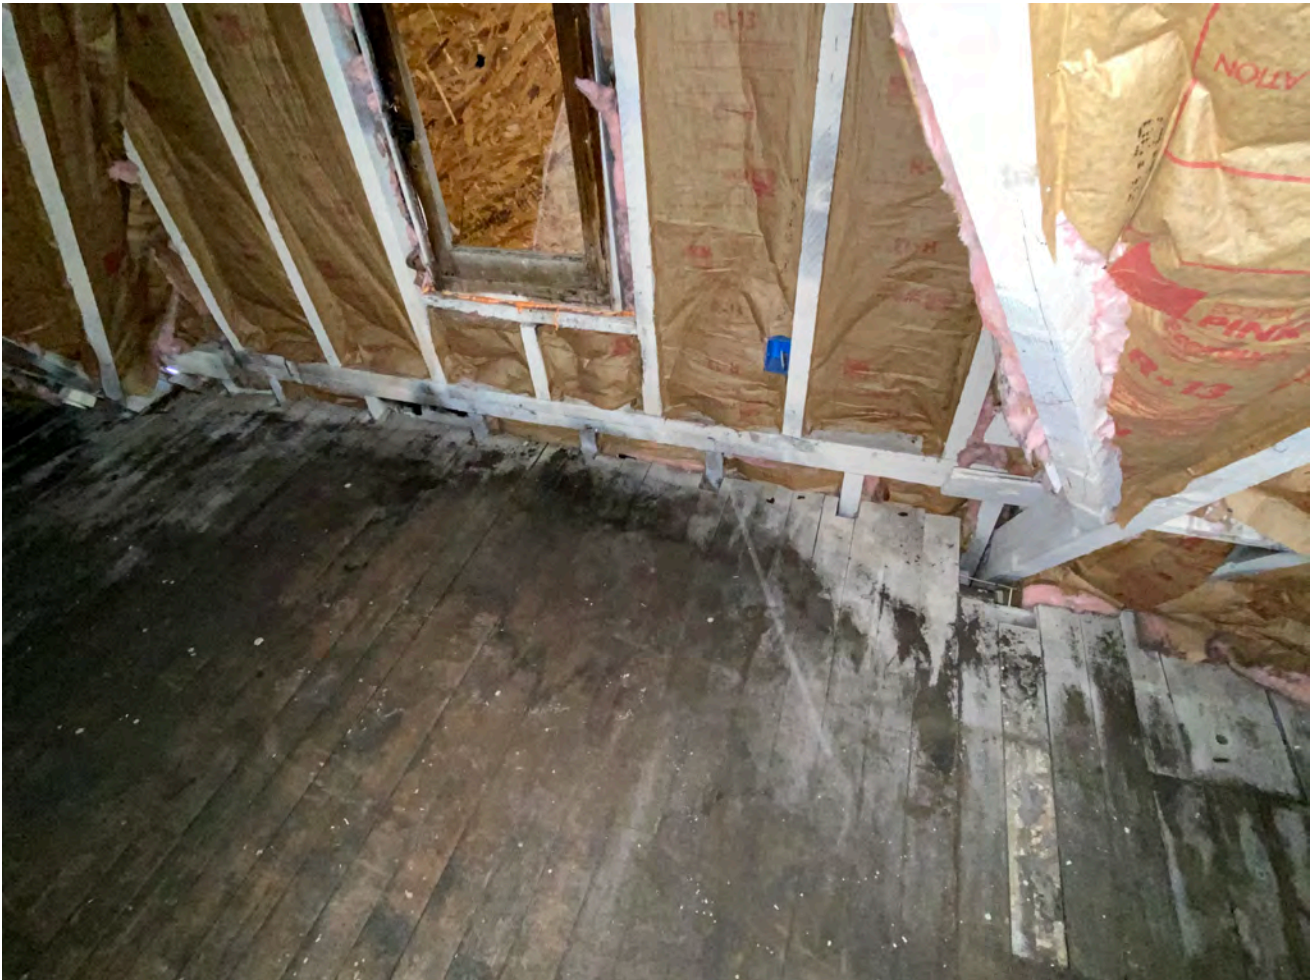
GAPS IN STRUCTURE CAUSED BY LOADS PLACED ON WALL BY THICK STUCCO OVERCOAT. WINDOW #8.
