STAFF REPORT: 4/14/2021 MEETING

ADDRESS: 1627 (1627-1639) LEVERETTE

HISTORIC DISTRICT: CORKTOWN

SCOPE: ERECT NEW CARPORTS; REHABILITATE BUILDING

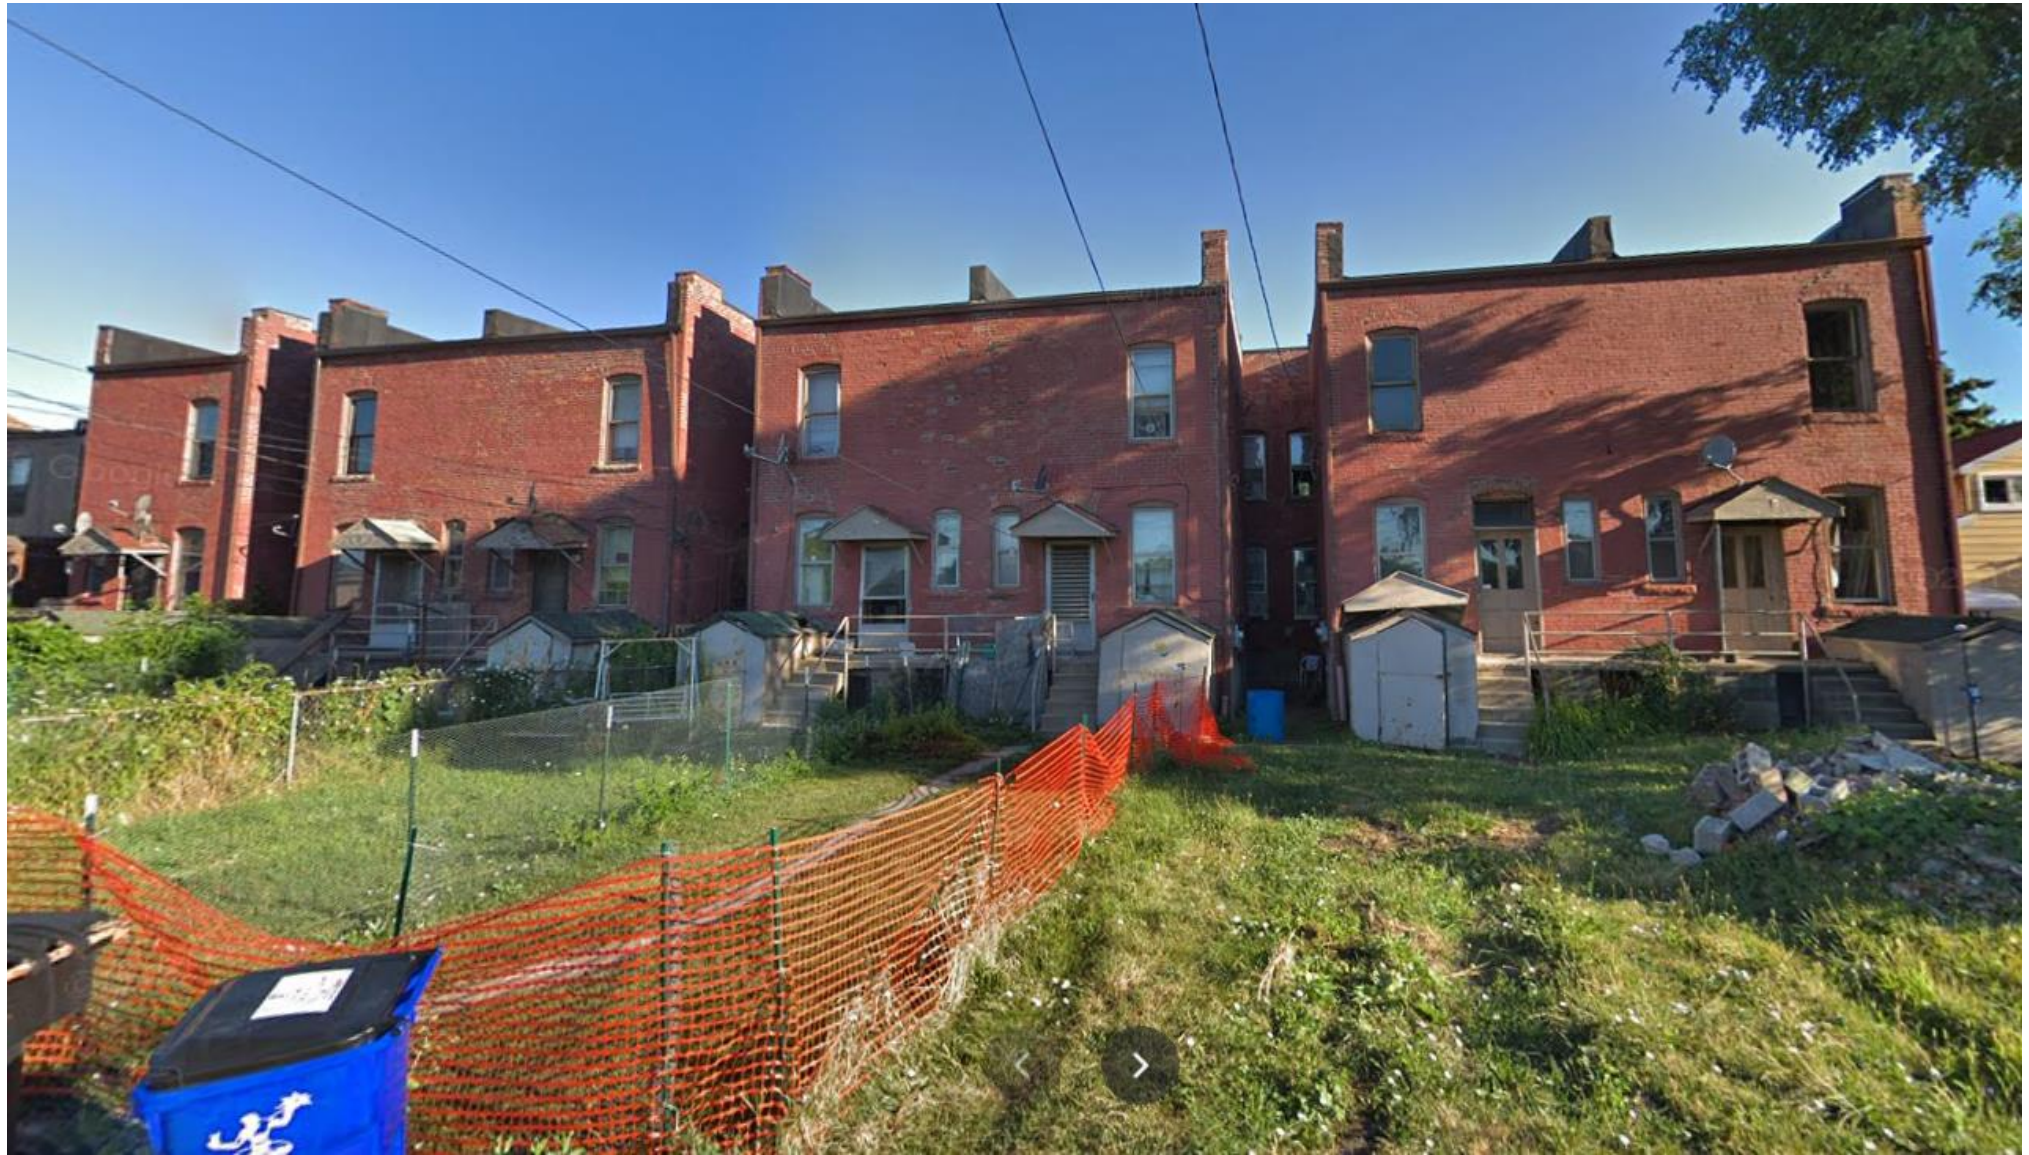
Rear elevations, prior to unapproved work

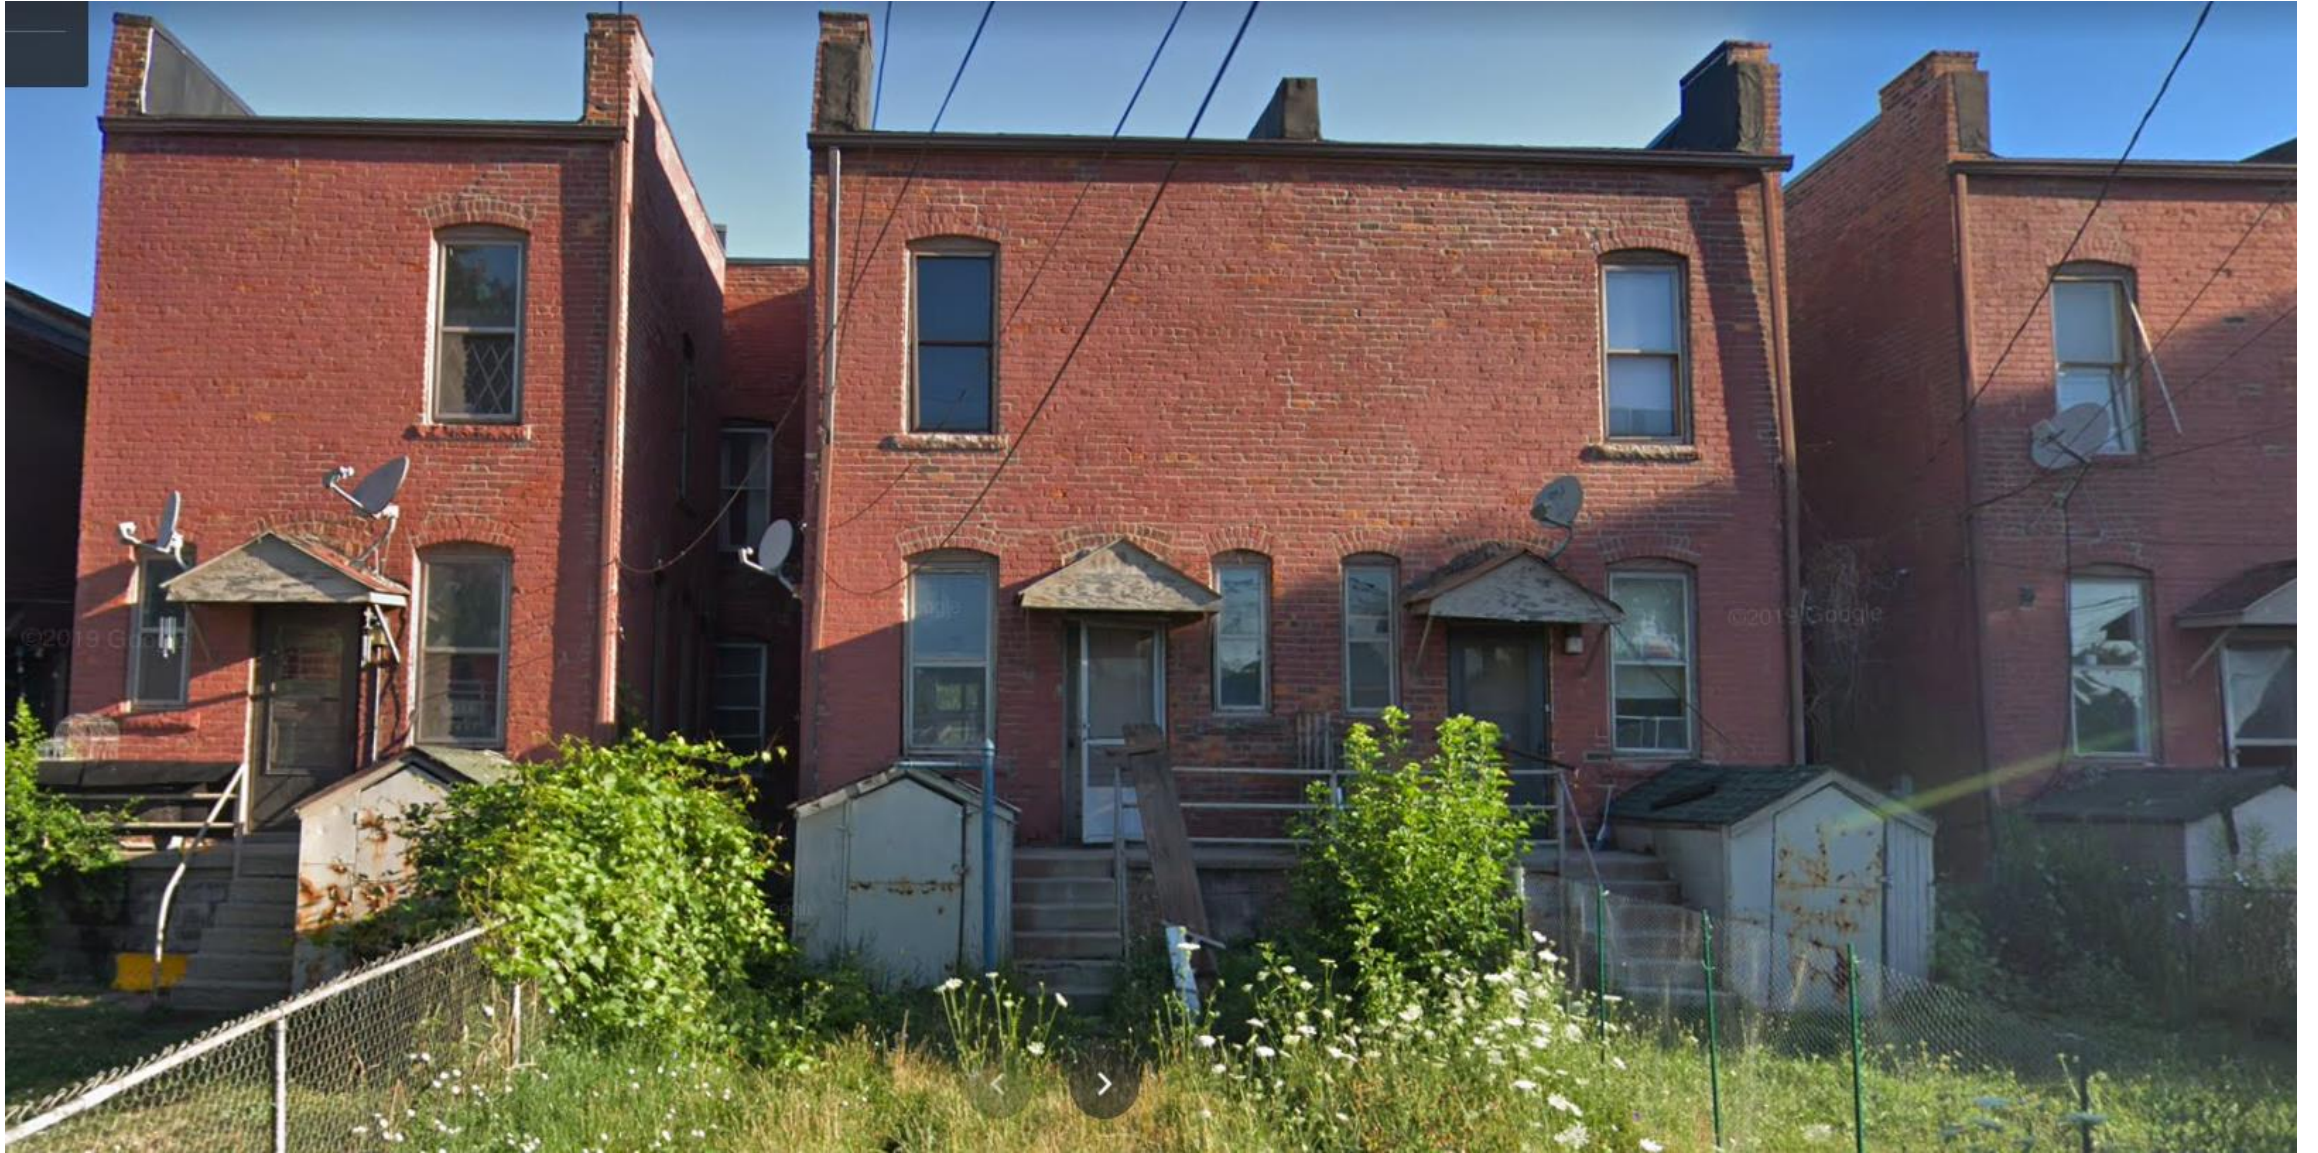
Rear elevations, prior to unapproved work

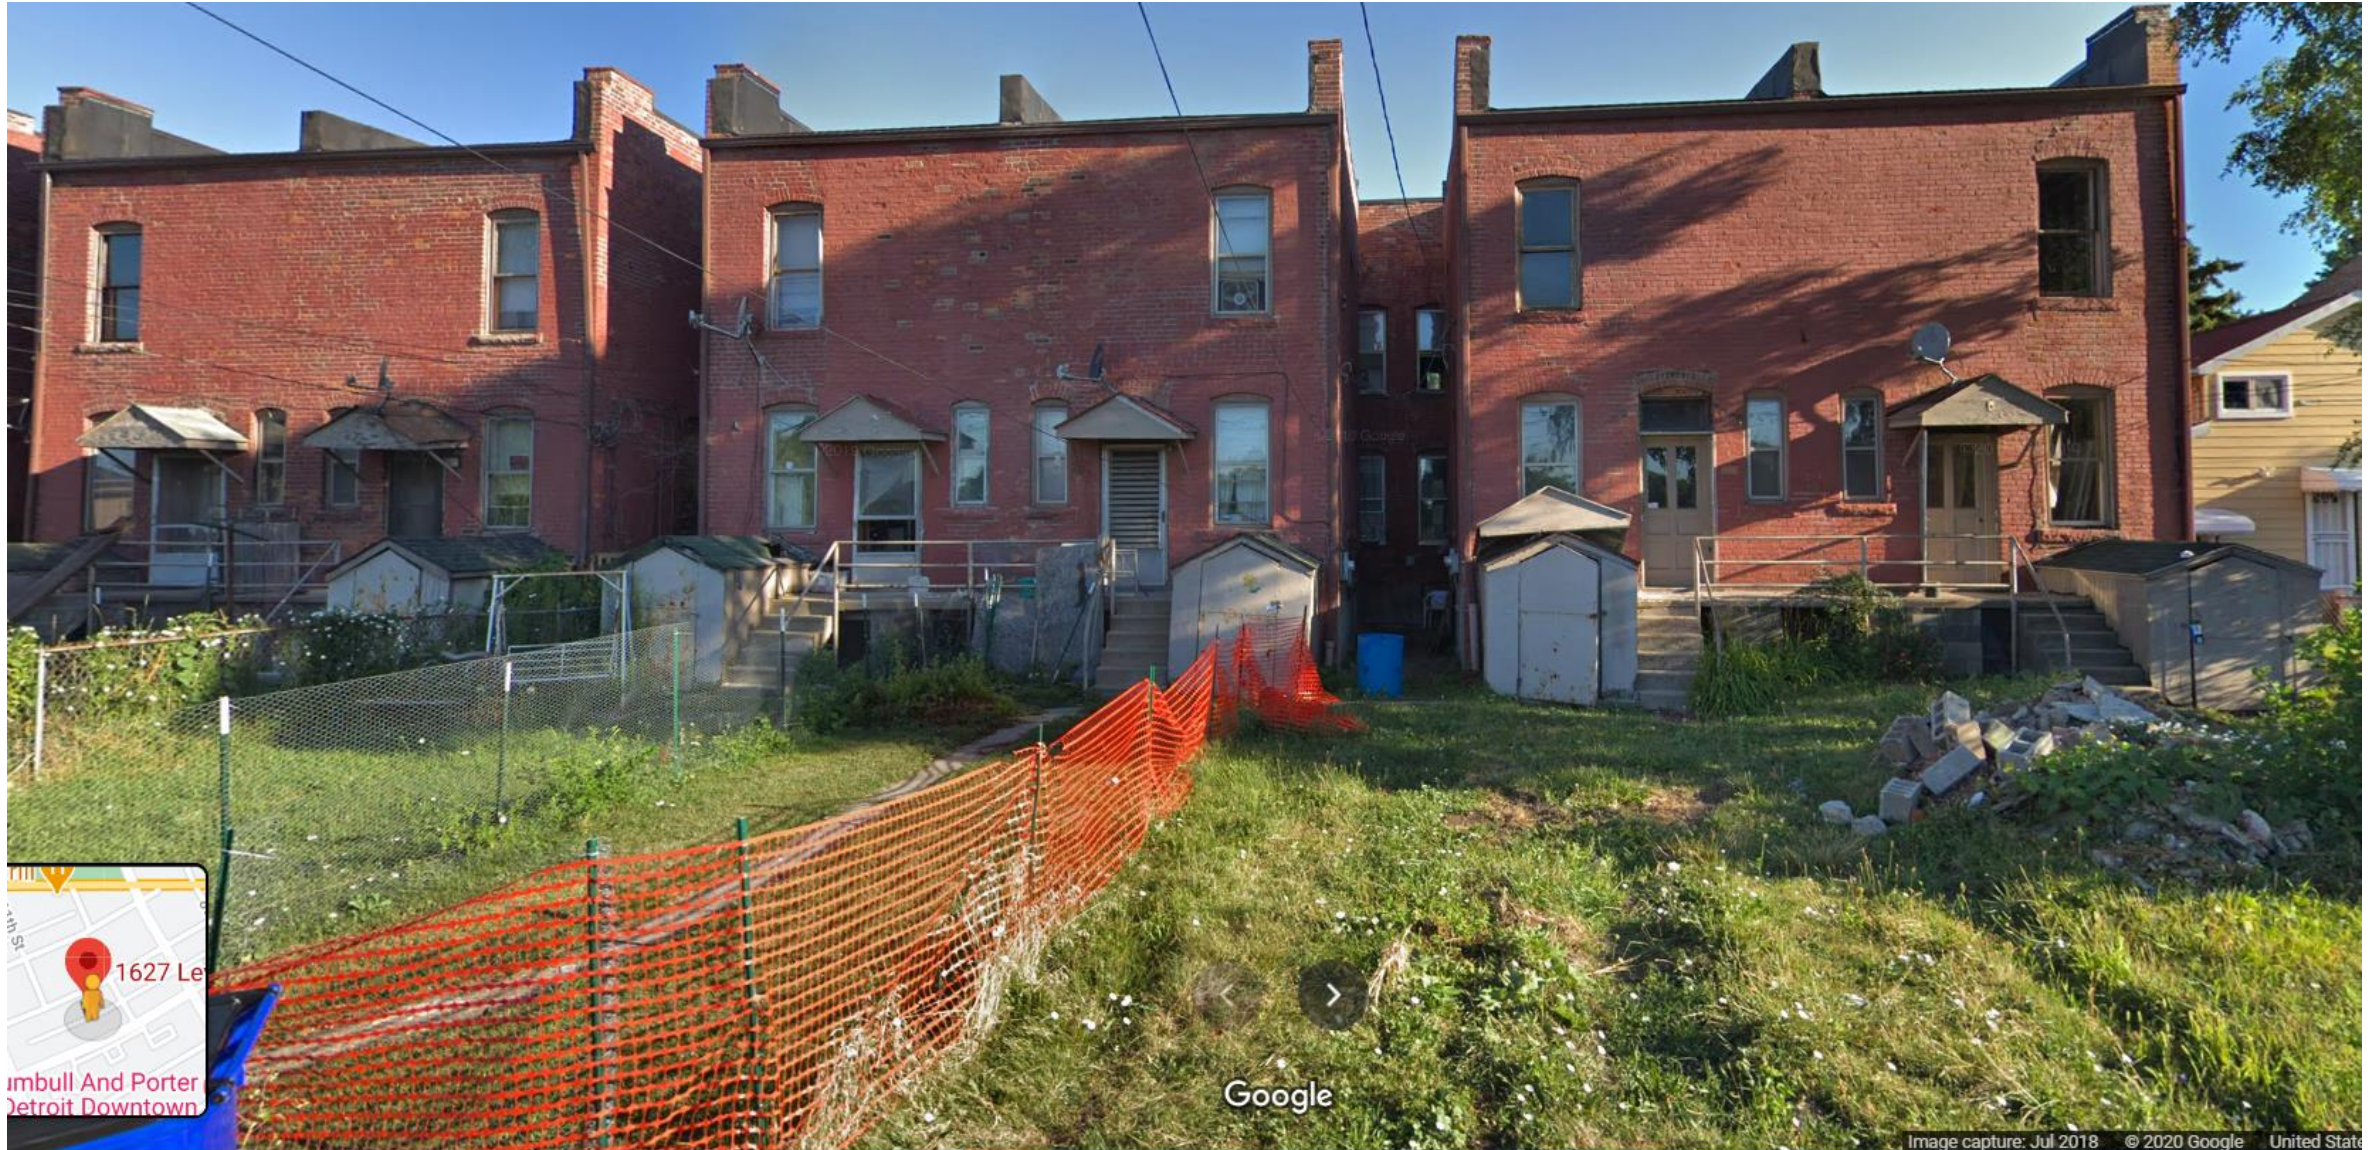
Rear elevations, prior to unapproved work

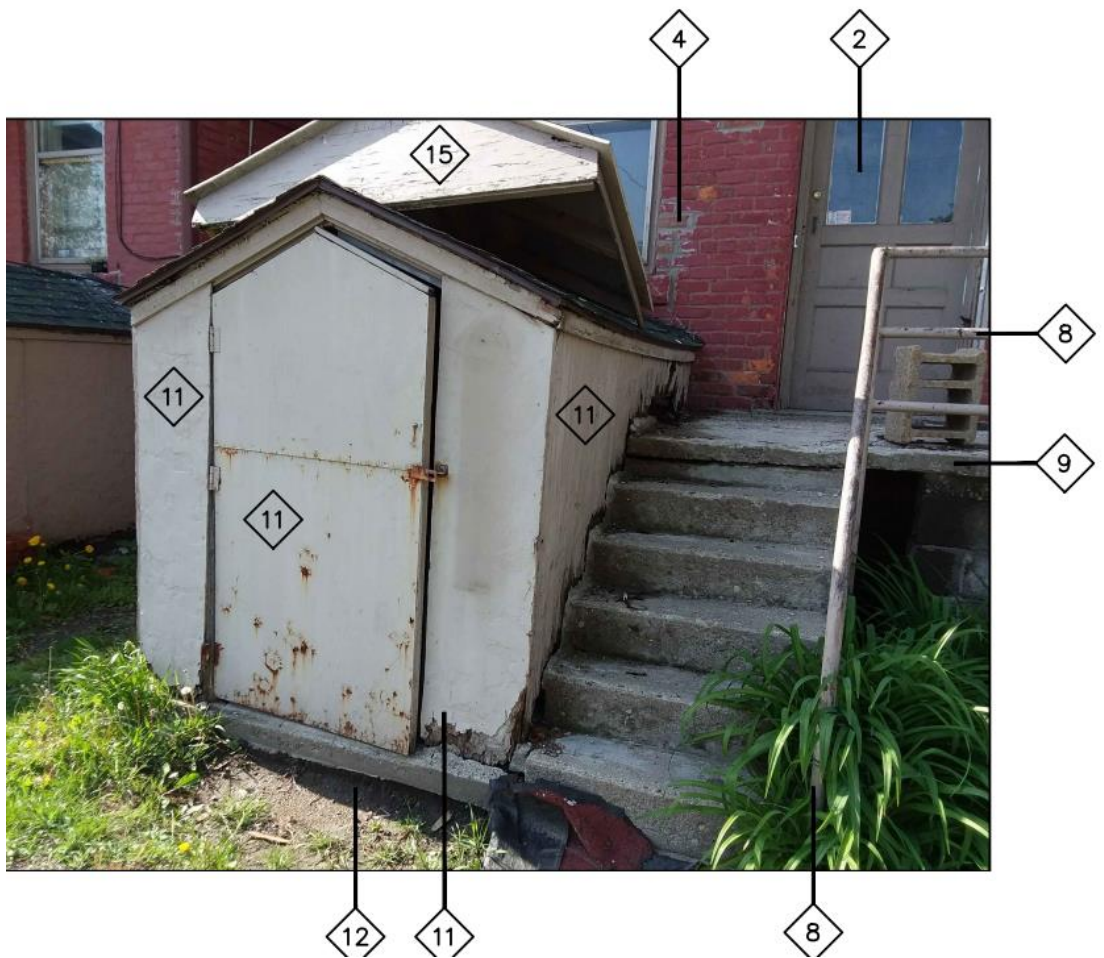
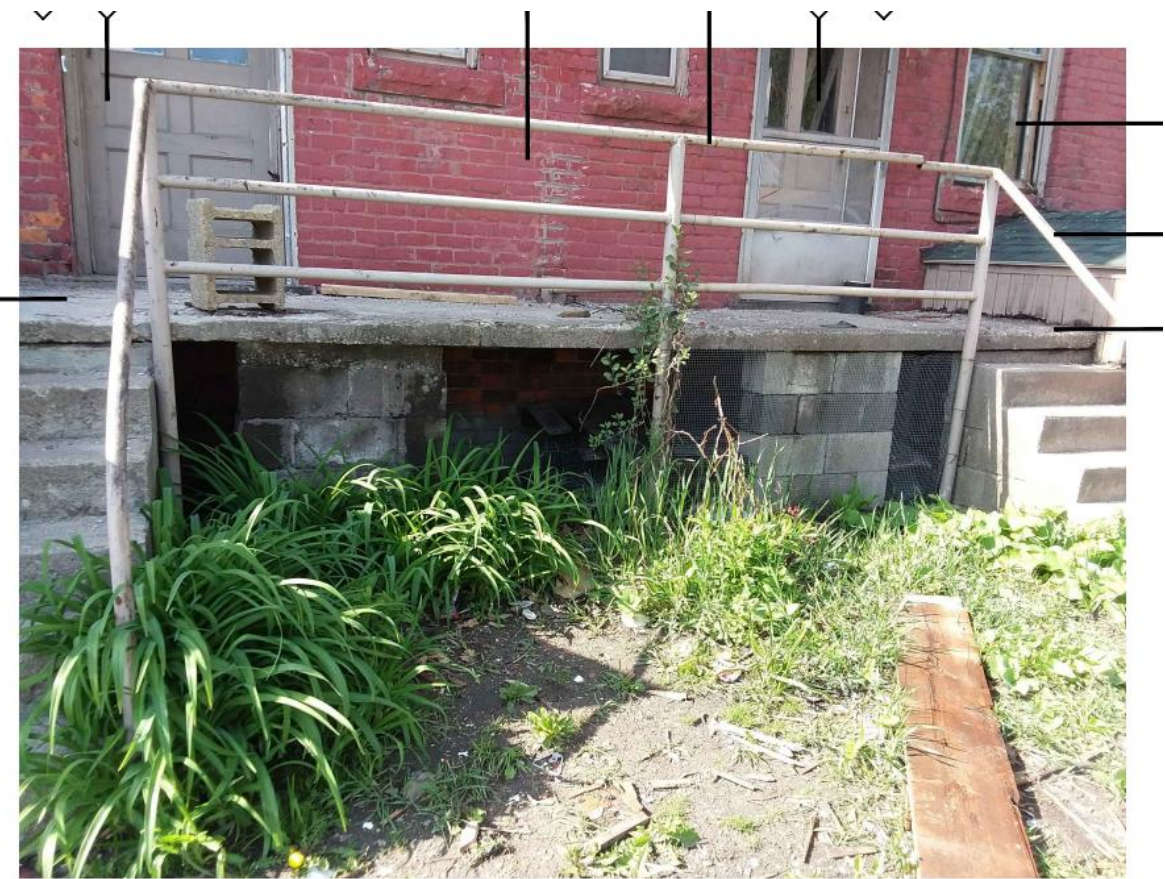
Basement stair enclosure and rear porch, prior to unapproved work. Note painted brick

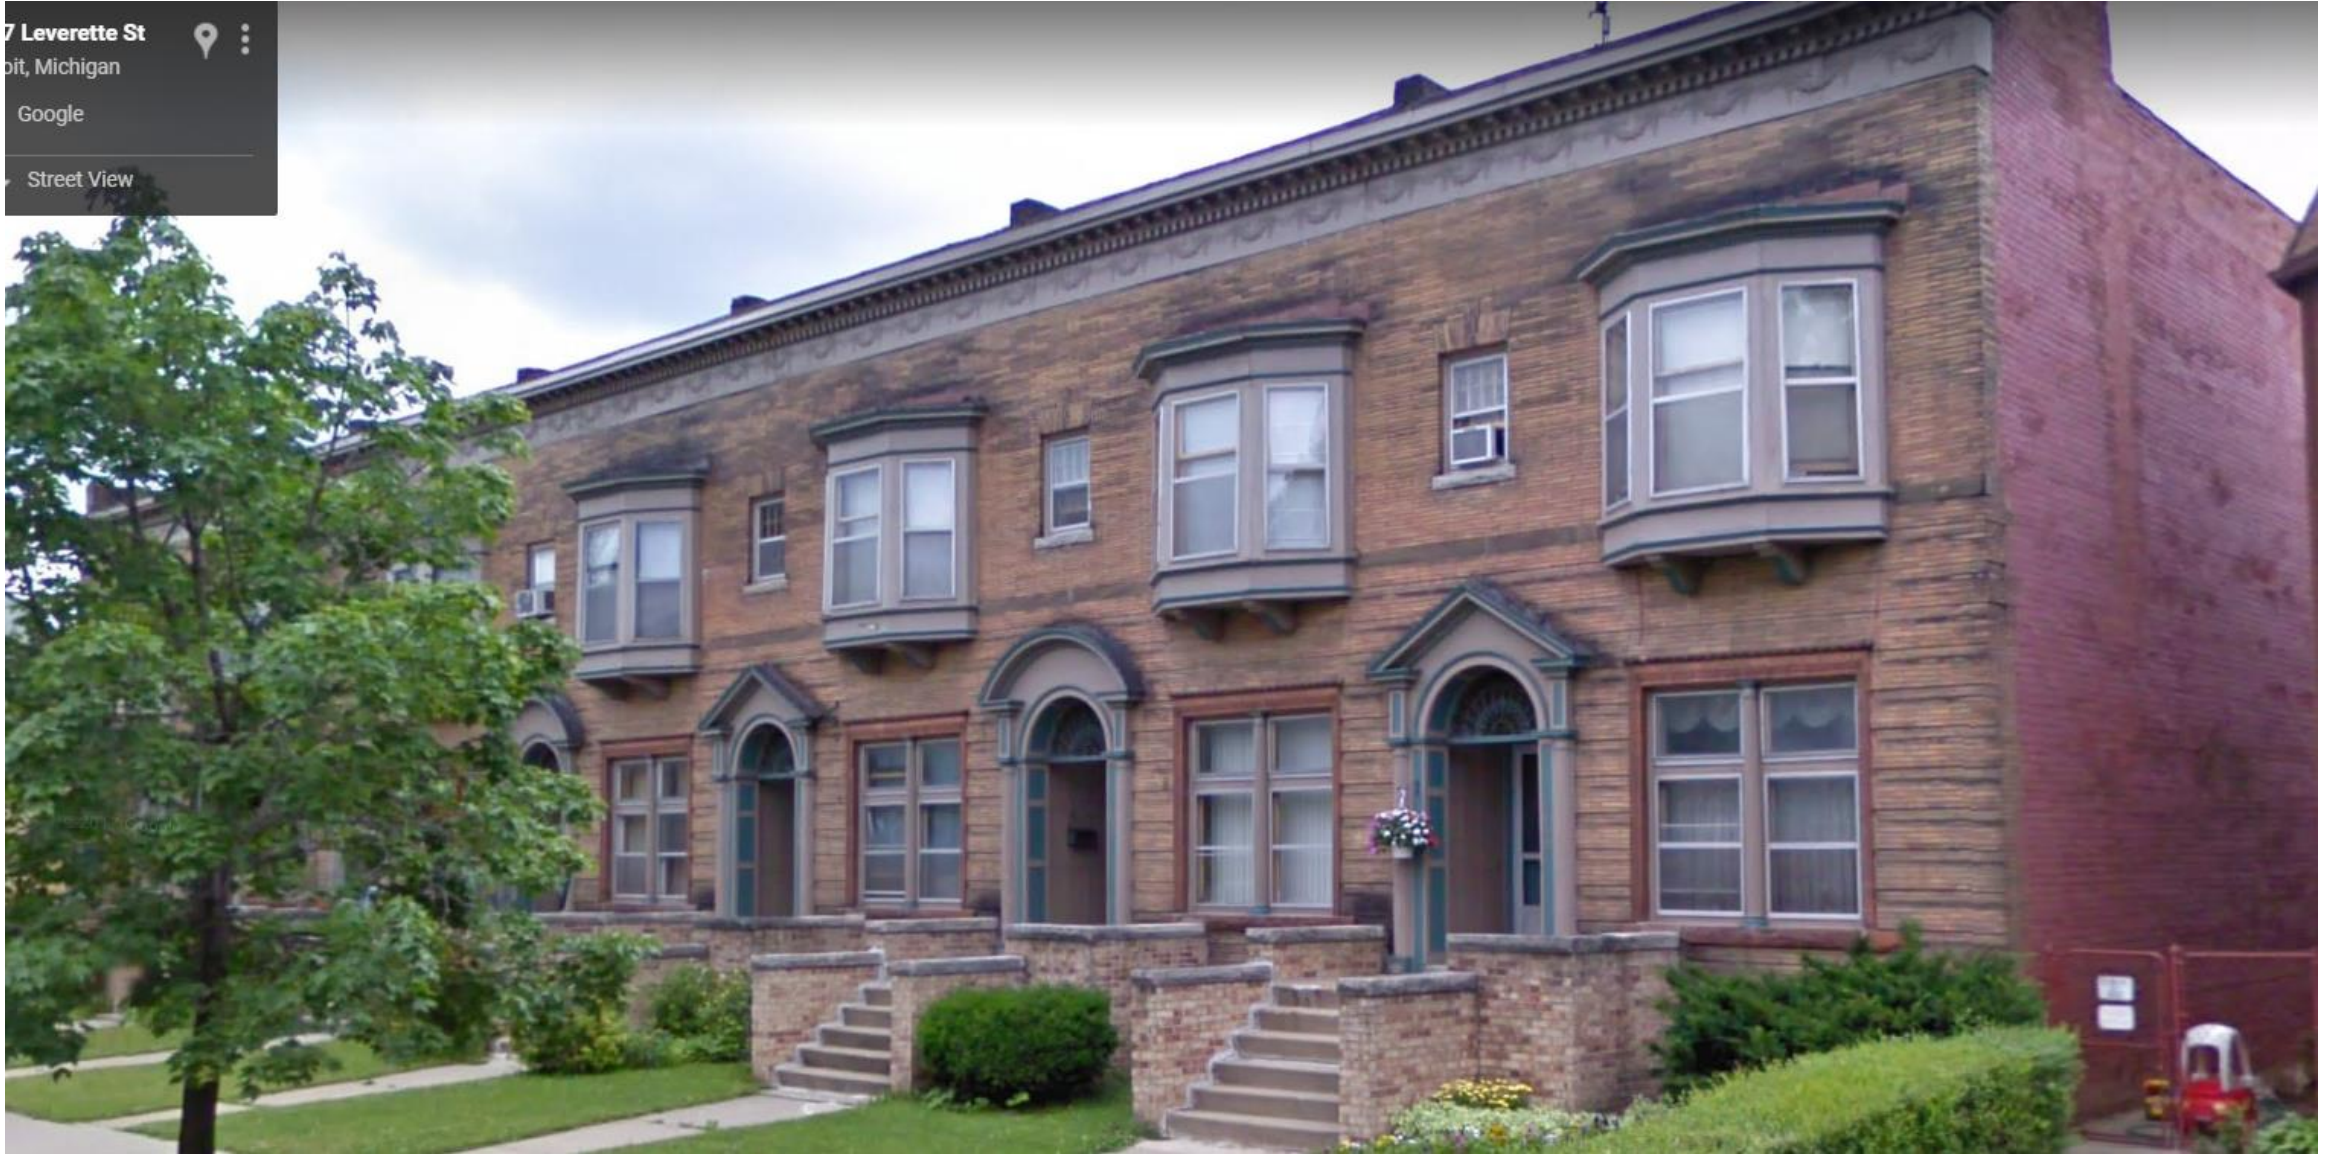
Front elevation, prior to unapproved work

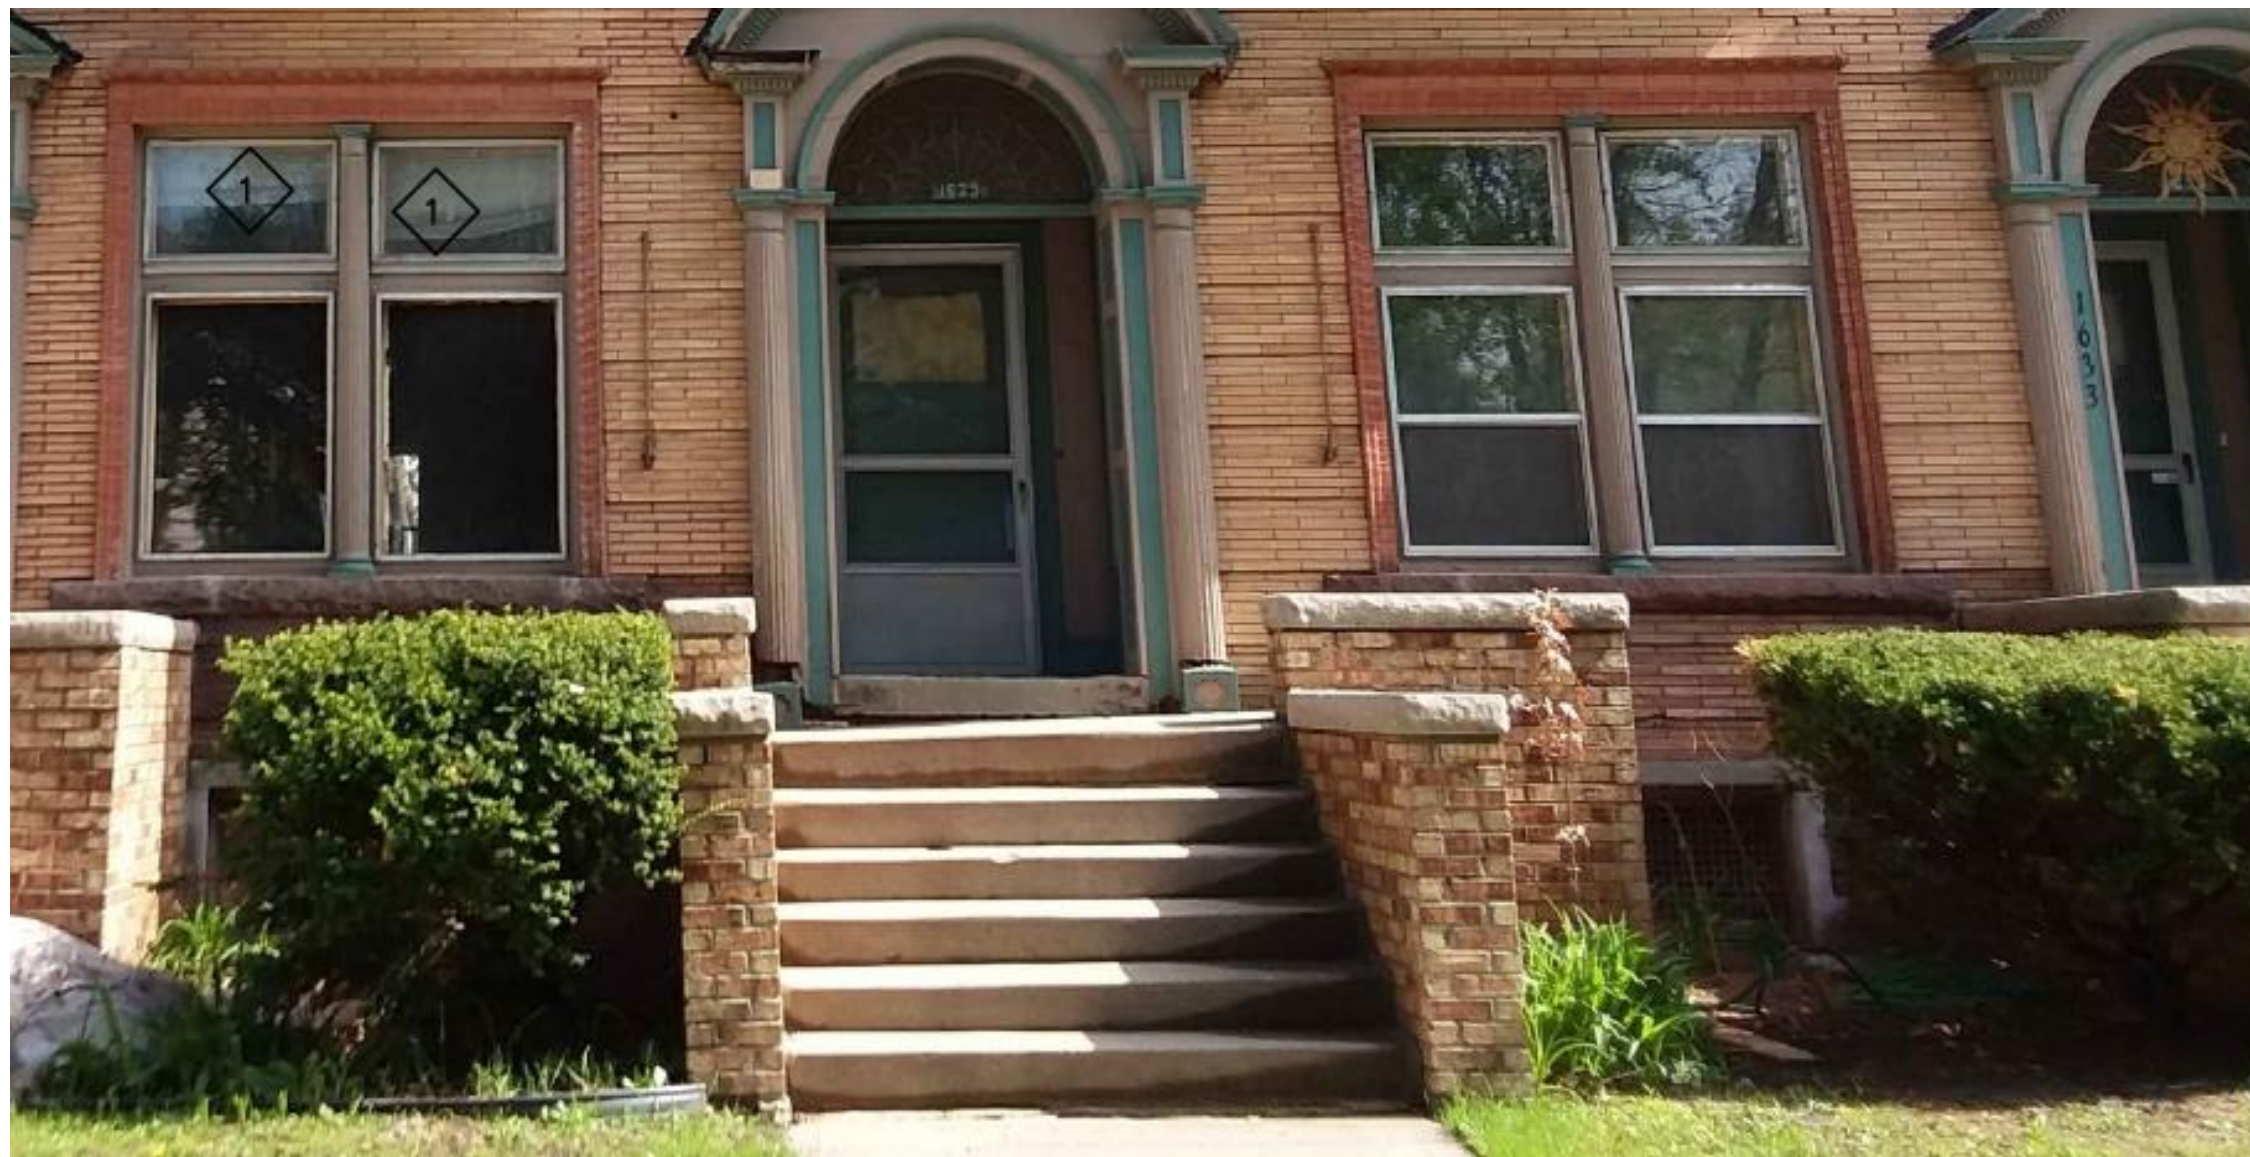
Front elevation porches, prior to unapproved work. Note, pilaster, wood trim, fixed windows and fixed transom

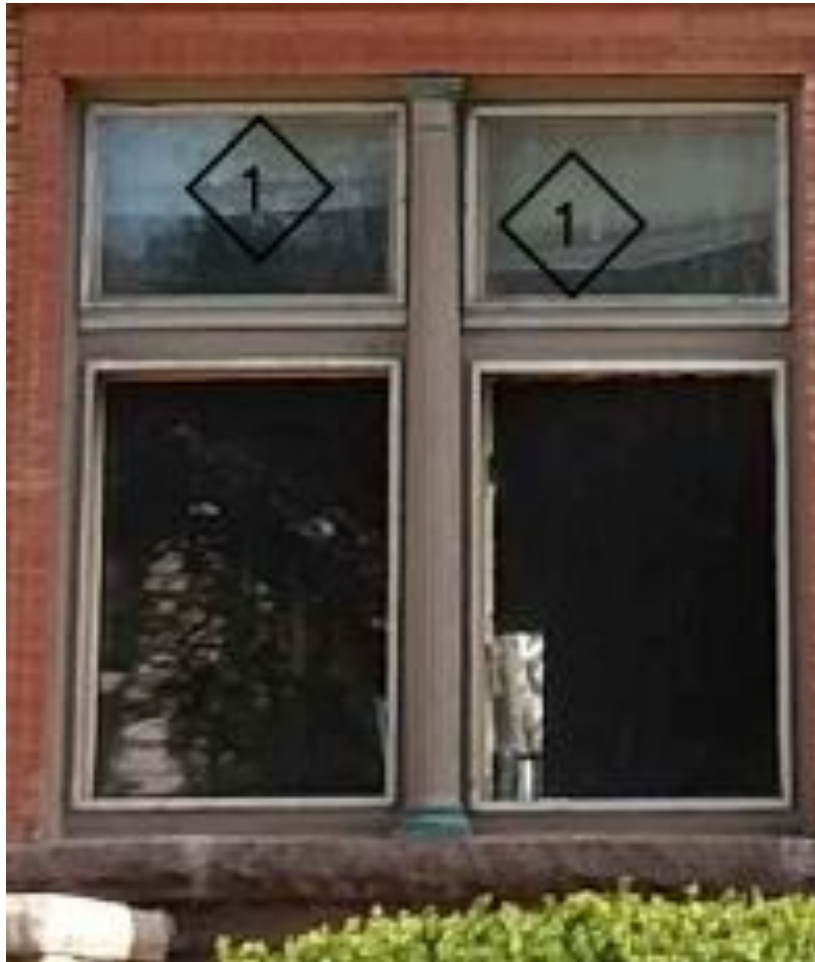
- Also, the applicant’s 8/8/2018 proposal to the Commission called for the repair of the existing wood windows. However, the applicant replaced all of the windows without HDC approval and off/without permit. Because these elements were replaced without application, it is impossible for staff to fully ascertain if they were deteriorated beyond repair and therefore merited replacement. It is staff’s opinion that the windows were character-defining features at the property

Current windows (typical), note wood trim between upper and lower windows has been removed, although pilaster remains

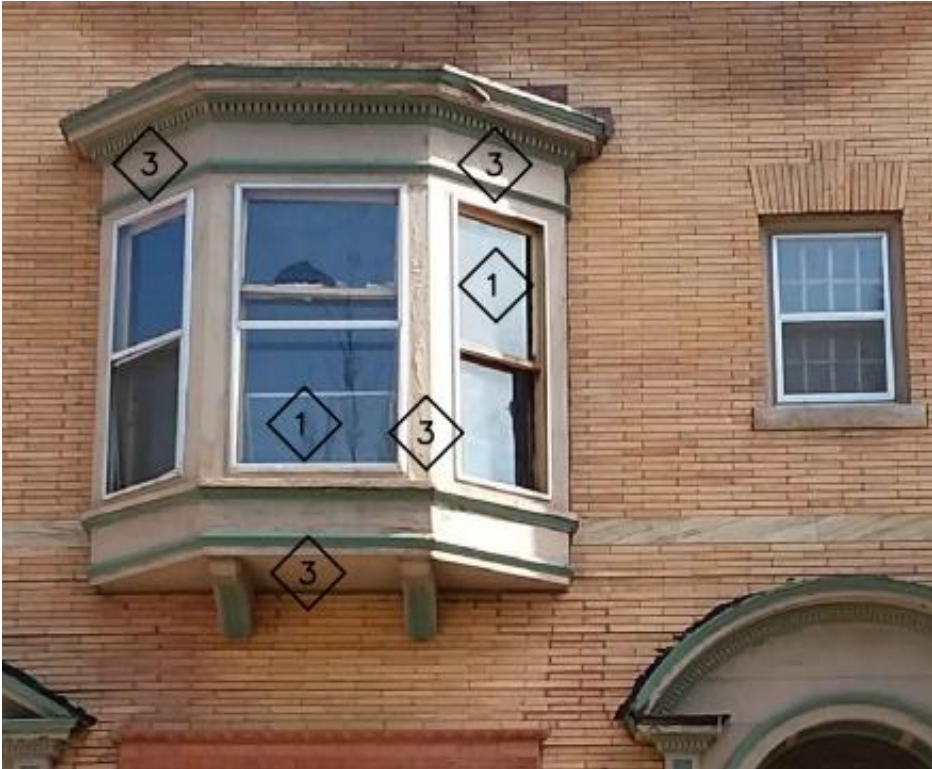
- At front elevation, second story bay windows – original sash were wood, 1/1, double-hung units. In 2020, these windows were replaced with wood, 1/1, double-hung units, each which is topped with a fixed wood transom window without approval. With the current submission, the applicant is proposing to REMOVE all

Second-story bay windows current (typical) note 1/1/ windows topped with transom. Also note 8/8 adjacent window

existing windows and replace with new 1/1 aluminum-clad wood units to match the original

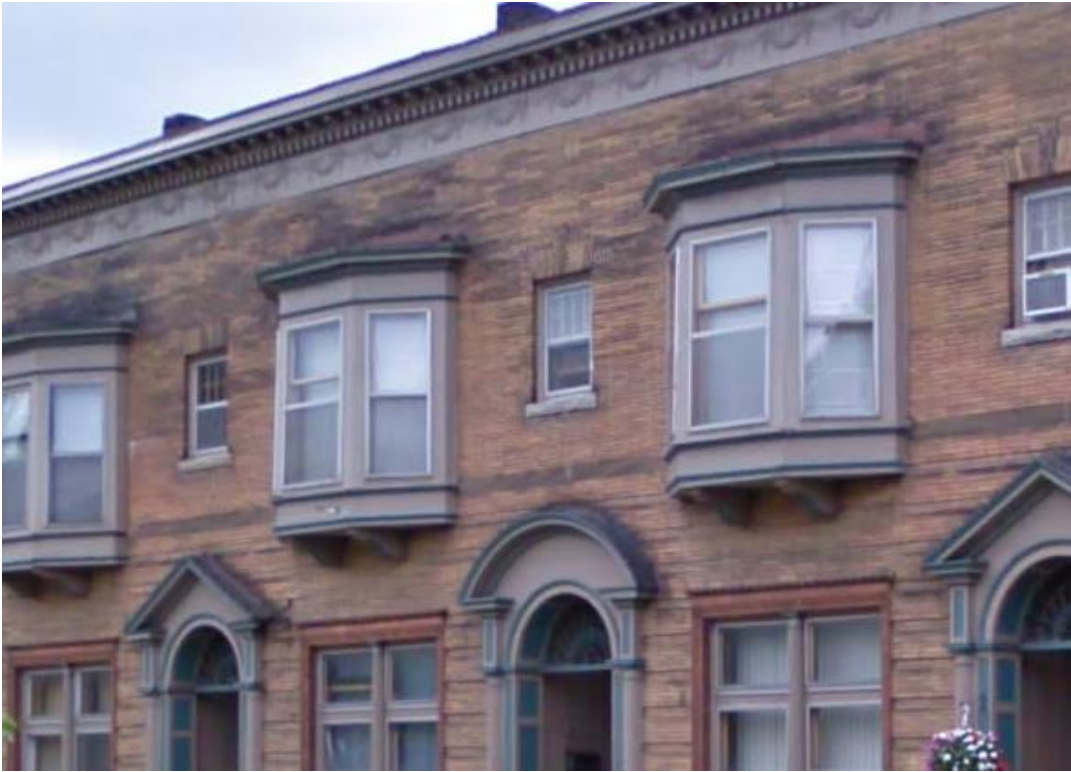
- As noted above, the applicant did appear in front of this Body in 2018 to address the unapproved removal of the building’s historic-age, decorative cornice. The applicant had also sought the Commission’s approval for a general rehabilitation of the building. The Commission approved the project with the condition that the cornice be exactly replicated. While reviewing the building conditions for the current application, staff did observe that the current replacement cornice is not an exact replication of the which was removed in violation of the Commission’s requirements. Specifically, the “swag” detailing was not replicated.

New FRP cornice. Note, that the decorative “swag”/garland was not replicated

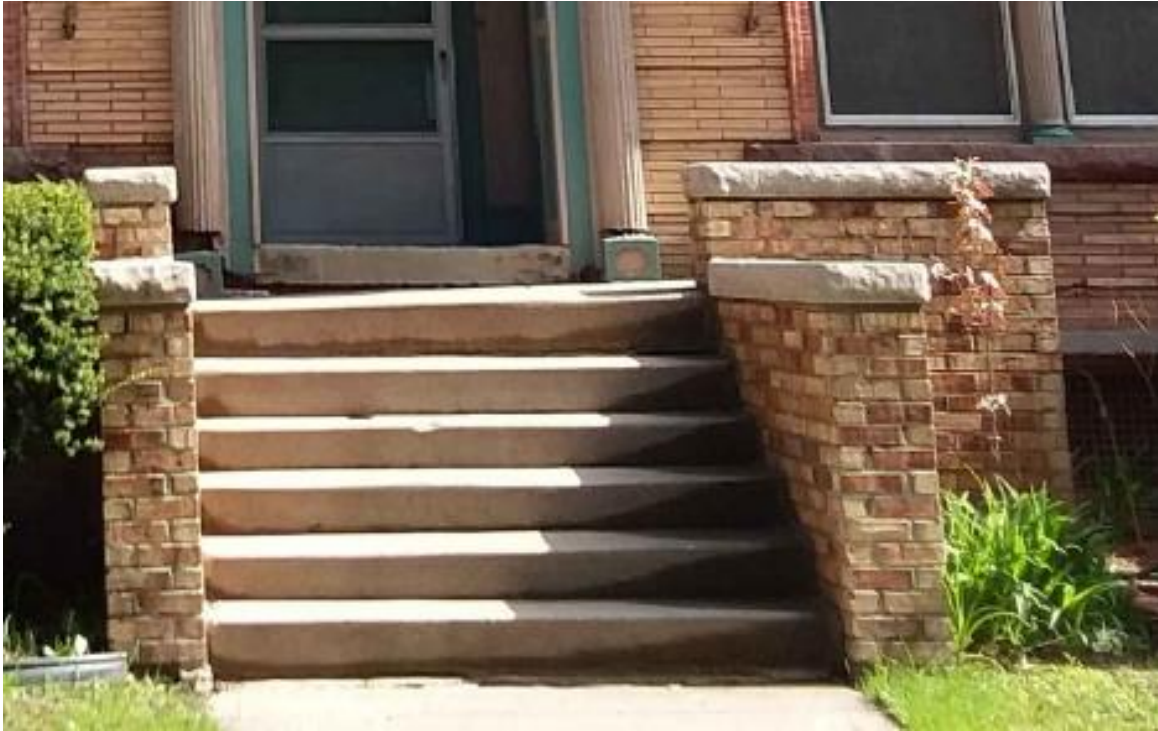
- As noted above, the brick wingwalls which were removed without approval and permit at the front porches do not appear to have been original/of historic age
- It is staff's opinion that the rear porches, rear doors, door overhangs, and basement stair enclosures were not character-defining features at the property
- As per the provided photos, the red common brick at the side and rear elevations had been painted red before the applicant repainted the brick the current dark red color. The color generally matches the natural color of the brick before it was painted.

Front elevation porch (typical), current appearance

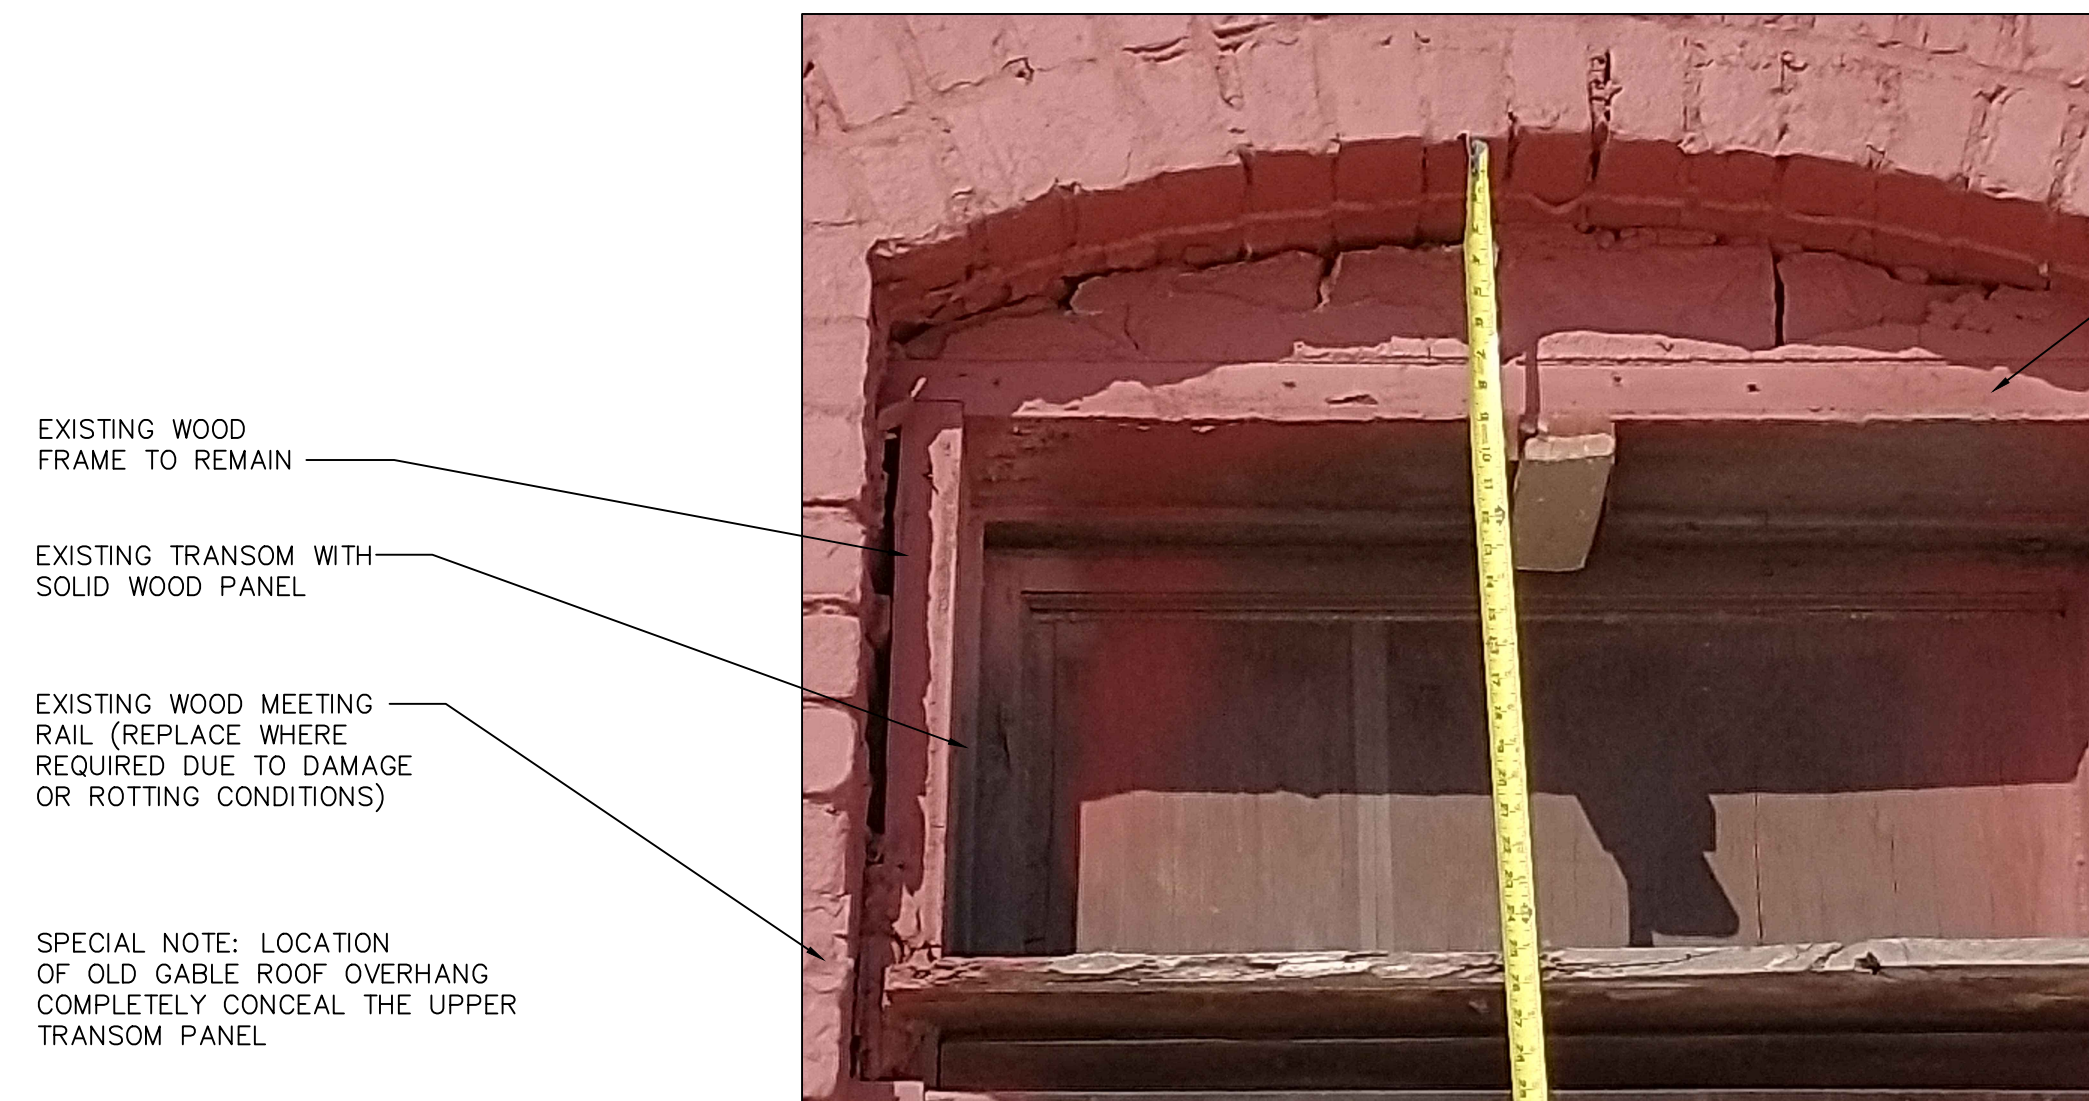
- As noted, the wood transoms over the rear doors were replaced without approval with the new aluminum-clad wood units. The new transoms are the same size, however, the amount of glass at the new transom is smaller when compared to the original because the frame is wider. However, see the photos of the original transoms. It appears that the glass at most of the transoms had been covered or removed. It is staff’s opinion that the original transoms

Enlarged View of Existing Door Transom Opening
