STAFF REPORT: 4/14/2021 MEETING

ADDRESS: 1627 (1627-1639) LEVERETTE

HISTORIC DISTRICT: CORKTOWN

SCOPE: ERECT NEW CARPORTS; REHABILITATE BUILDING

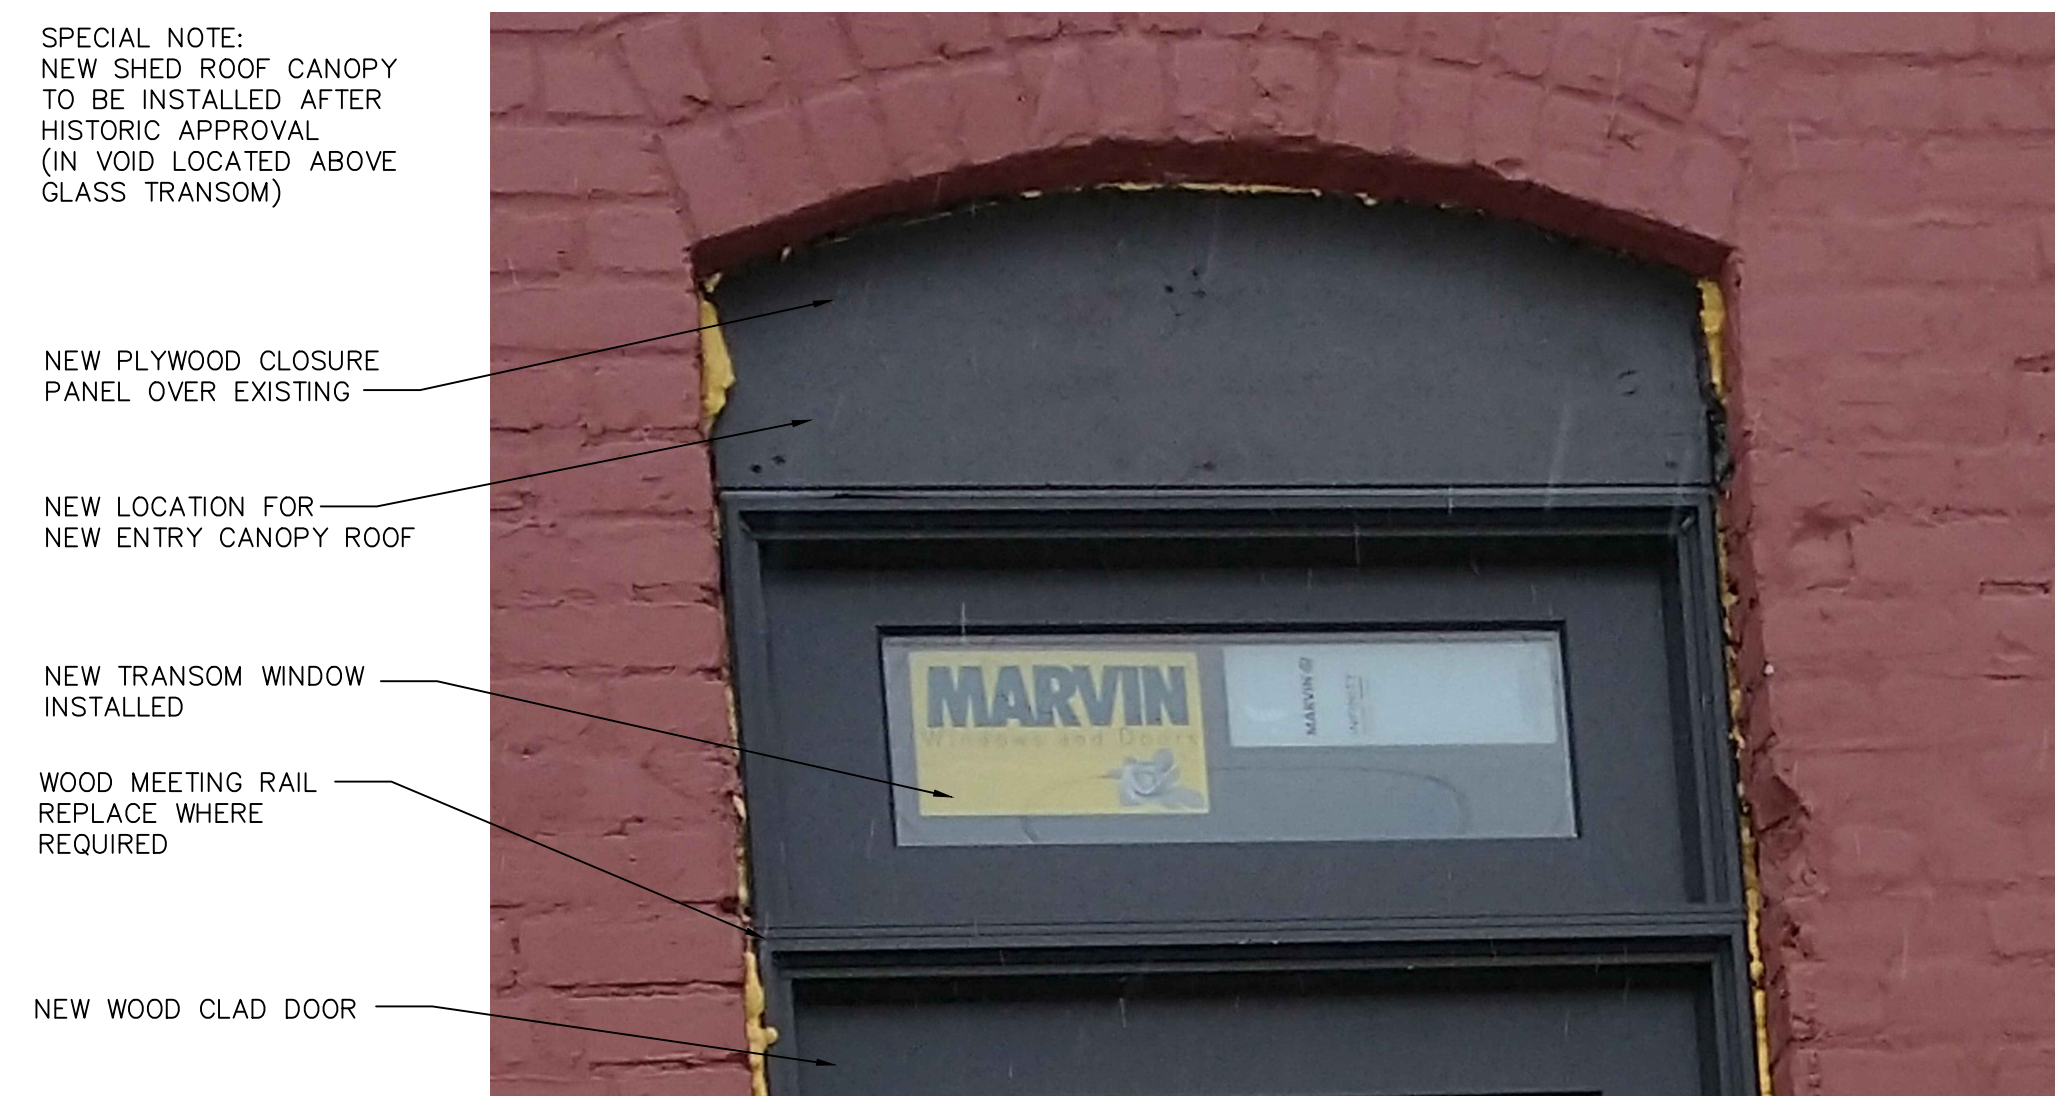
merited replacement. However, the new units do not adequately replicate the original due to their wide framing.

Enlarged View of New Door Transom Opening

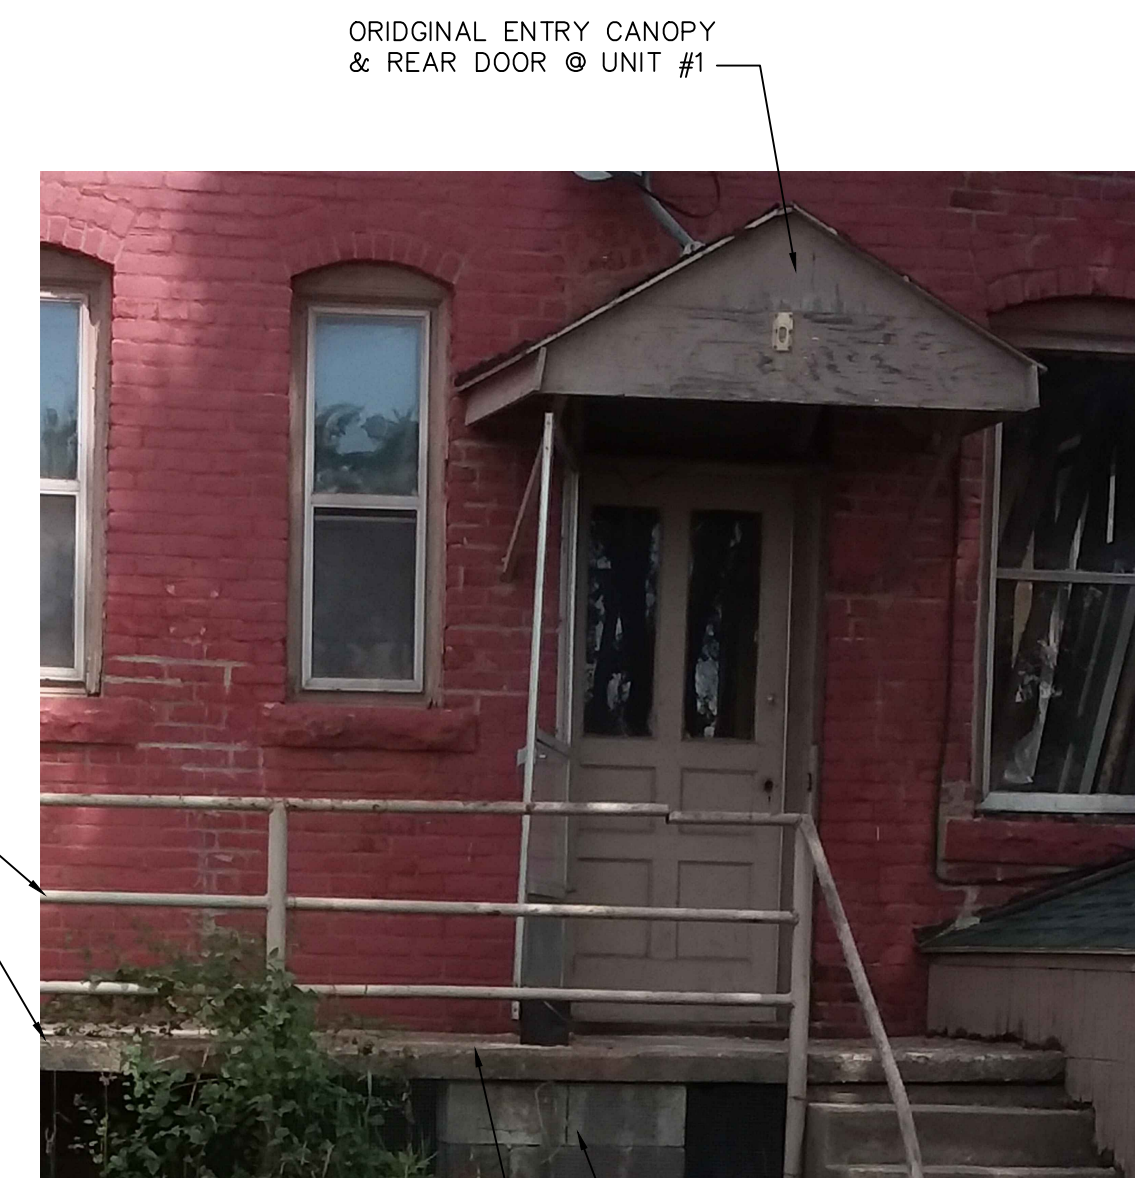
Existing Porch - Rear Door

- REMOVED GABLE ROOF ENTRY CANOPY
- REMOVED PIPE RAILING & FAILING CONCRETE PORCH DECK
- REMOVED & REPLACED EXISTING WINDOWS
- REMOVED & MODIFIED BASEMENT STAIR ENCLOSURE
- INSTALLED NEW TREATED WOOD PORCH DECK AND TREATED WOOD RAILING & PRIVACY SCREEN

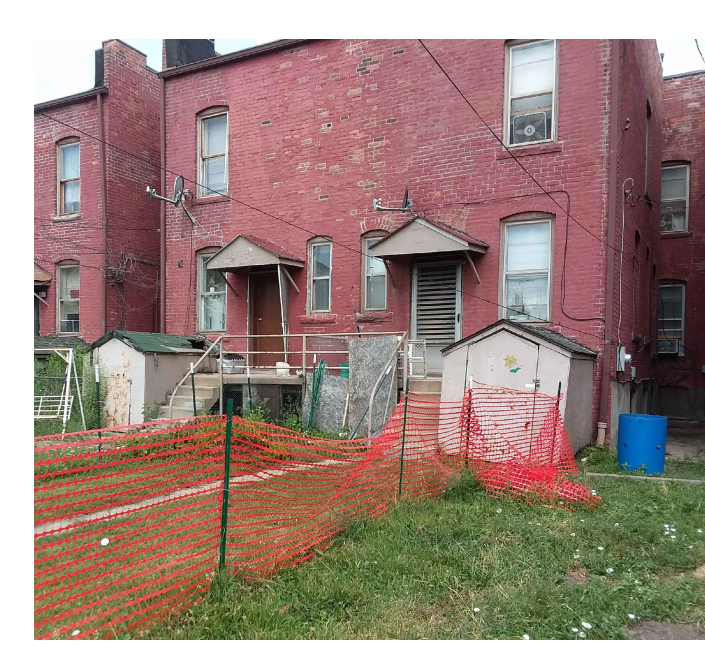
Condition of Rear Building Before Exterior Modifications

(NOTE - TUCK POINTING & WALL REPAIRS UNDERWAY)
 NEW ROOF & DOWNSPOUTS INSTALLED

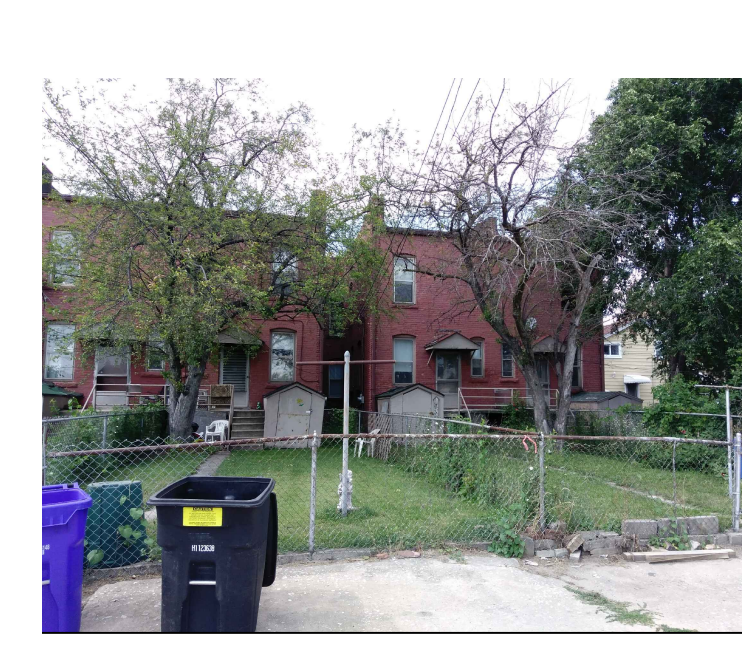
View of Rear Yard (East End) Before Renovations

NOTE: NEW ROOF & DOWNSPOUTS INSTALLED

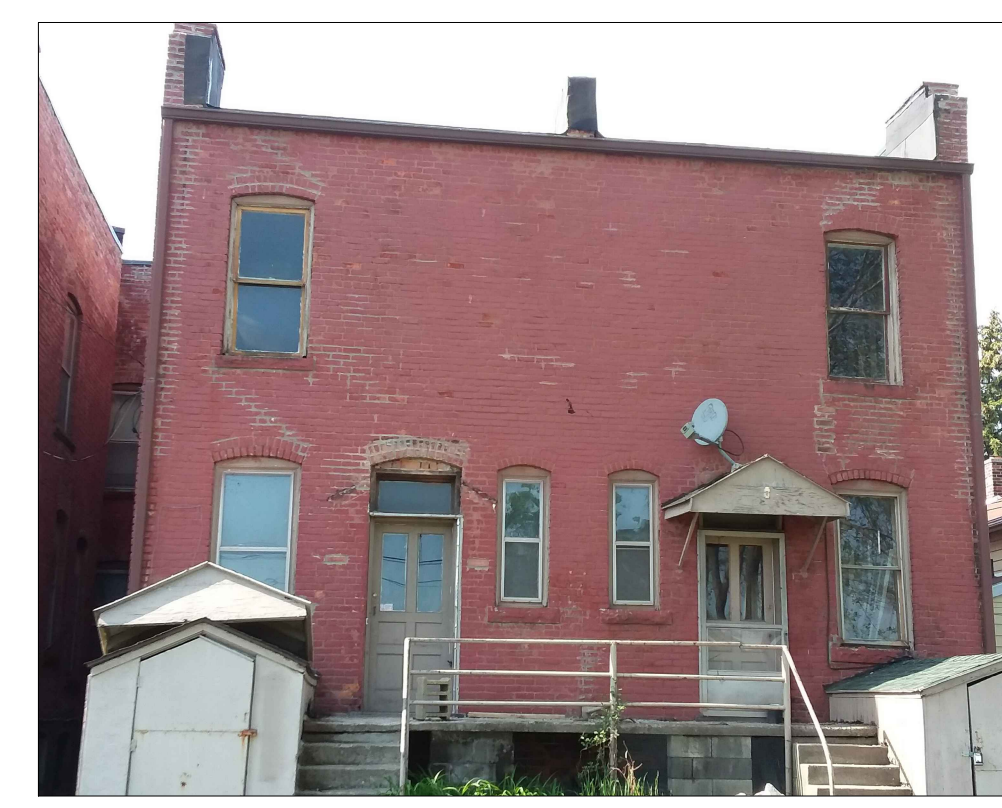
Building Before Renovations
South Wall - Units 1 and 2

SPECIAL NOTE:
THE EXISTING WOOD WINDOWS HAVE DETERIORATED BEYOND THE POINT OF REPAIR, OVER 65 PERCENT HAVE ROTTED &/OR HAS INSECT DAMAGED SILLS, JAMBS & SASHES. MANY OF THE ANCHORAGE LOCATIONS HAVE DAMAGED BLOCKING OR FAILED ANCHORS
MOST SASHES ARE DAMAGED BEYOND A COST EFFECTIVE REPAIR

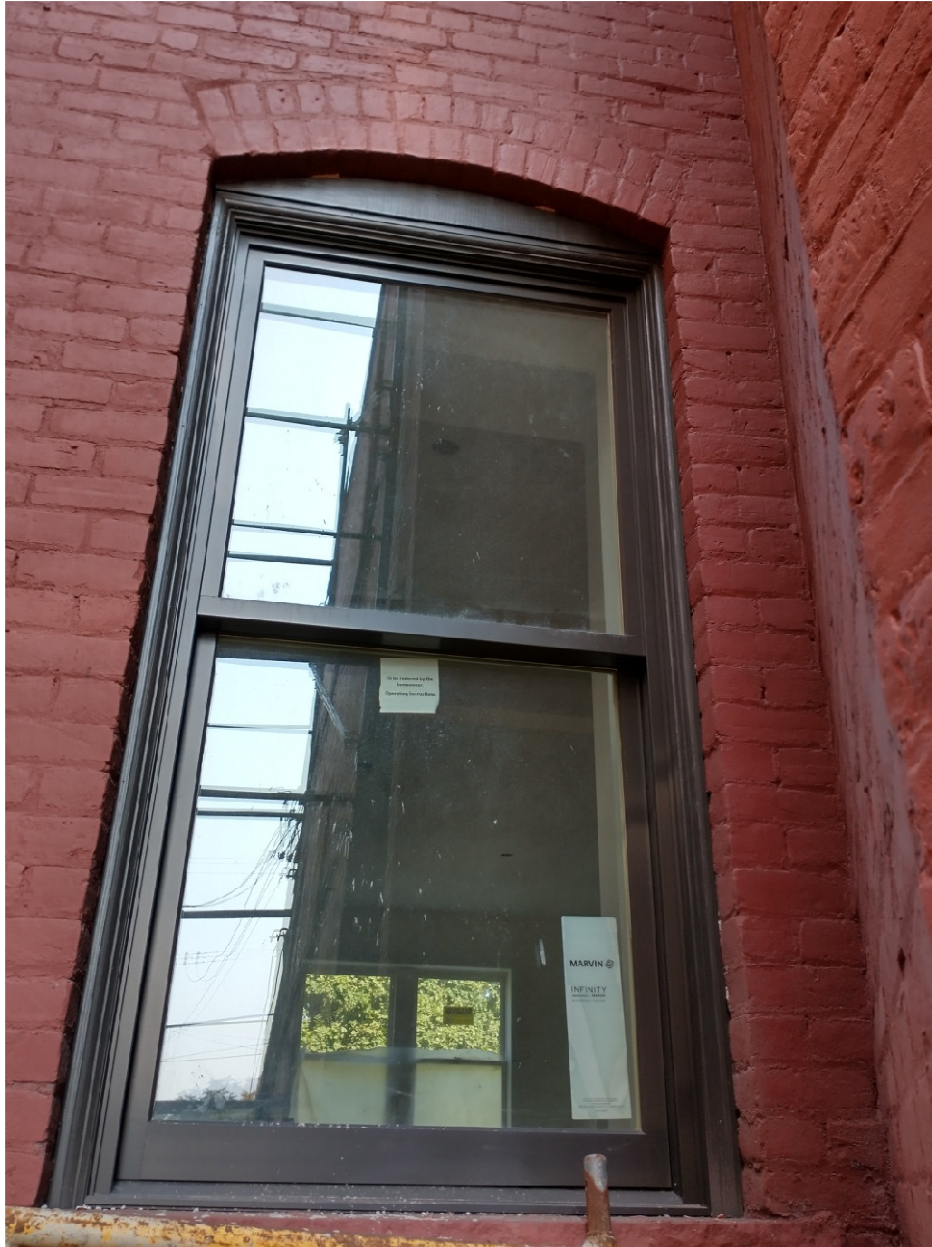
Typical Window Opening

New Window / New perimeter nailer / New Brick Mold

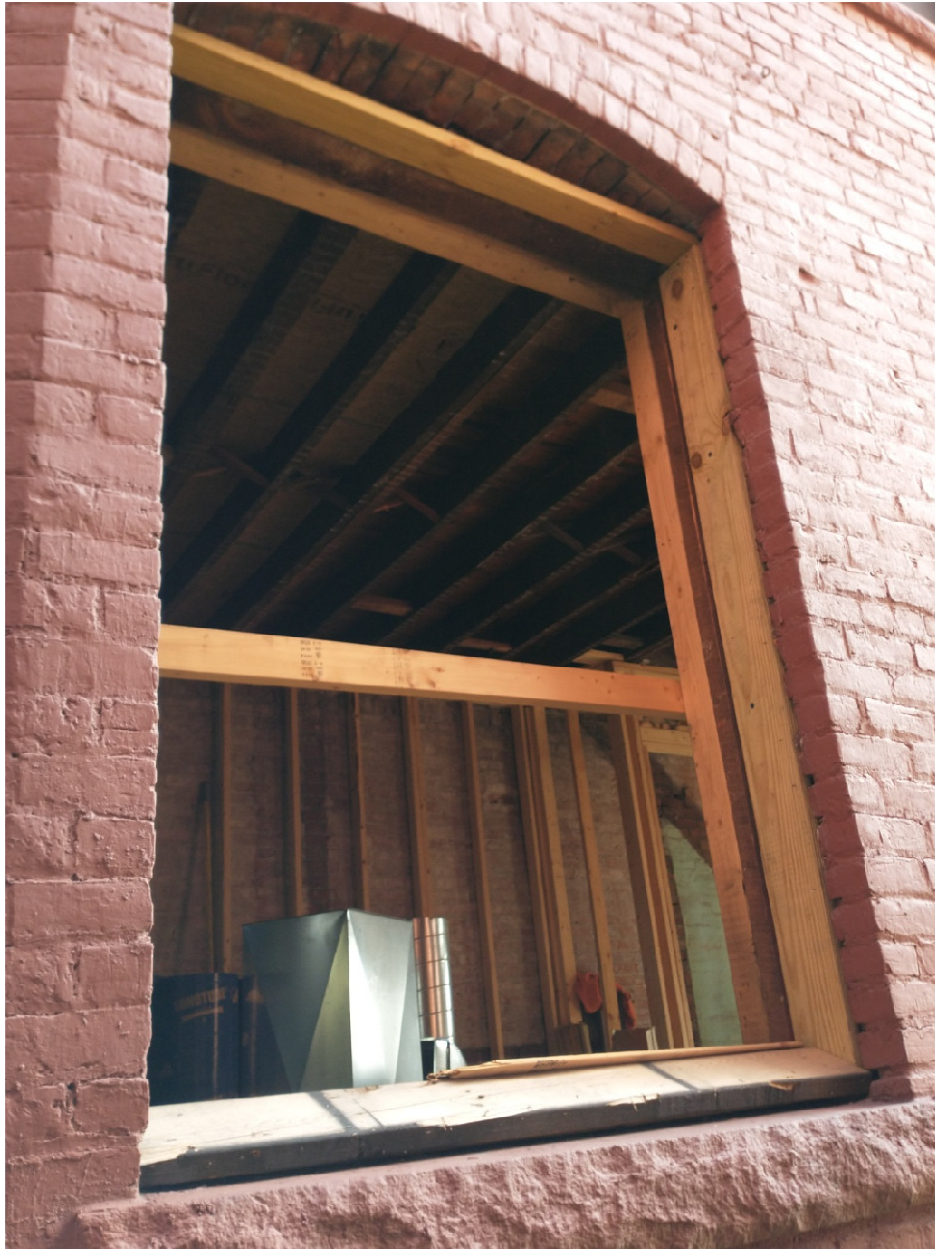
Window Opening (Typical)

Existing sill nailer / blocking - water or insect damage (to be removed & replaced)

Special Note: Removed all damaged wood framing & nailers. Replaced with new wood at all window openings

Remove all existing perimeter framing

Install new perimeter framing & new wood nailer within existing brick wall cavity

Point & repair loose brick at head & lintel bearing
