STAFF REPORT 9-8-2021 REGULAR MEETING

APPLICATION NUMBER: 21-7395

ADDRESS: 4784 STURTEVANT STREET

SCOPE: DEMOLISH EXISTING GARAGE, REPLACE COLUMNS AND RAILING AT FRONT PORCH

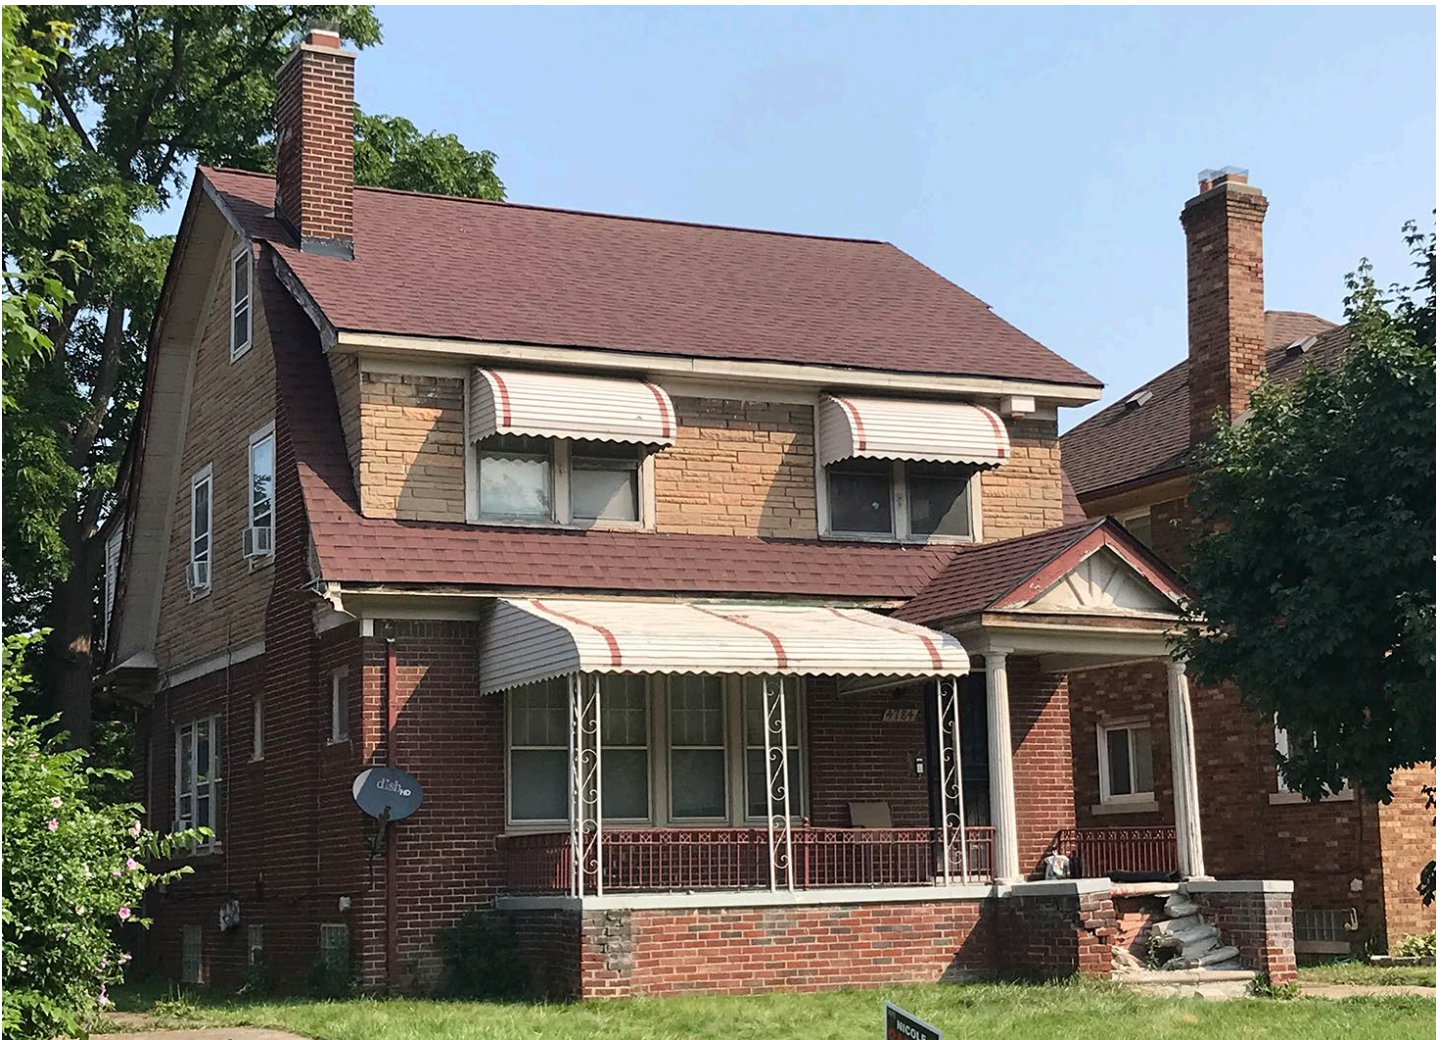
4784 Sturtevant. View from Sturtevant Street looking northeast. Photo taken by HDC staff, July 31, 2021.

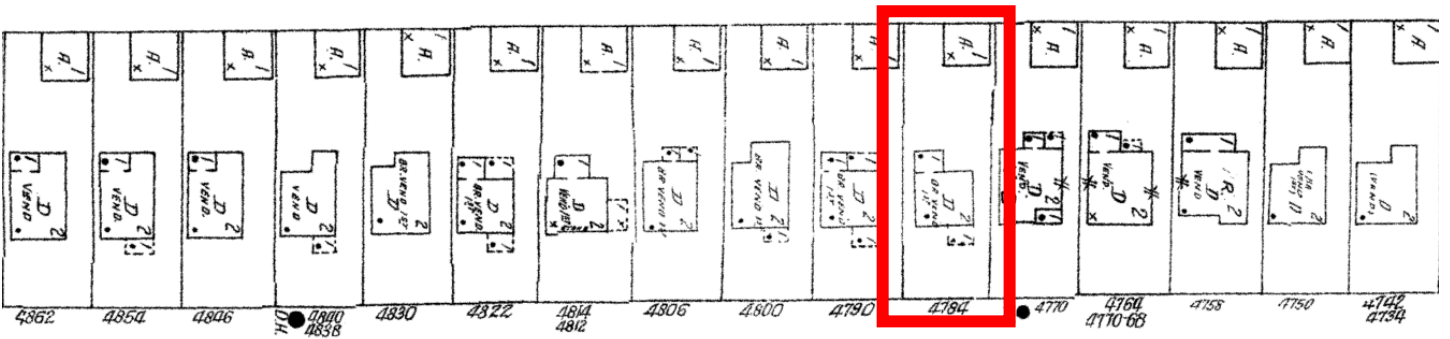
4784 Sturtevant. View from Sturtevant Street looking northeast. Roof replacement started and in progress on July 28, 2021 without COA and completed by July 31, 2021. The work was pending an administrative approval when it was started and when HDC staff documented the work in progress on July 28th. A COA for the roof along with miscellaneous other scope items was issued by staff on July 30th, 2021. Photo taken by HDC staff, July 28, 2021.

- Staff observed active work happening (re-shingling the roof of the house) when completing their routine field visit on Wednesday, July 28th, 2021. This work was started without a COA, however, the work was pending an administrative approval at that time. The official COA was issued by staff on Friday, July 30th, 2021. Staff then went back out to the site on July 31st and the work had been completed. Multiple scope items were included in the administrative approval that was issued on July 30th, 2021 (see attached COA).
