STAFF REPORT: 9-08-2021 MEETING PREPARED BY: D. RIEDEN

APPLICATION NUMBER: #21-7393

VIOLATION NUMBER: #378 ADDRESS: 2071 LONGFELLOW

SCOPE: PAINTING OF PREVIOUSLY PAINTED MASONRY (WORK DONE WITHOUT PERMIT)

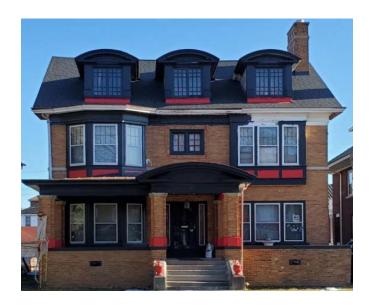
I would like approval to change the color of the paint for the wood rectangular boxes that are on the 2^{nd} and 3^{rd} floors which are currently painted red, to cream? For the second floor, three boxes are on the left, and three boxes are on the right. For the third floor, one rectangular box is on the bottom of each dormer. Please see the pictures below that show the red rectangular boxes on the 2^{nd} and 3^{rd} floors.

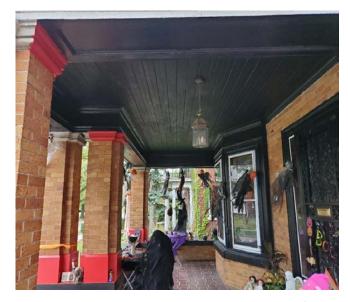
From the Color System C that was provided to me, C:4 Yellowish White and C:5 Yellowish White are closest to the color cream. My plan is to go to Home Depot with these two colors and have them match as closely to one of these two colors. Moreover, I wish to use the same cream color to paint the inner part of the front door the cream color (to give the door contrast) and change the porch ceiling color from black to the same cream (to brighten the area). Please see the pictures below that show the front door and the porch ceiling which are both wooden.

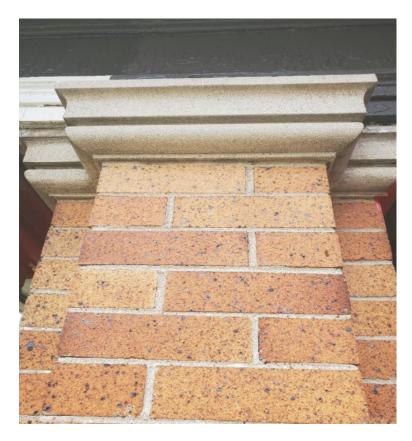
I hope that this message finds you well. This is a follow up to our telephone conversation regarding requesting to paint the concrete. I physically went to Sherwin Williams and Home Depot to try to match the brick as close as possible to an available color. Overall, I have found that the breathable paint is only available through Sherwin Williams and it has to be custom ordered. The Loxon brand is not stocked in the Sherwin Williams store however it can be ordered in the store or online. Sherwin Williams offers a paint match online and that is how I came to pick the color that I did. When uploading a photograph, their system picks many matching colors however all colors are not available to be picked for the Loxon brand which is a special brand that includes the breathable mixture. So after all of this, this is what I have picked and here is a recent picture of the brick.
