**STAFF REPORT: SEPTEMBER 8, 2021 MEETING**

**APPLICATION NUMBER: 21-7468**

**ADDRESS: 360 LODGE**

**SCOPE: REMOVE CONCRETE DRIVEWAY; NEW ASPHALT DRIVEWAY**

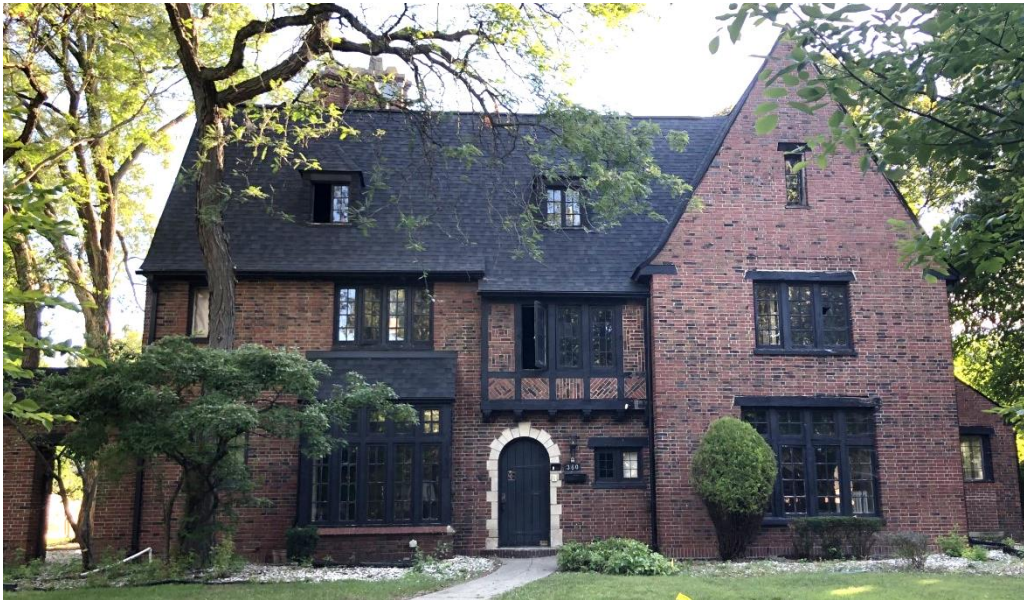
HDC Staff photo, September 1, 2021

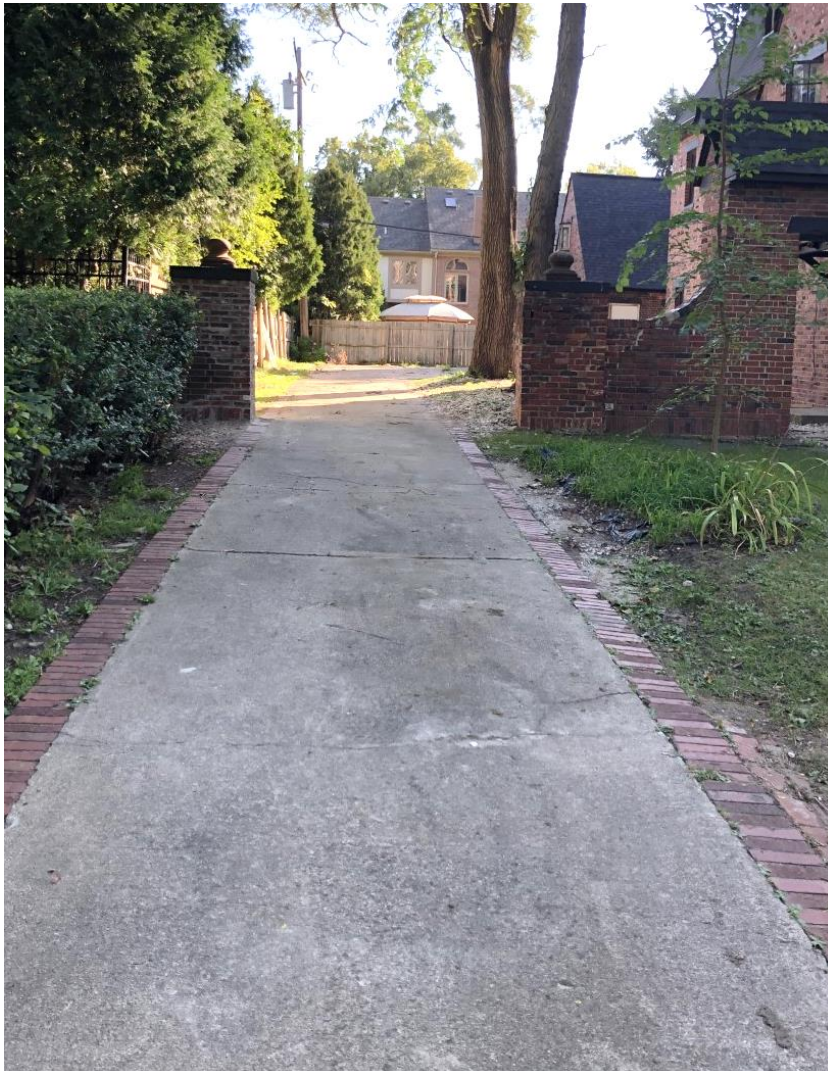
- The concrete and brick pavers lining the driveway were in place at the time of district designation.
- The concrete blocks between the street and the masonry pier do show some cracks but are primarily intact. From the sidewalk, and confirmed in the applicant's photographs, the concrete beyond the masonry piers are at a higher level of deterioration.

HDC Staff photo, September 1, 2021

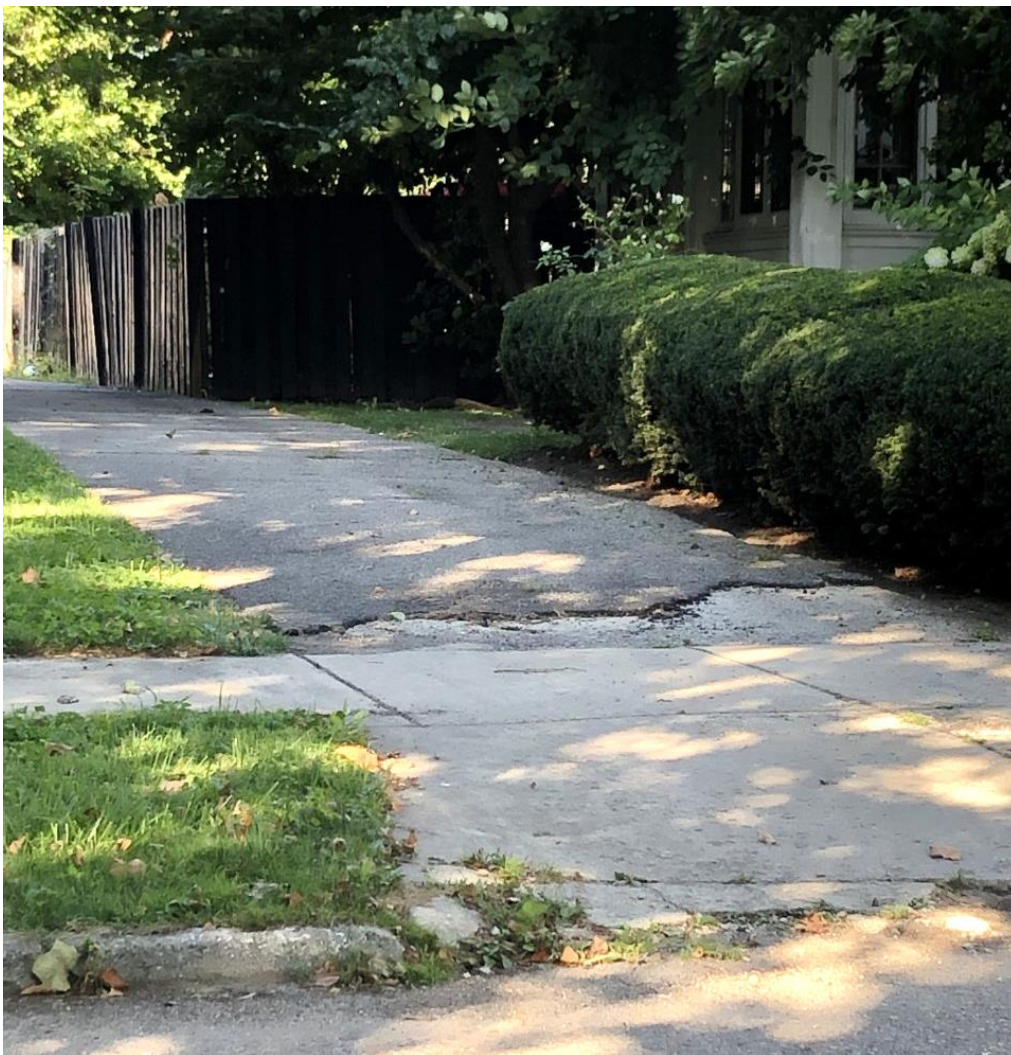
HDC staff photo, September 1, 2021

Current Condition with Pictures:  
Concrete all damaged and broke

Driveway And pad by the garage concrete is going to be removed and replaced with Black Asphalt.
