STAFF REPORT: DECEMBER 8, 2021 MEETING PREPARED BY: A. DYE

APPLICATION NUMBER: 21-7613

ADDRESS: 1409 BAGLEY

HISTORIC DISTRICT: CORKTOWN

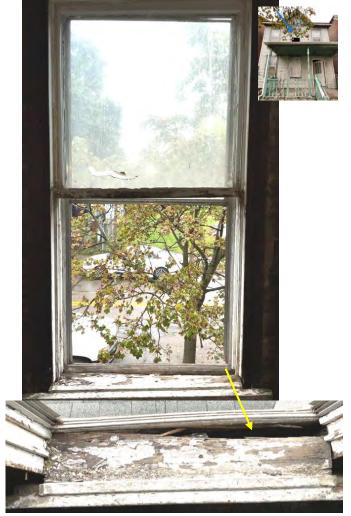
The upper left window unit remains intact, with minimal noticeable deterioration to the sash and sill.

The upper right window unit is missing the lower sash as well as the storm window glass. Due to exposure, the sill has deteriorated to the point that part of it is gone.

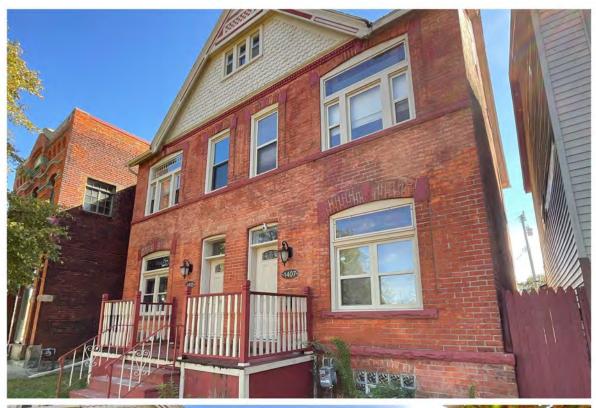
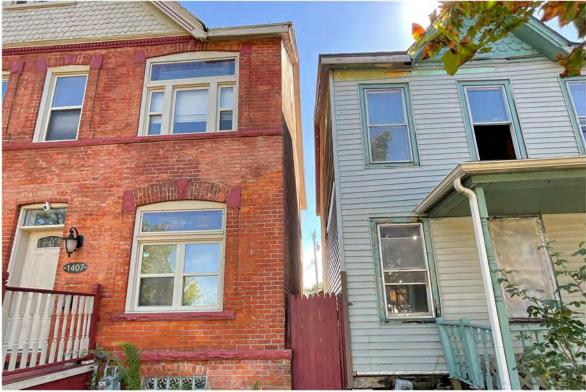
1407 BAGLEY

Neighbors on each side currently have all vinyl windows:
