STAFF REPORT: APRIL 13, 2022 MEETING PREPARED BY: A. DYE

APPLICATION NUMBER: 22-7752

ADDRESS: 15004 WARWICK

SCOPE: REPLACE WOOD WINDOWS WITH VINYL WINDOWS

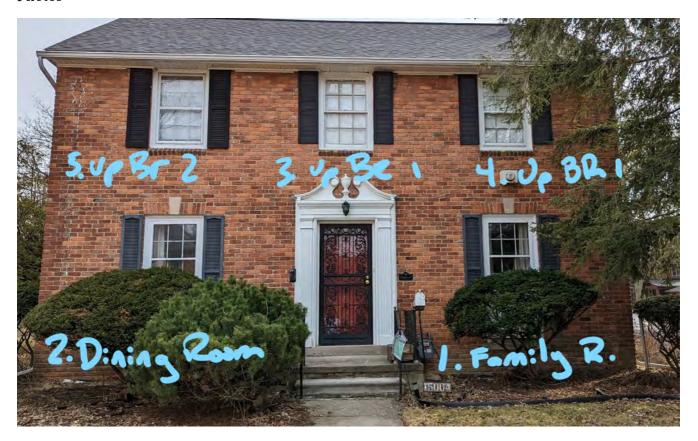
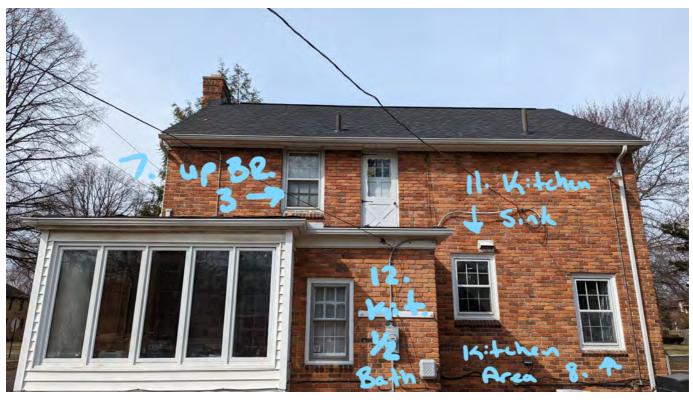
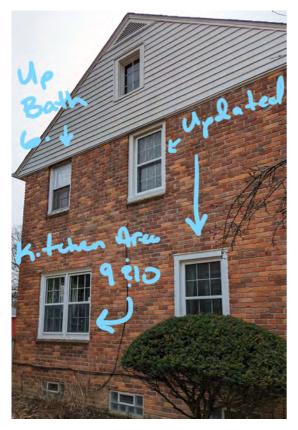
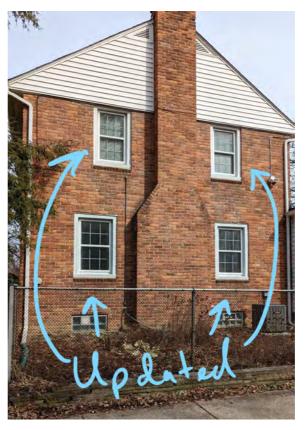
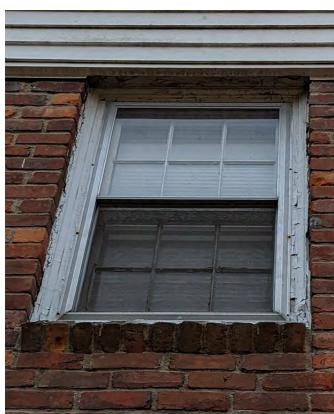
*Notice on the above elevation pictures the improved appearance of the updated vinyl windows that have the colonial grills.
