**STAFF REPORT: JULY 13, 2022 MEETING**

**APPLICATION NUMBER: 22-7906**

**ADDRESS: 1659 LONGFELLOW**

**HISTORIC DISTRICT: BOSTON EDISON**

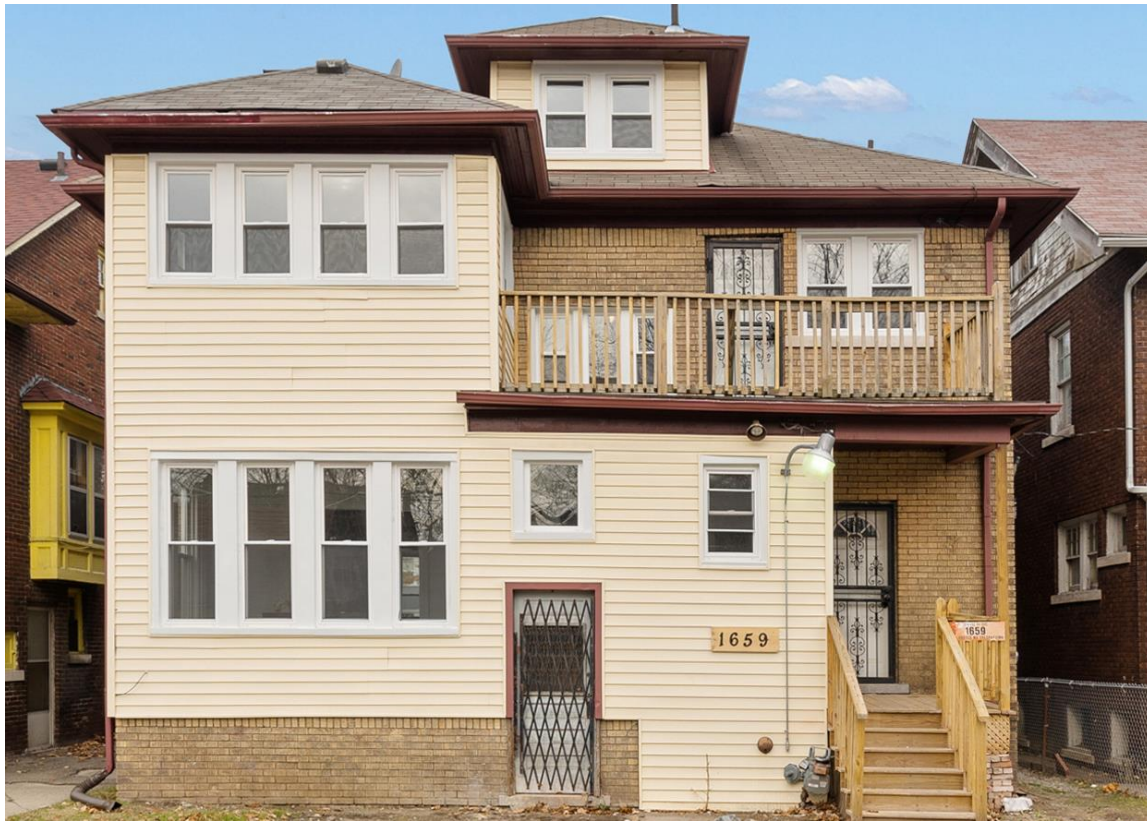
*Applicant photo*

Cream-colored vinyl siding is also present at the building's the rear, projecting wing and the east/side elevation projecting bay. White, vinyl double-hung windows were installed on each elevation. The front entry contains a solid panel replacement door. White doors (possibly an original door at-grade, and replacement doors leading to each porch) are located at the rear elevation.
