**STAFF REPORT:** 9/14/2022 MEETING

**APPLICATION NUMBER:** #22-8009

**ADDRESS:** 269 WATSON

**SCOPE:** REPLACE EXTERIOR WALL AND DOORS (WORK STARTED WITHOUT APPROVAL),  
INSTALL REAR DECKS, ENCLOSED BASEMENT STAIRWELL AND BALCONY

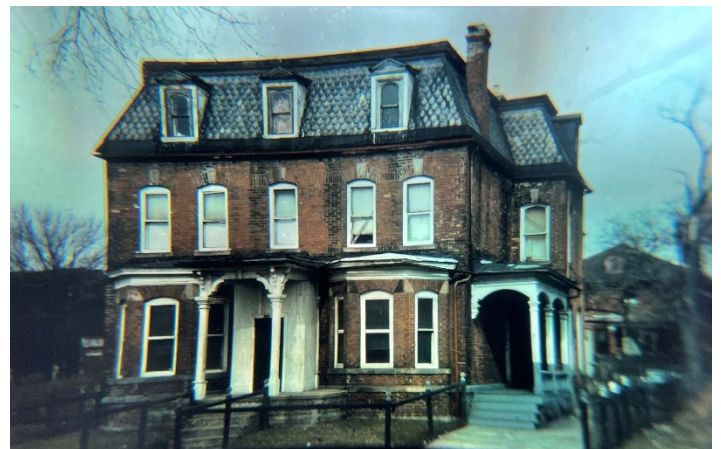
Designation Image, 1975: (Southeast) front elevation.

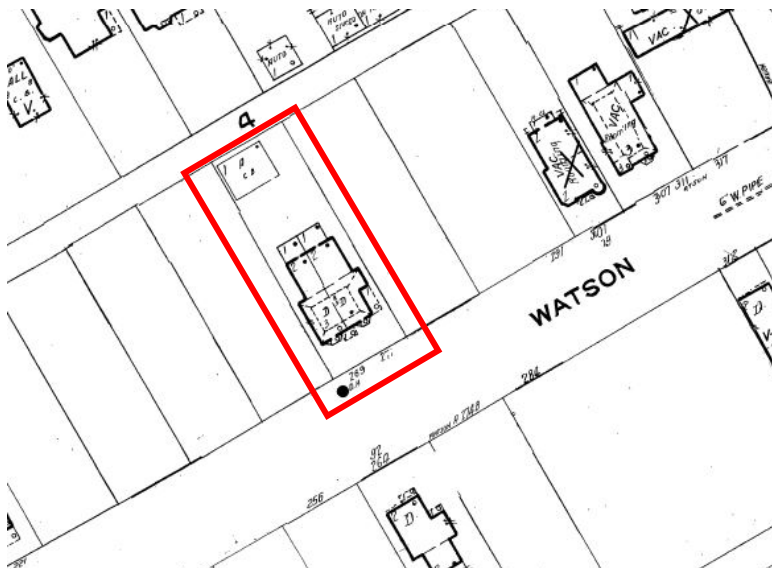
Sanborn V3, P030

- Staff observed from the Sanborn map that the rear elevation once supported a rear deck and/or balcony that has since been removed. Staff reviewed Google Street and saw images from Brush street that confirms this rear elevation has had no rear structures since at least 2008.
