STAFF REPORT: 9/14/22 REGULAR MEETING

APPLICATION NUMBER: 22-8016

ADDRESS: 1773 PARKER

SCOPE: REPLACE WINDOWS ON ATTIC DORMERS, SOUTH ELEVATION BAY WINDOW, AND REAR PORCH

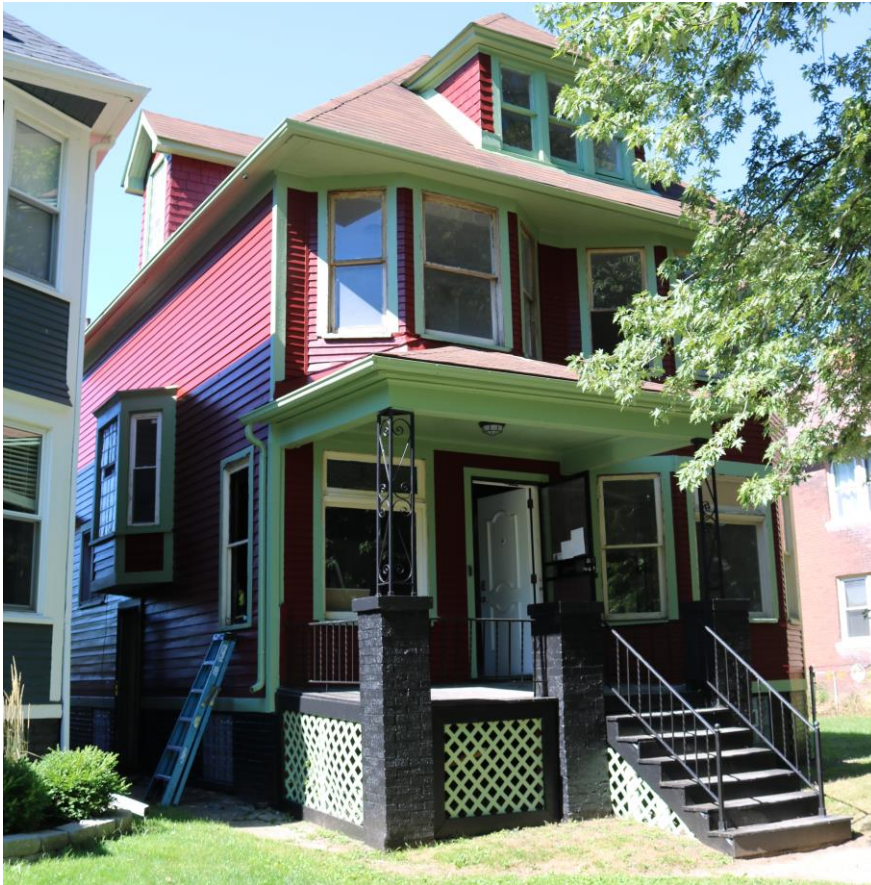
1773 Parker is a two-and-a-half story, wood-sided house built in 1909. It faces east onto the street in the West Village Historic District. The house is comparable to the other houses on its block in age and scale. Ornamentation specific to a particular architectural style does not exist.

September 2022 photo by staff.
