**STAFF REPORT: 10/12/2022 REGULAR MEETING**

**APPLICATION NUMBER: #22-8056**

**ADDRESS: 4290 LESLIE**

**SCOPE: REHABILITATE DWELLING, INSTALL FENCE (WORK COMPLETE WITHOUT APPROVAL)**

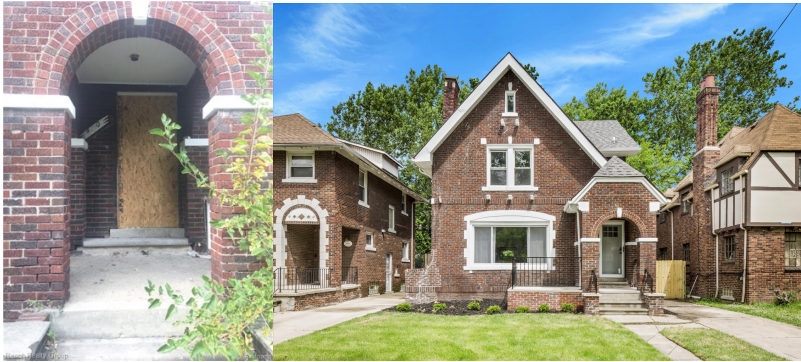
1. Front Door was replaced and painted white. Added a screen door as well. Old door was missing and only had plywood on it when I purchased the home originally.

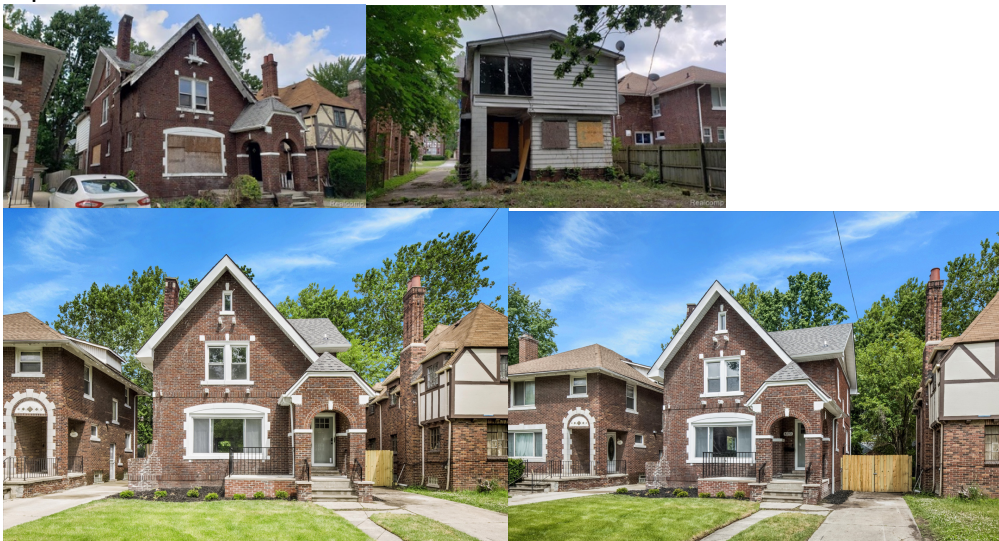
2. Front railing was added. They were custom made for the house. We can remove them if needed.
3. Vinyl soffits. When purchased the home already had vinyl siding and soffits. We replaced and added the missing pieces. Some areas were repainted white.
4. Windows. The home had 0 wood windows when purchased. It was a mix of vinyl and aluminum windows. The aluminum windows were replaced by local contractor. The vinyl windows were refurbished. Some had cracks in glass and just the glass pane was replaced.

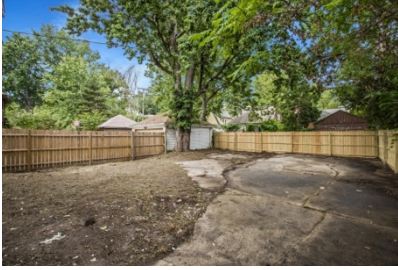
5. Fencing. When purchased home had chain link fence. We used the old fence line to replace with the new wood fencing. Used the same fencing our next door neighbor had.

- Applicant supply HDC staff with a paint or stain product information to be applied to the fence for approval.
