STAFF REPORT: 10/12/2022 REGULAR MEETING

APPLICATION NUMBER: #22-8066

ADDRESS: 2011 LONGFELLOW

SCOPE: REPLACE WOOD WINDOWS WITH WOOD AND FIBERGLASS UNITS ALTER PORCH
(WORK COMPLETE WITHOUT APPROVAL)

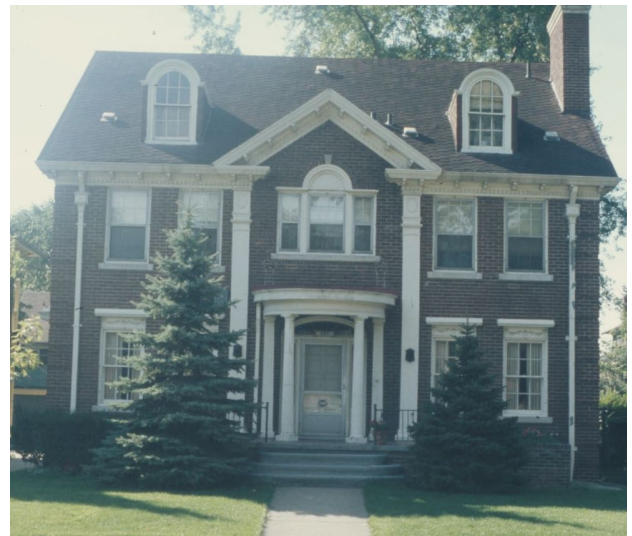
Site Photo 2, designation slide 1980: (North) front elevation.

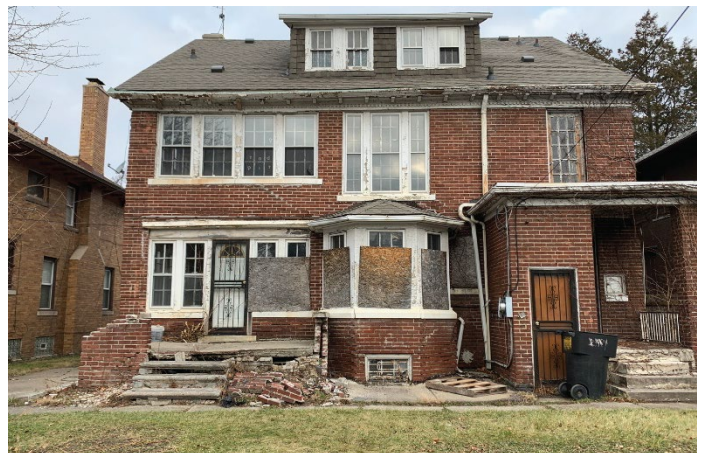
Site Photo 5, by Applicant Jan 2021: (Southeast) rear elevation showing previous windows.

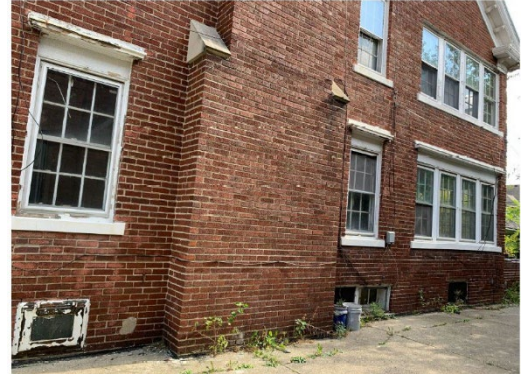
Site Photo 7, by Applicant: (West) side elevation showing original wood windows.

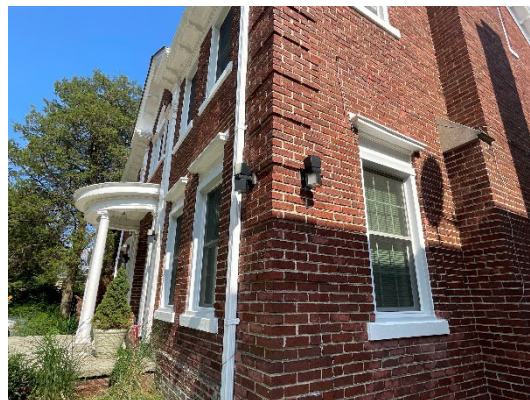
- Staff invited the applicant to address the installation of security lights without approval and the applicant responded with the purpose and details of the lighting equipment.
- It is staff's opinion that the side elevation locations (east and west) may be appropriate, but their current locations on the brick quoin detailing at the front elevation and the front pilasters is not appropriate. It is staff's opinion that the front pilasters, if used for lighting at all, would be of a design and style that is more appropriate for a colonial style of architecture, and distinguishes itself from security lighting that is also used on the sides of the house.

Site Photo 8, by Staff: (Northwest) front and side elevations showing locations of security lights at on the brick quoins and front pilasters of the house.
