STAFF REPORT: OCTOBER 12, 2022 MEETING

APPLICATION NUMBER: 22-8048

ADDRESS: 1515 CHICAGO

SCOPE: REPLACE FRONT PORCH COLUMNS AND REPAIR PORCH FLOOR AND STEPS, ERECT REAR DECK

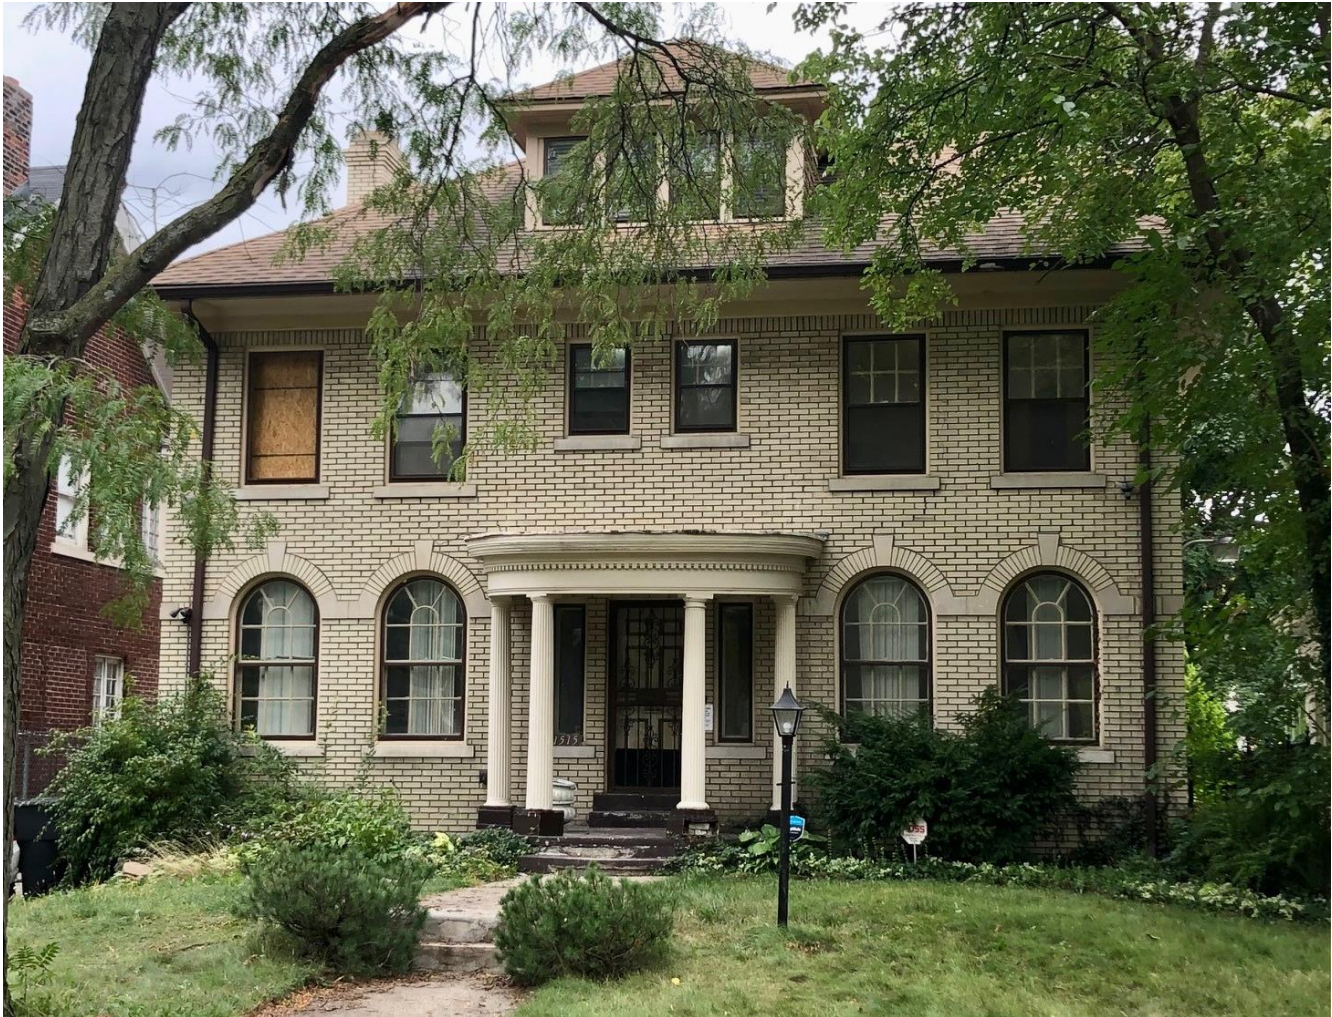
HDC staff photo, September 27, 2022

Erected in 1916, this structure exhibits Colonial Revival details and Prairie influences. The symmetrical front elevation is punctuated by a classically designed half-round portico featuring dentil trim and four equally placed Doric fluted columns which rest on square pedestals. The first floor's arched windows are tied together through semi-circular brick courses and stone banding. The rowlock course at the cornice offers an echoing vertical pattern to the dentil trim at the front porch. Prairie details include the low pitch hip roof, broad overhanging boxed eaves, and corbel brick at the top of the chimney. A straight walkway leads from the sidewalk to the front door; two steps were centrally placed along the walk to accommodate the raised lawn.

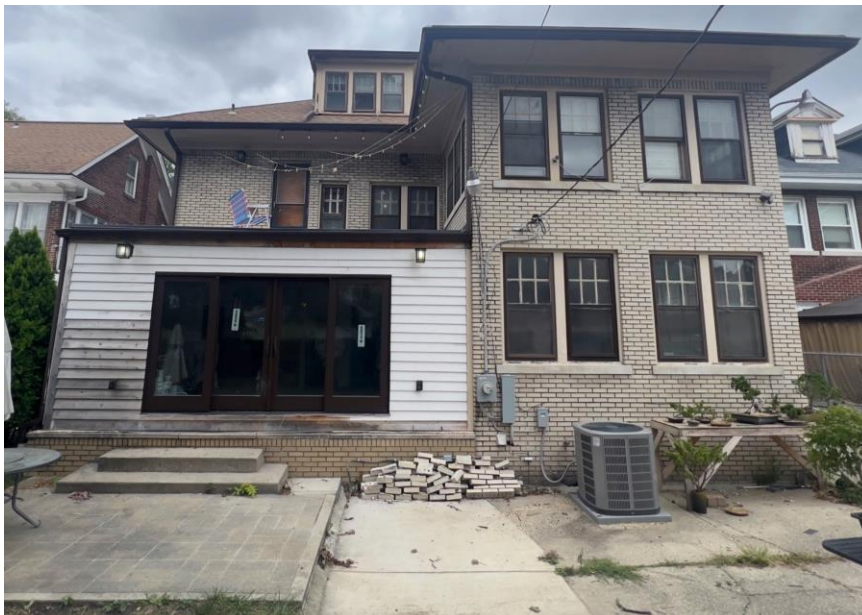
Applicant photo

The articulation of the rear elevation through the mulled windows, asymmetrical volume, and deeply overhanging eaves, strongly identifies with the Prairie style. The one-story structure covered with wood siding was approved by the Commission and erected in 1980, and replaced a deteriorated one-story screened porch. The sliding door, approved by the Commission in 2021, replaced the original design's single sliding door and small off-set window. A small, raised patio and concrete steps that were proportional to the single sliding door remain, and are proposed for replacement in this application.

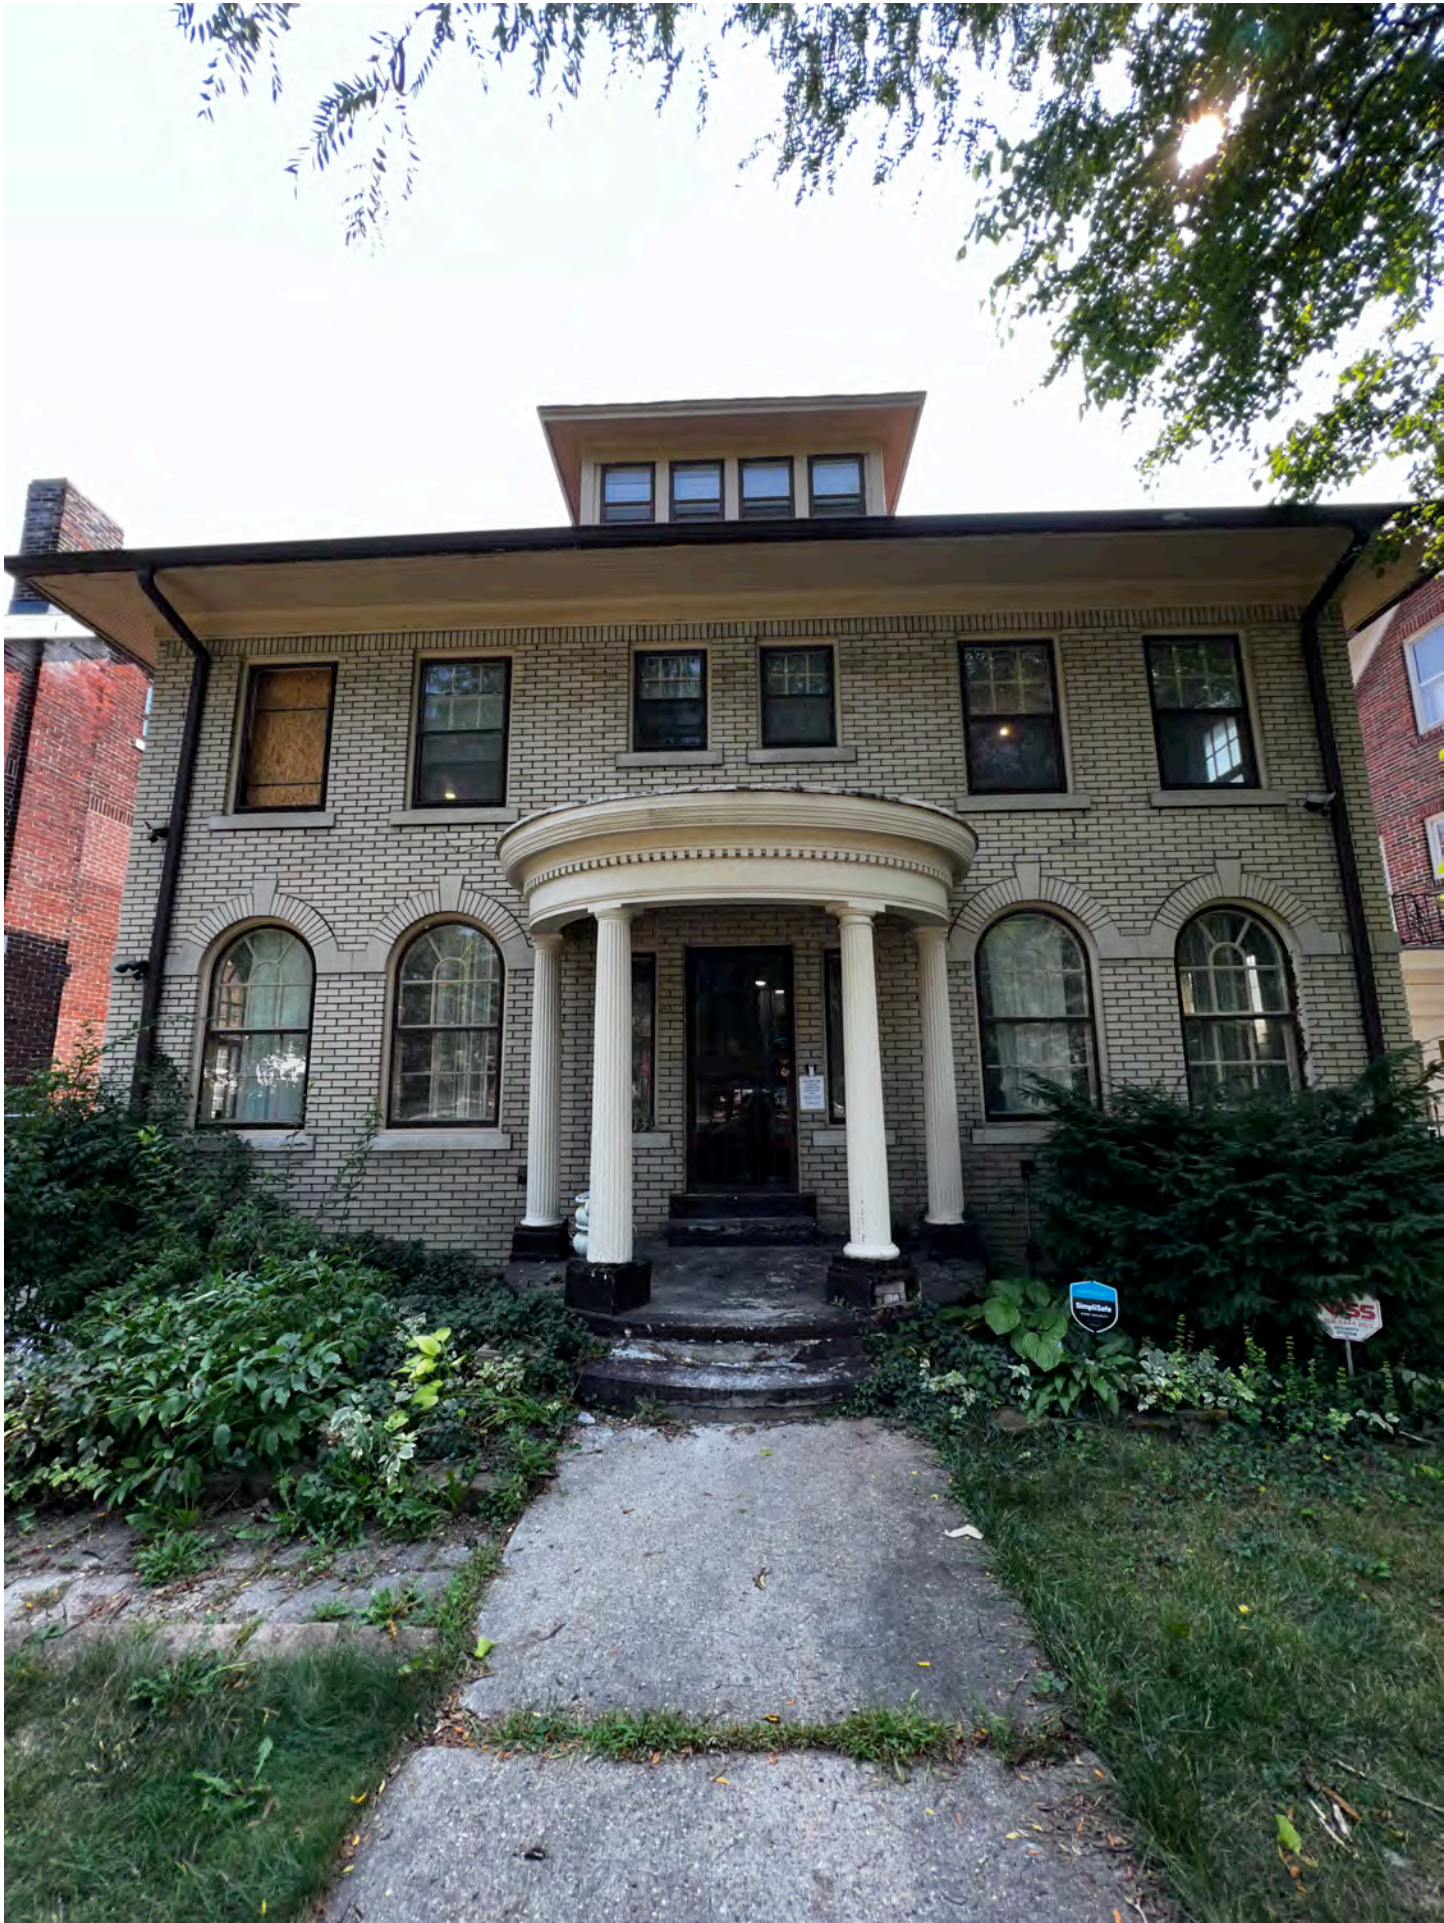
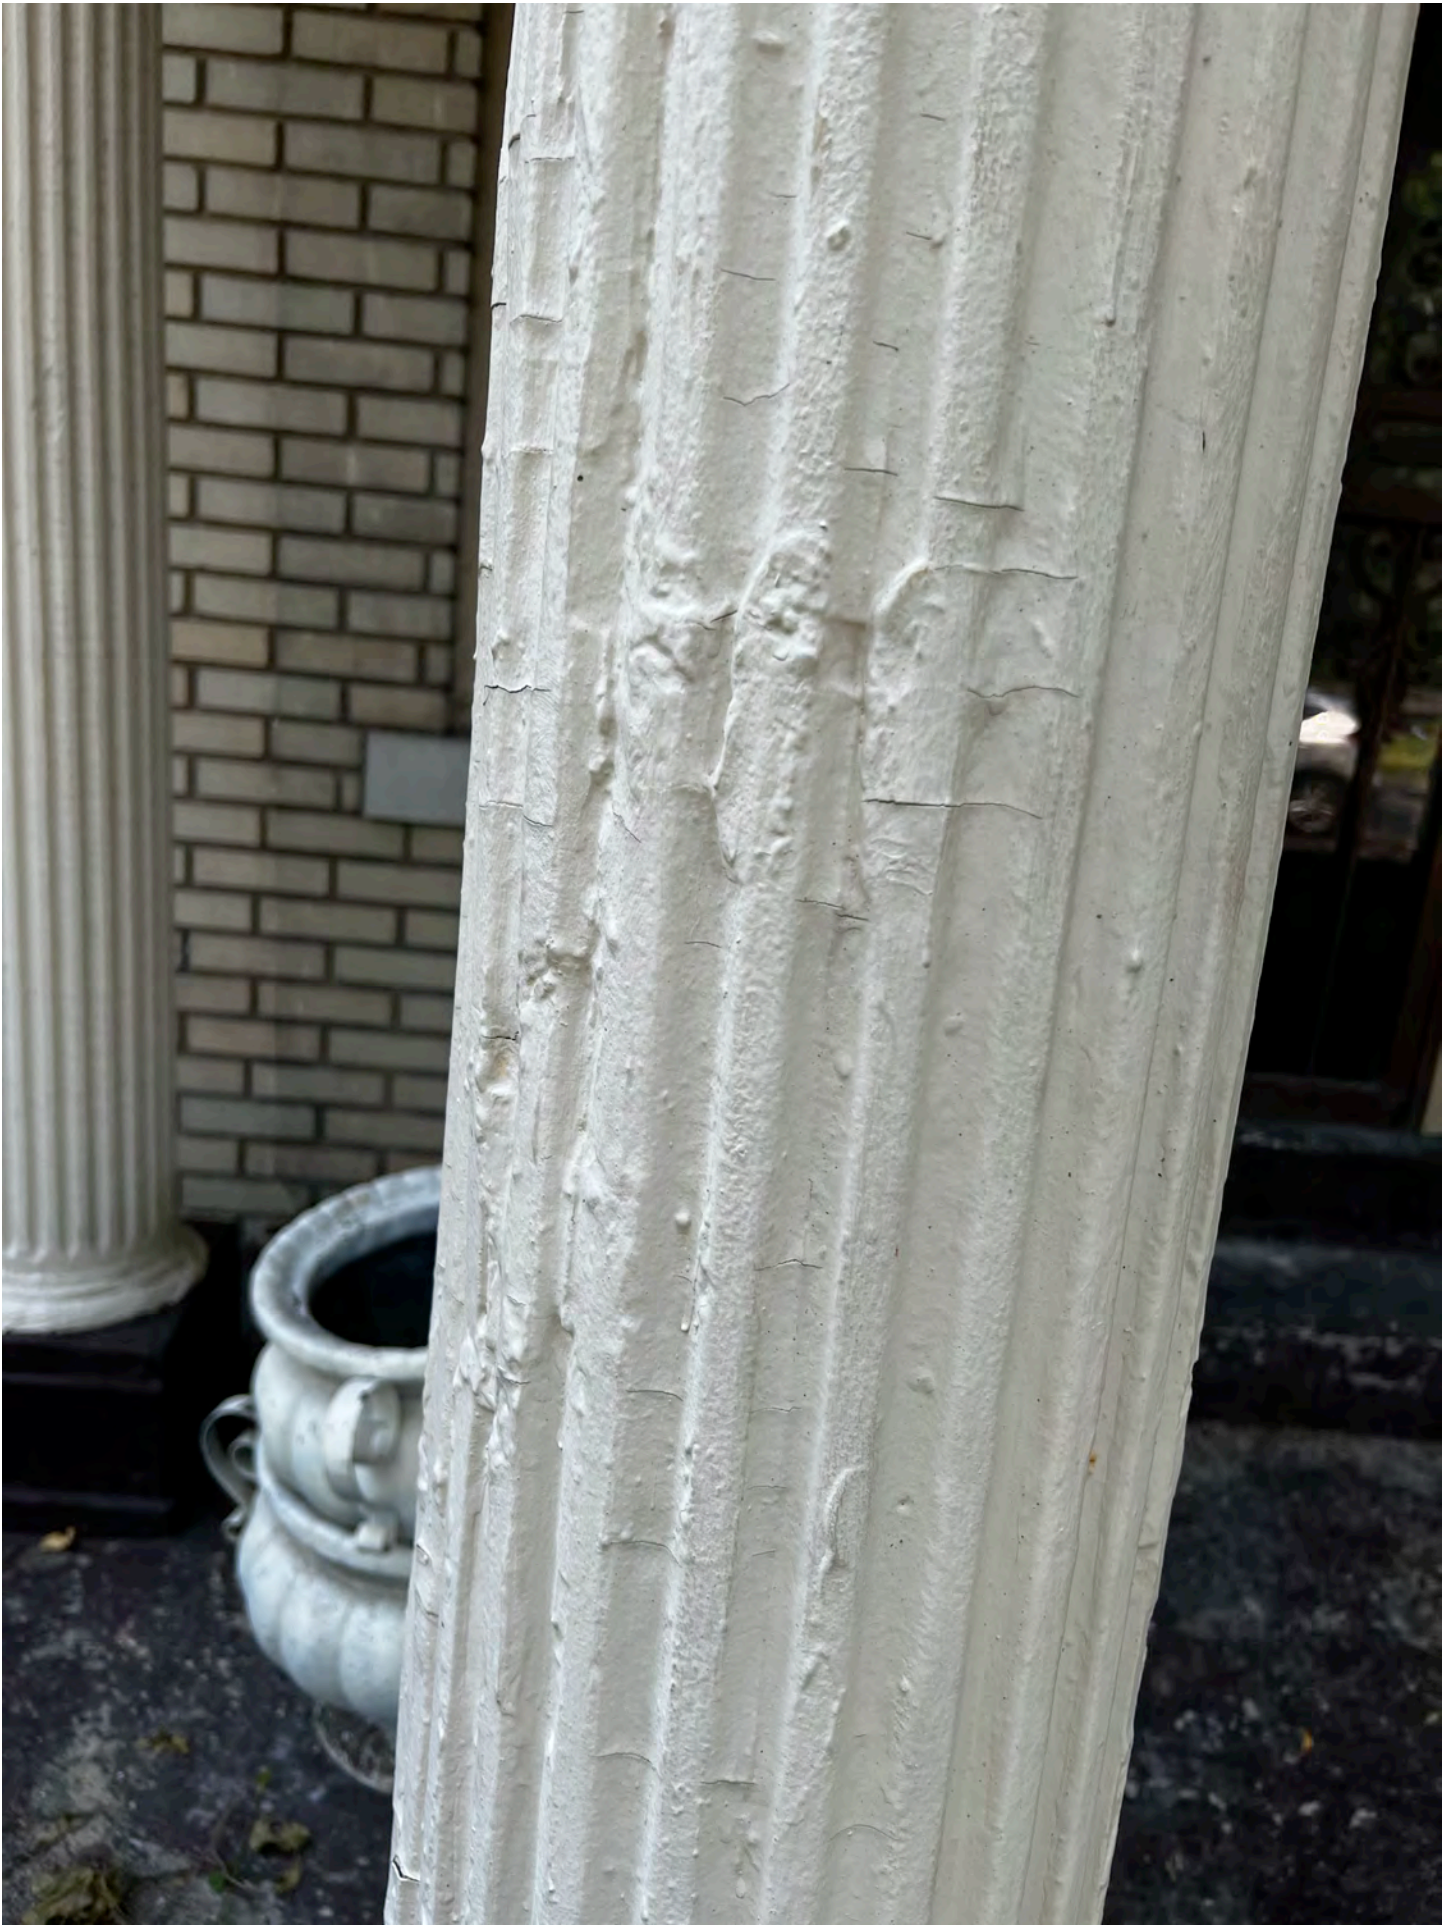
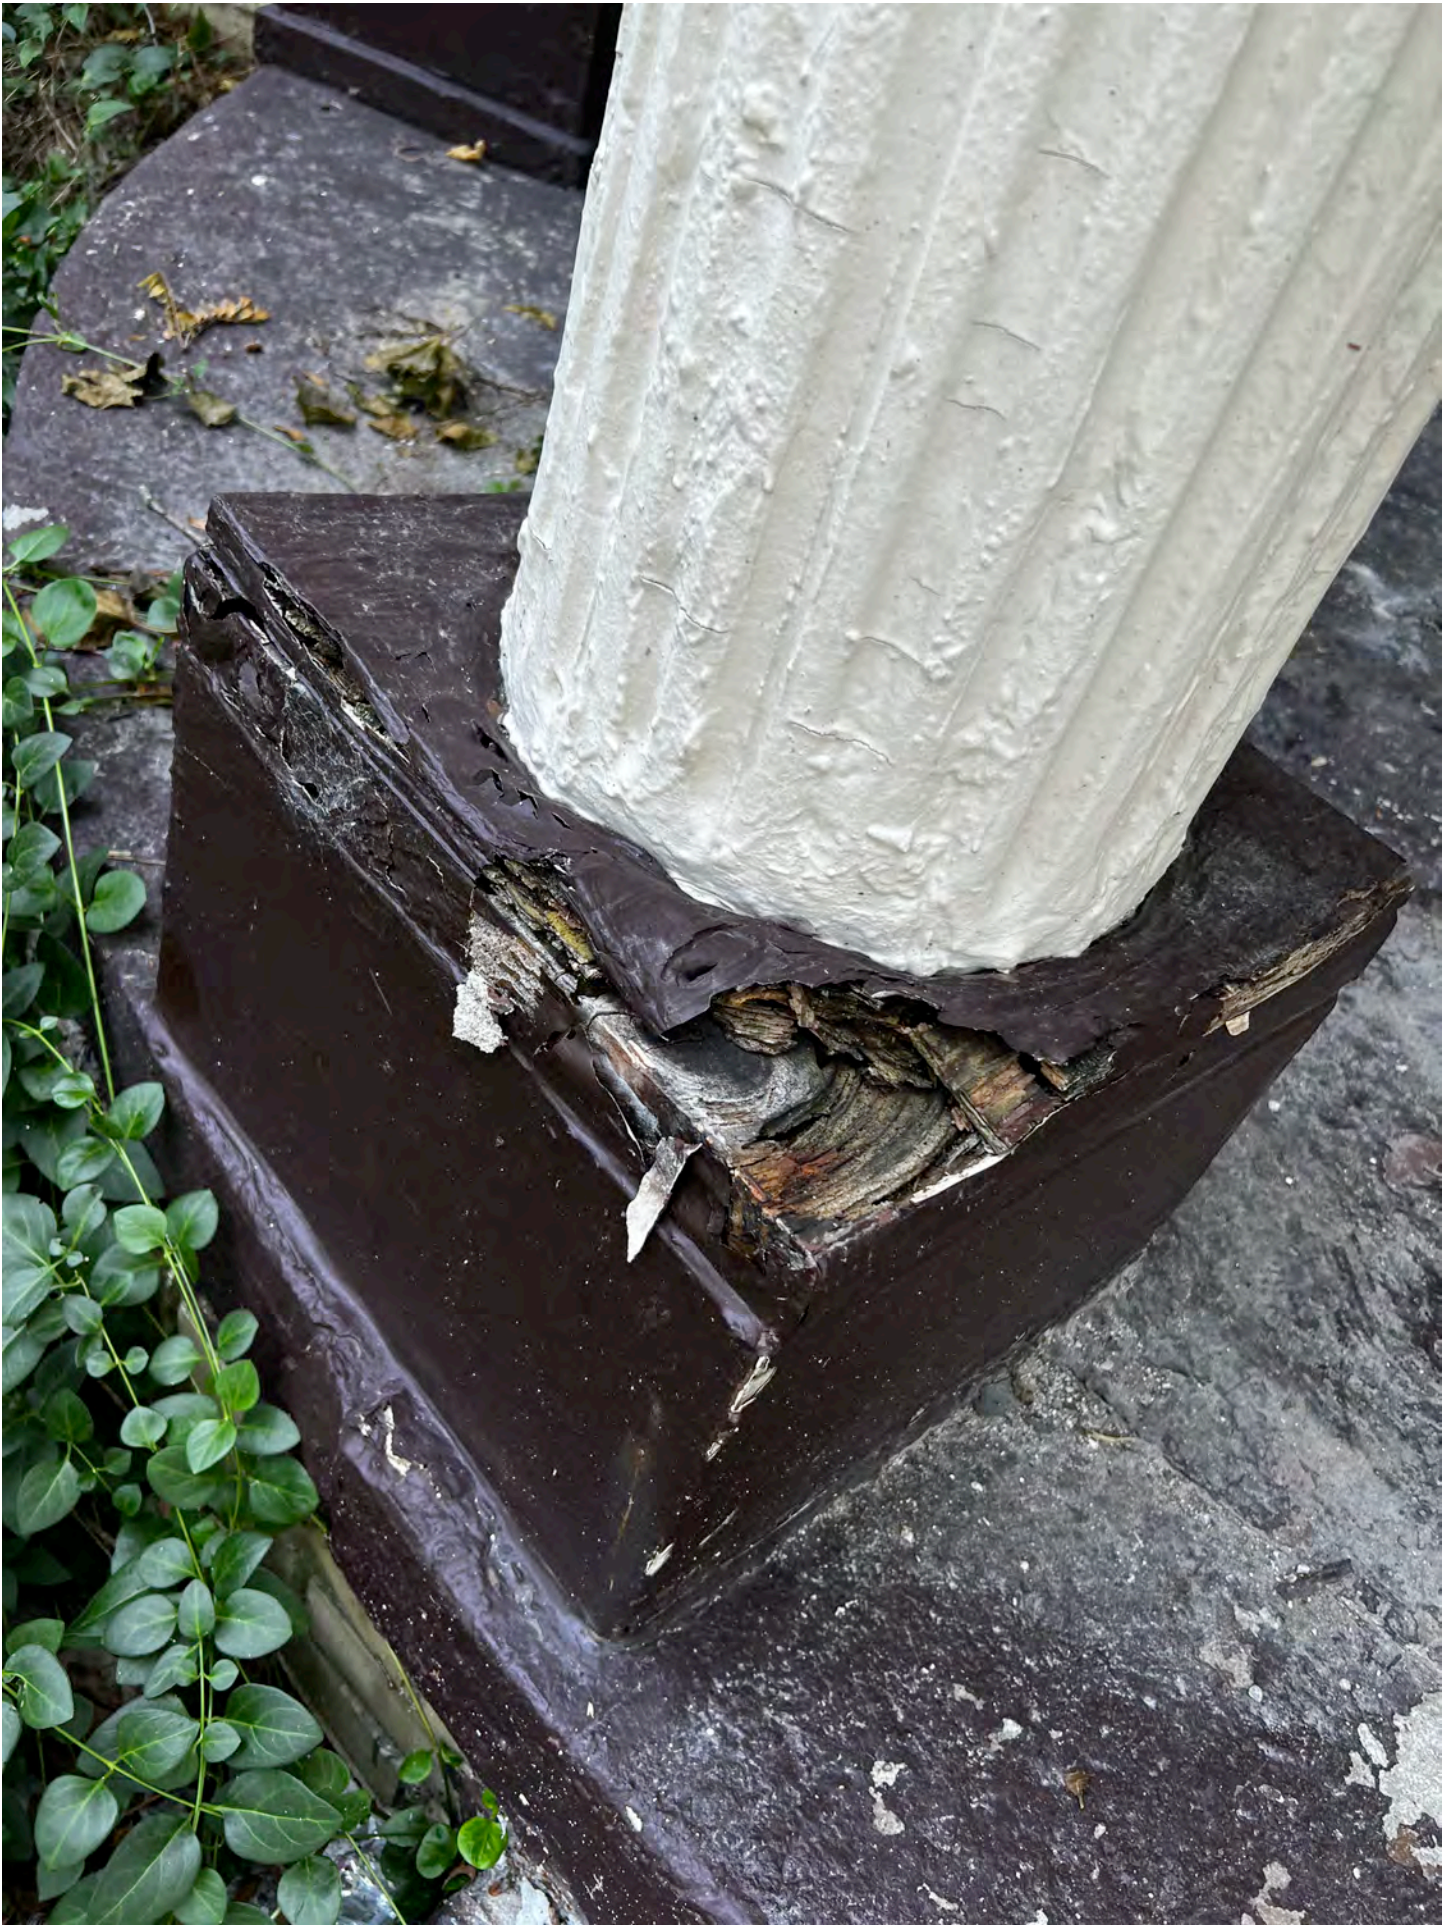
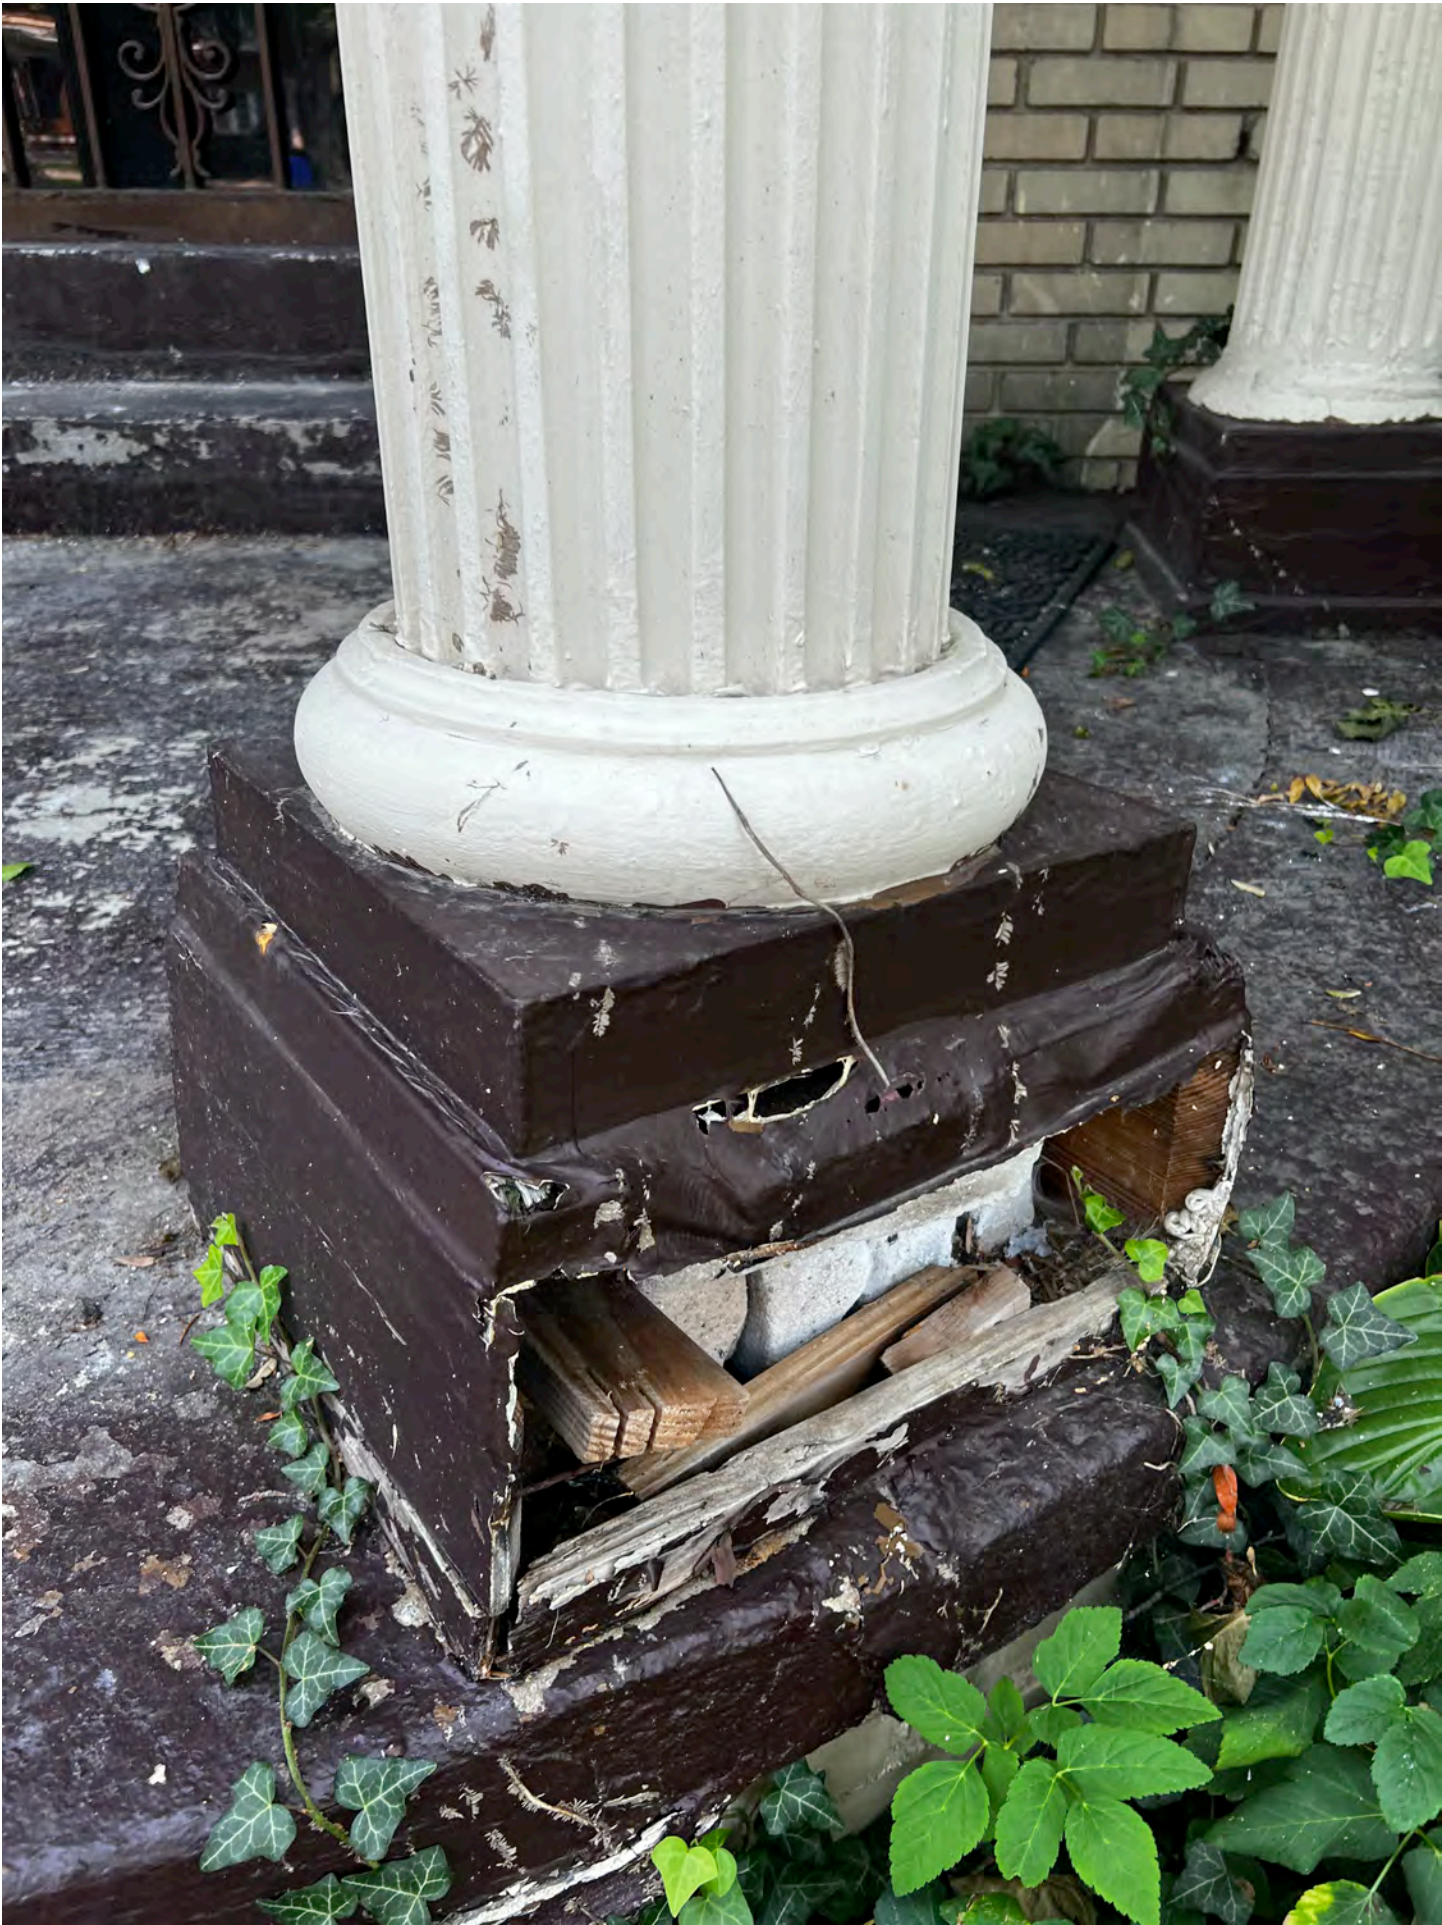
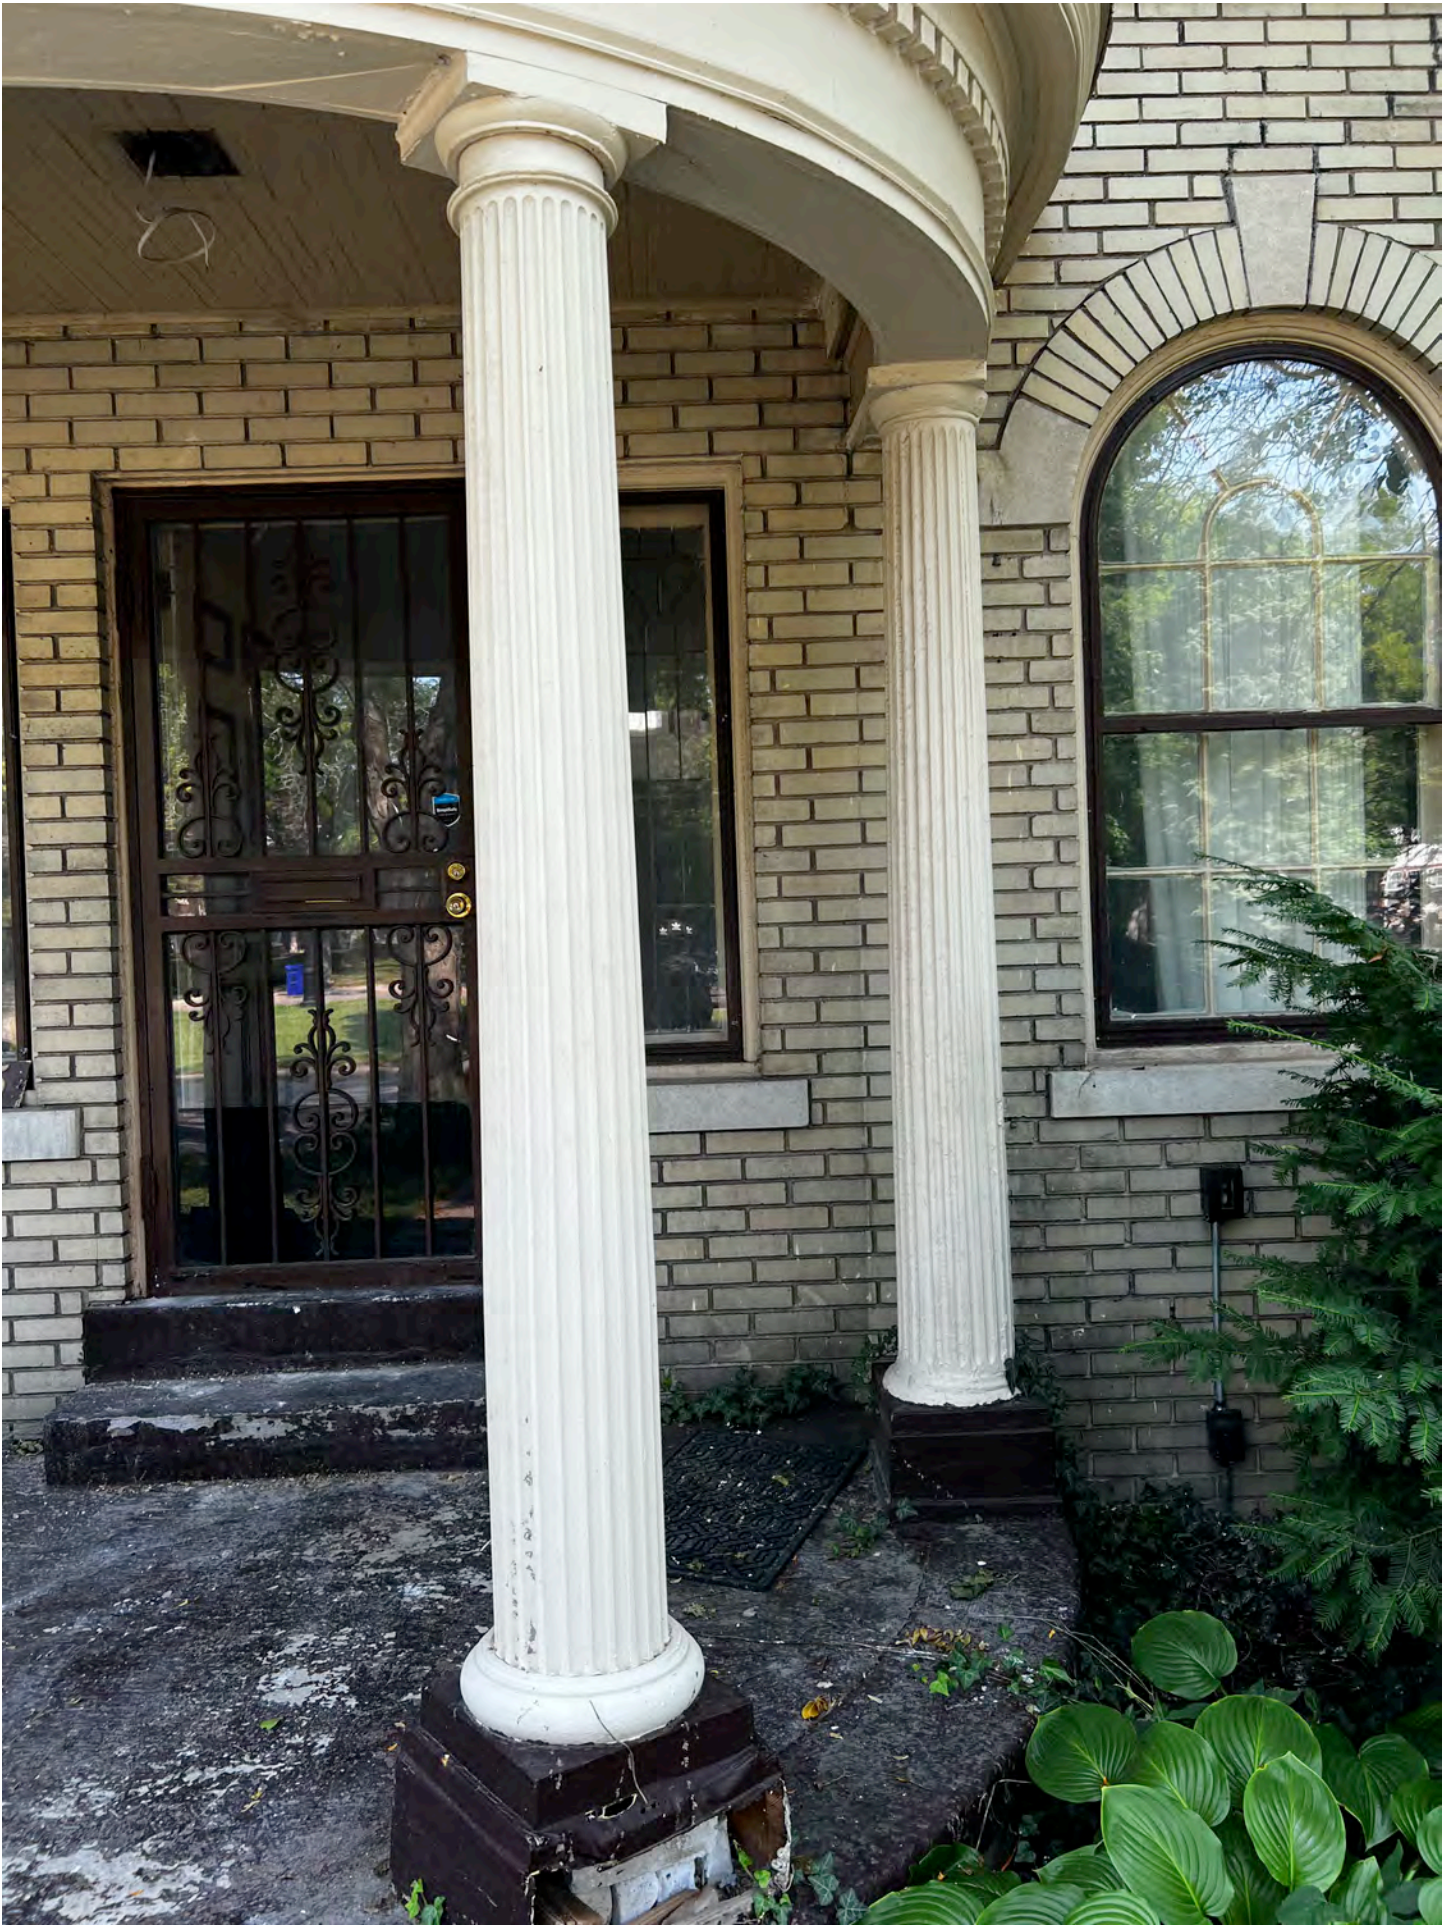
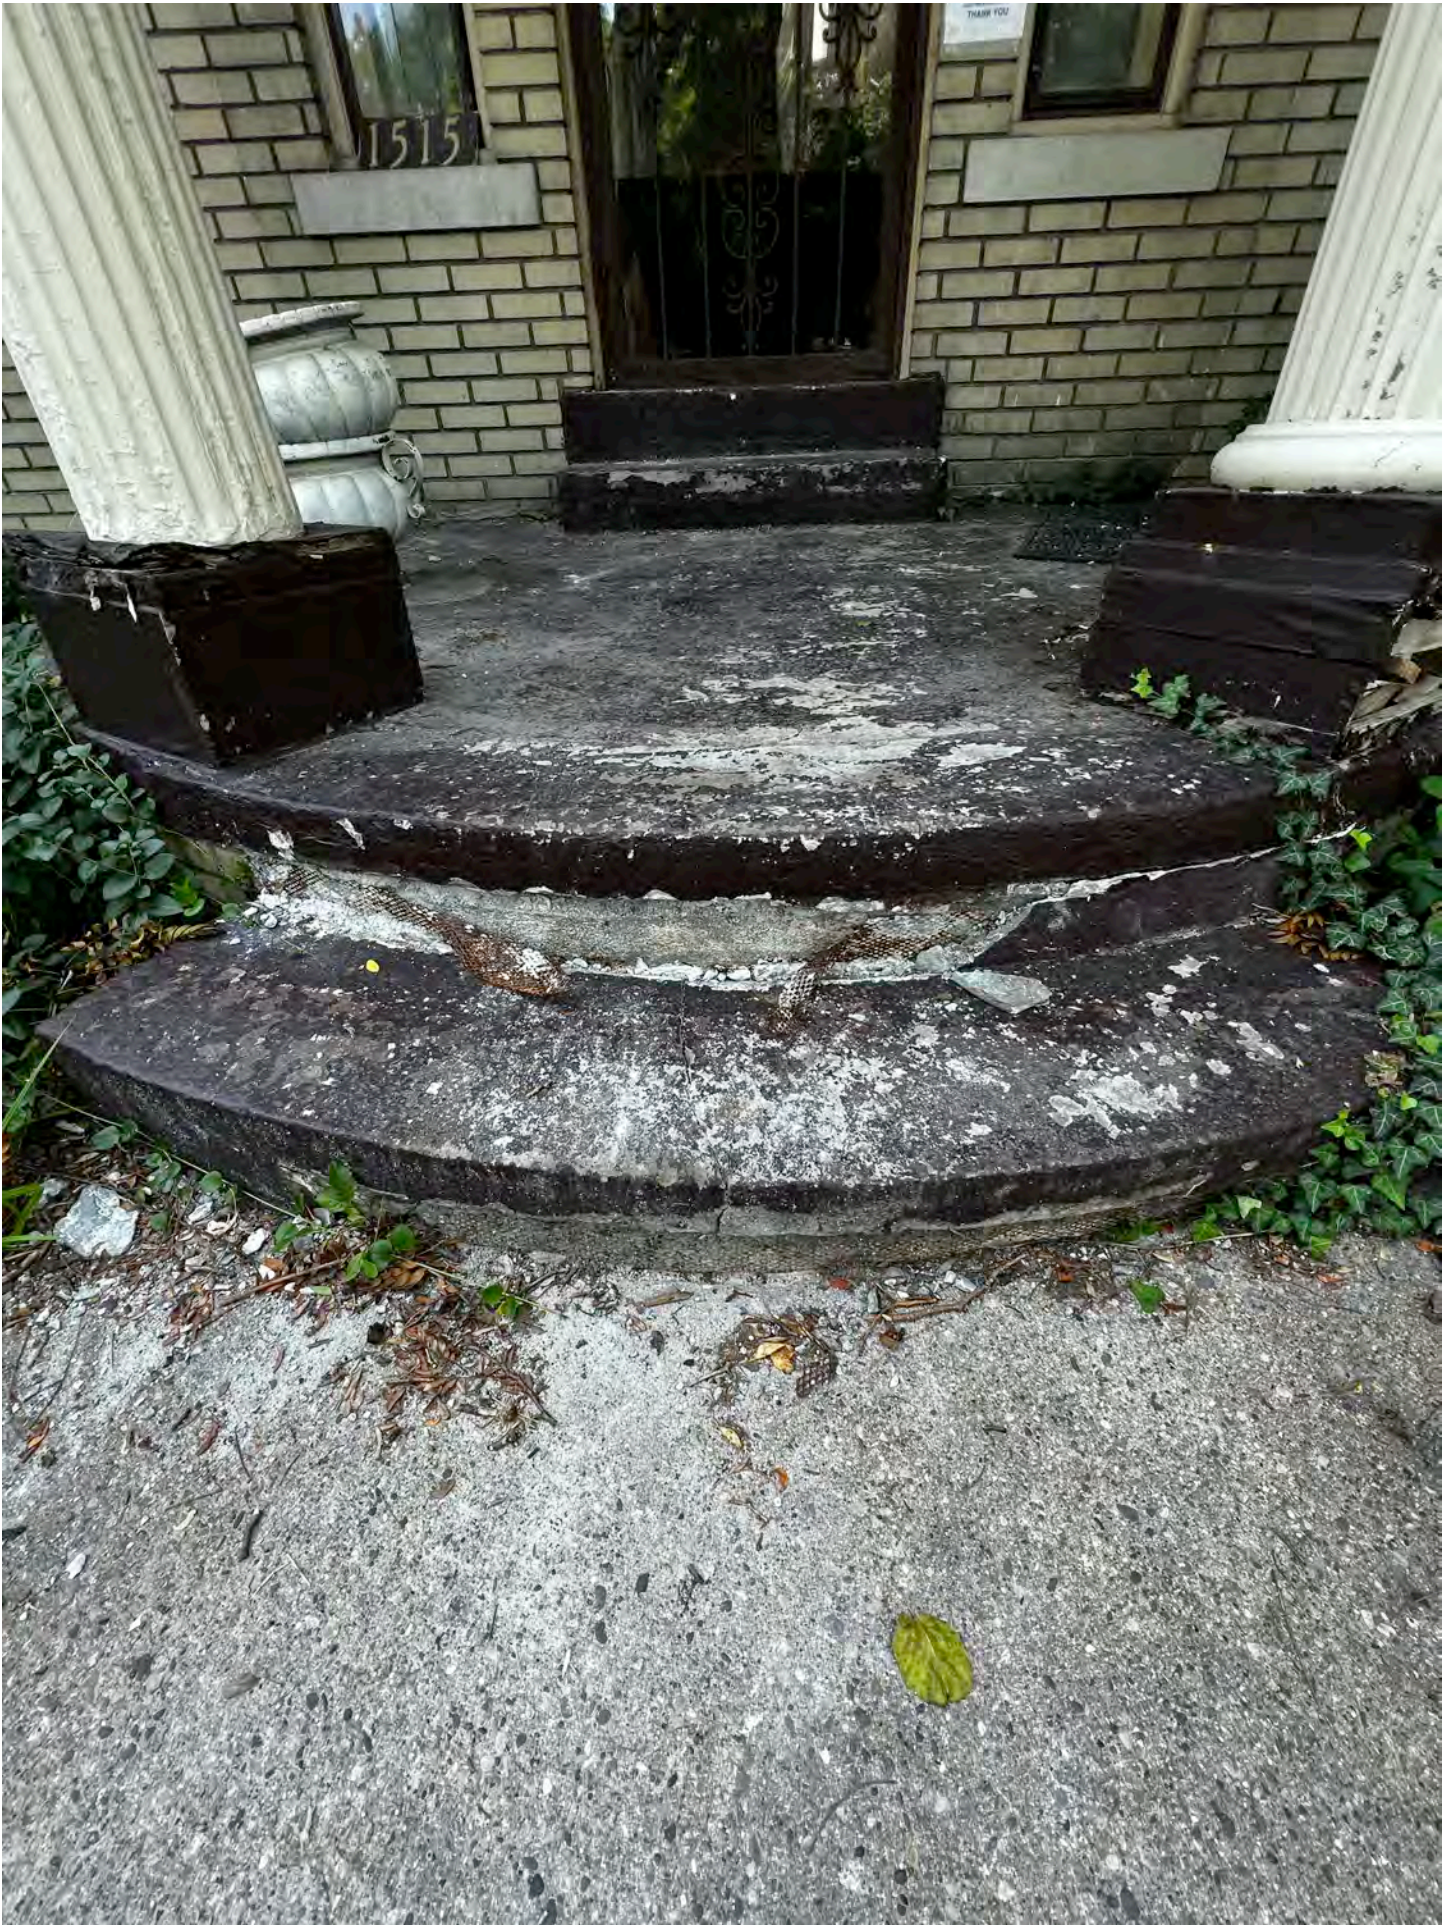
Currently the front porch consists of three severely damaged/weathered columns of one design, and one poorly installed and damaged column of a second design. Along with the columns, the two steps onto the porch are also damaged/weathered. There is a cement sidewalk that leads up to the porch, and in the middle of that path there is a set of two cement stairs which are damaged and have been poorly repaired at some point by a previous owner.

- Build proper temporary support for porch roof
- Remove four current columns
- Install four new load bearing fiberglass columns with top and bottom trim pieces, paint yellowish-white to match existing column color
- Demo damaged cement from front steps of porch
- Install necessary re-bar reinforcements and new concrete steps
- Paint porch landing with brown weatherproof paint
- Demo existing cement stairs on path to house
- Build frame/mold for two new cement steps
- Pour cement steps
