STAFF REPORT: 12/14/2022 REGULAR MEETING

APPLICATION NUMBER: 22-8151

ADDRESS: 3385 CAMBRIDGE

SCOPE: REPLACE WOOD SHAKE ROOF WITH ASPHALT SHINGLES

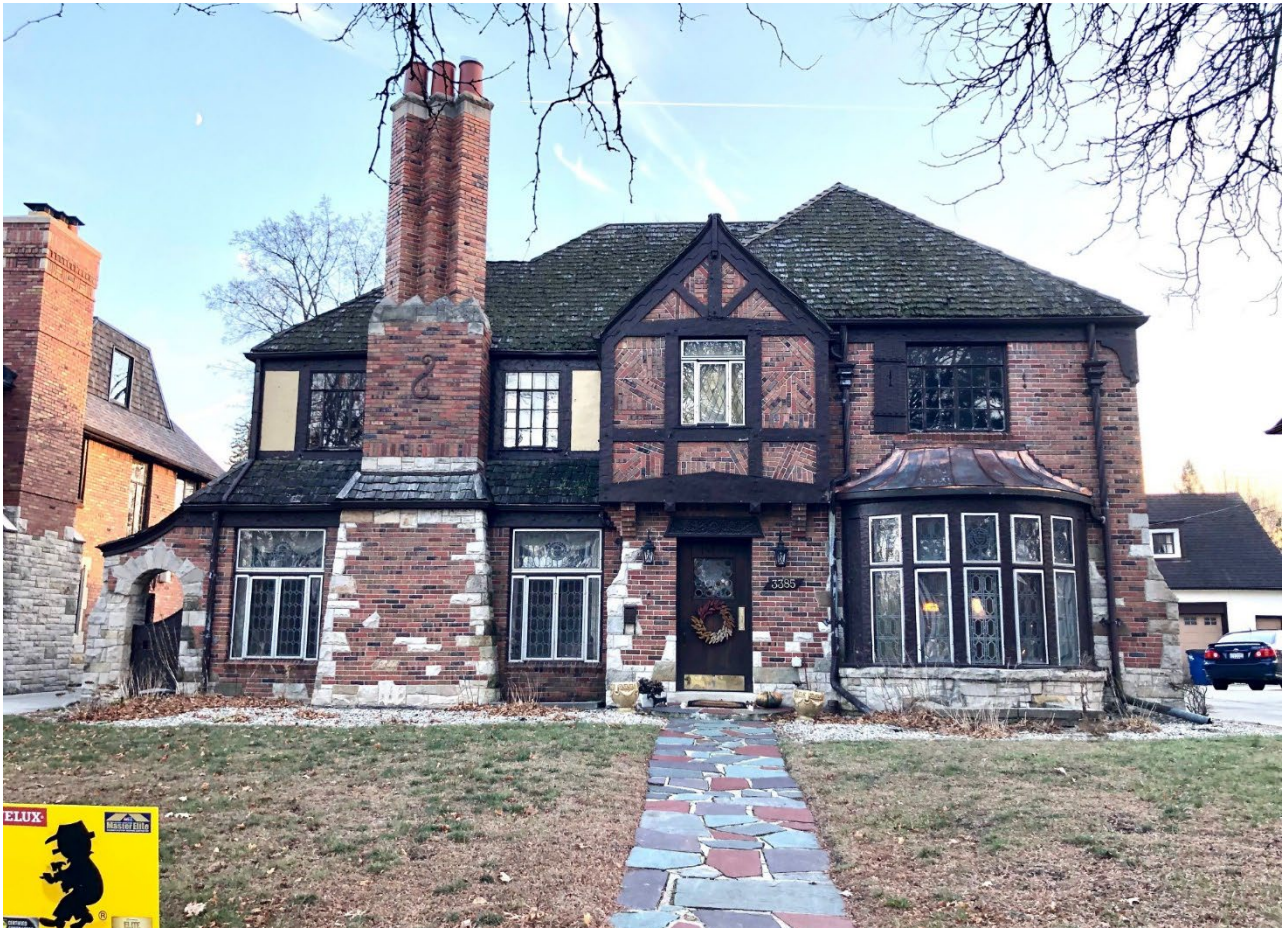
The steeply pitched roof is comprised of two roof designs, hip and side-gable, which created the maximum allowance of visible roof surface for this structure. The shake shingle material is another distinctive character-defining element.

Site Photo 1: Staff photo, November 29, 2022
