STAFF REPORT: MARCH 8, 2023 MEETING

APPLICATION NUMBER: 23-8237

ADDRESS: 2905 GARLAND (AKA THE OSSIAN SWEET HOUSE)

SCOPE: REPLACE REAR SECOND STORY PORCH* (WORK STARTED WITHOUT APPROVAL), INSTALL GLASS BLOCK WINDOWS

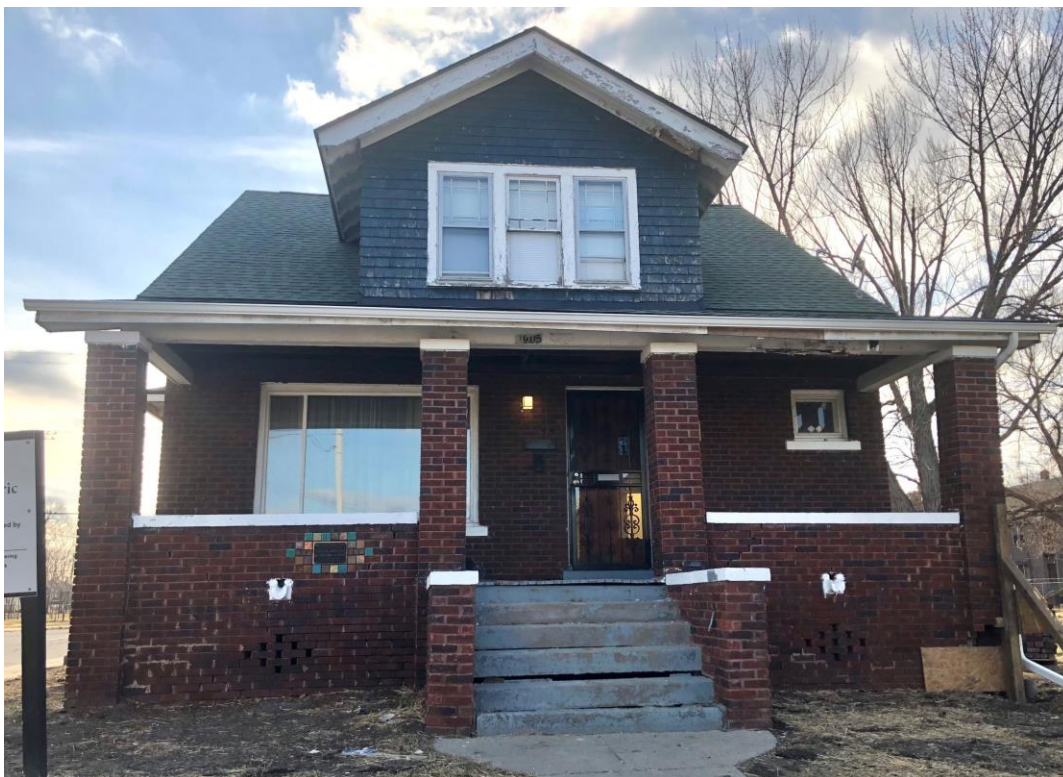
Staff photo, February 21, 2023

The centrally placed main entrance contains a single door that is now covered with a security door. A picture window is located to the left, or south, of the door, and a single small square window is located to its right, or north. The opening in the roof dormer contains three-double hung sash windows separated by mullions.

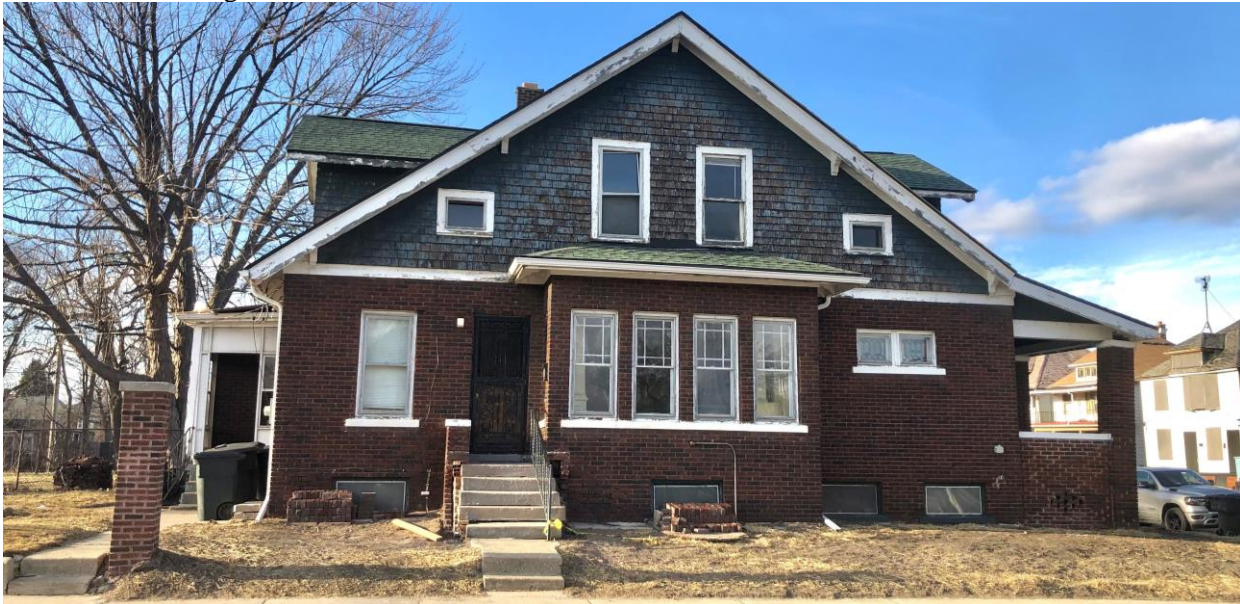
Staff photos, February 21, 2023

The large side-facing gabled ends of the roof have raking verge boards. The south side elevation, facing Charlevoix, features a secondary entrance and a box bay. A pair of small, horizontally rectangular leaded glass windows, quite typical of bungalows, punctures the wall eastward of the box bay, though they appear to be later replacements. Similarly sized and shaped basement windows circle the perimeter. The box bay is covered by a shallow hipped roof. Its depth is one elongated double hung sash window; its width contains four similar windows sharing a common sill.

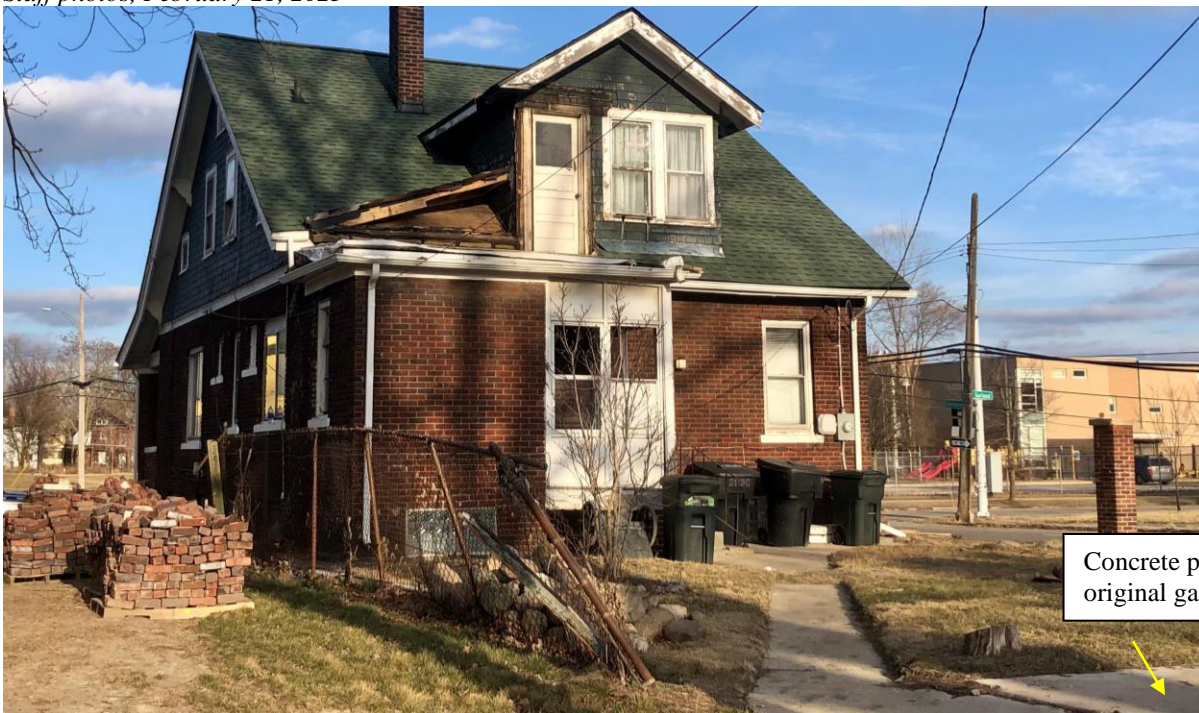
Concrete pad of original garage.

The house is situated close to the north lot line; grass turf covers the front and south yards which is graded about one foot above the public sidewalk (evidenced by two sets of two-step stairs at the side and rear yards as seen in the top photo). A small backyard extends west from the house and a concrete pad remains at the southwest corner of the rear lot, giving evidence to the location of the original alley-facing garage (consumed by fire and removed in 2019). A concrete walkway adjacent to the concrete pad bisects the rear yard at a southeast angle towards the first story rear entrances.

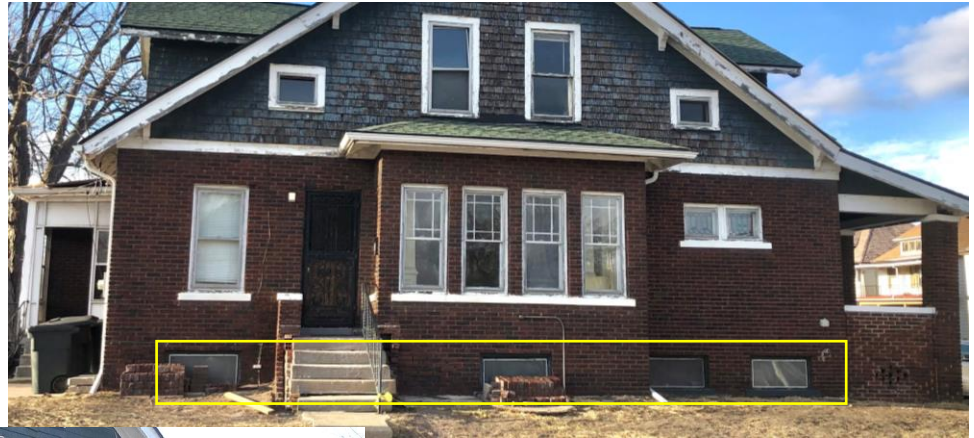
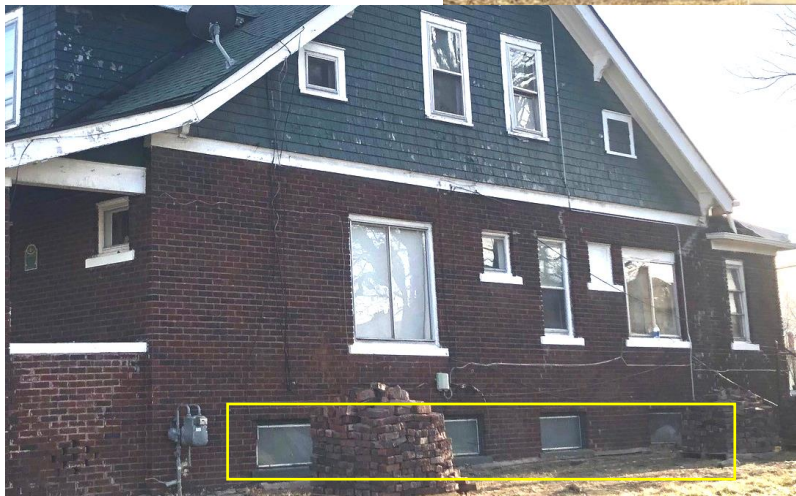
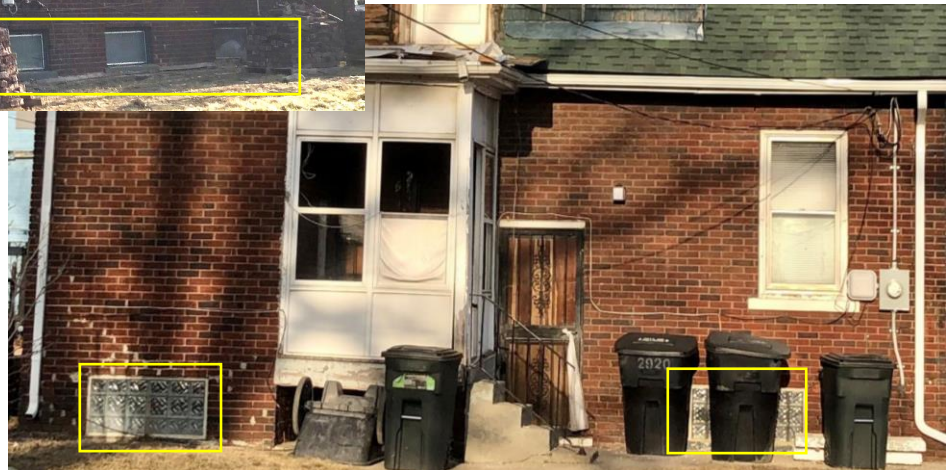
Staff photos, February 21, 2023
Above: south street-facing elevation
Right: north elevation
Below: rear elevation

Wide, rectangular basement windows are located on the side and rear elevations. The north and south side openings are original/historic wood framed inswing hopper units (each sash has two clear glass panels equally divided by one wide wood vertical muntin bar), with the exception of one missing unit on the south/Charlevoix elevation. The basement openings at the rear/west elevation are filled with patterned glass block. The sills are cast stone.

- Repair masonry in north/south elevation basement window openings; replace rotted wood elements with matching materials in existing sash; reinstall sash upon completion of all repairs.

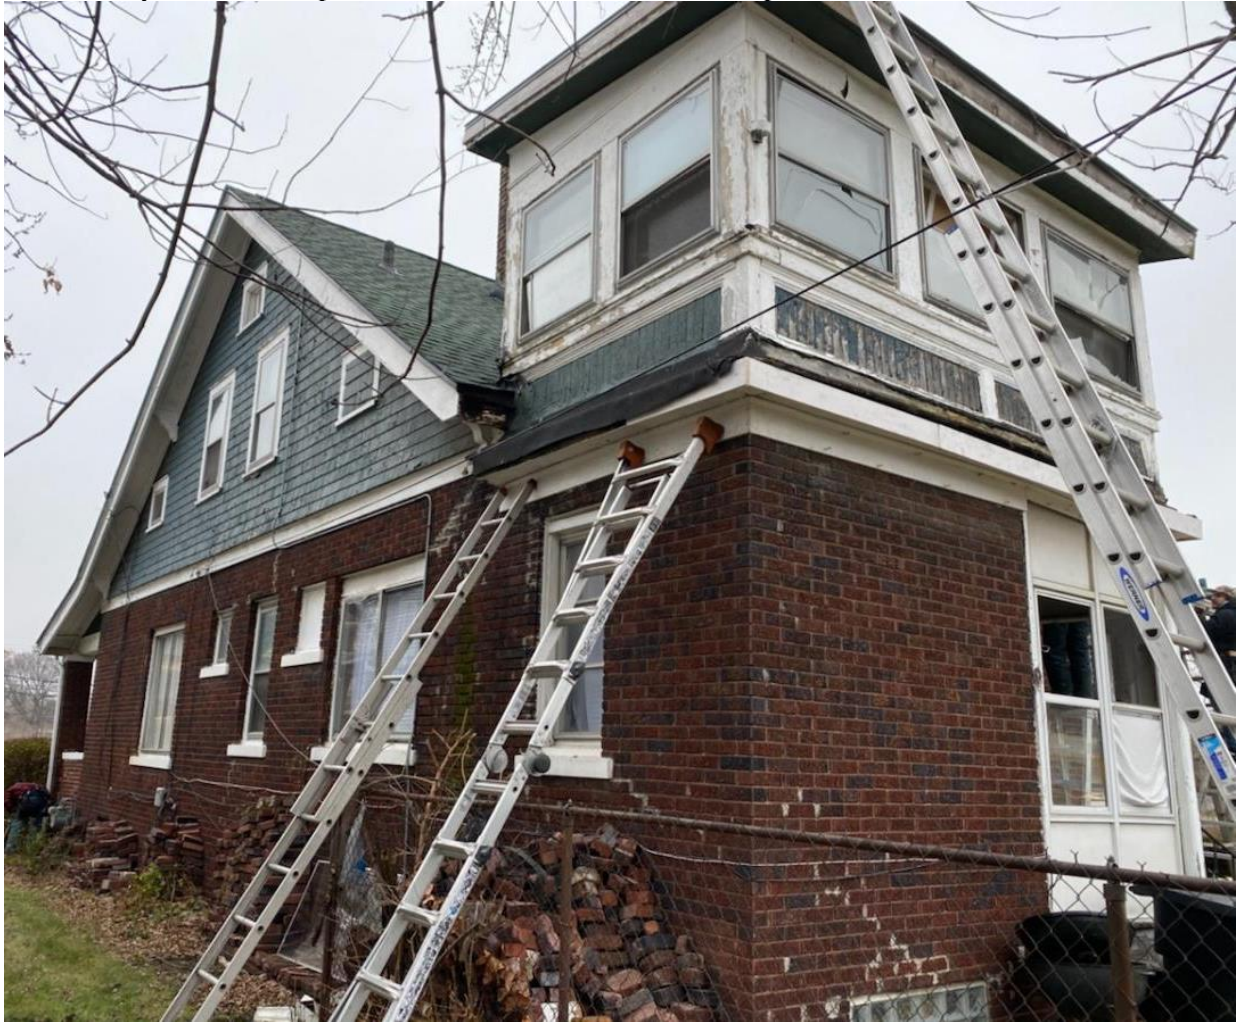
2020 applicant photo provided with gutter replacement application.

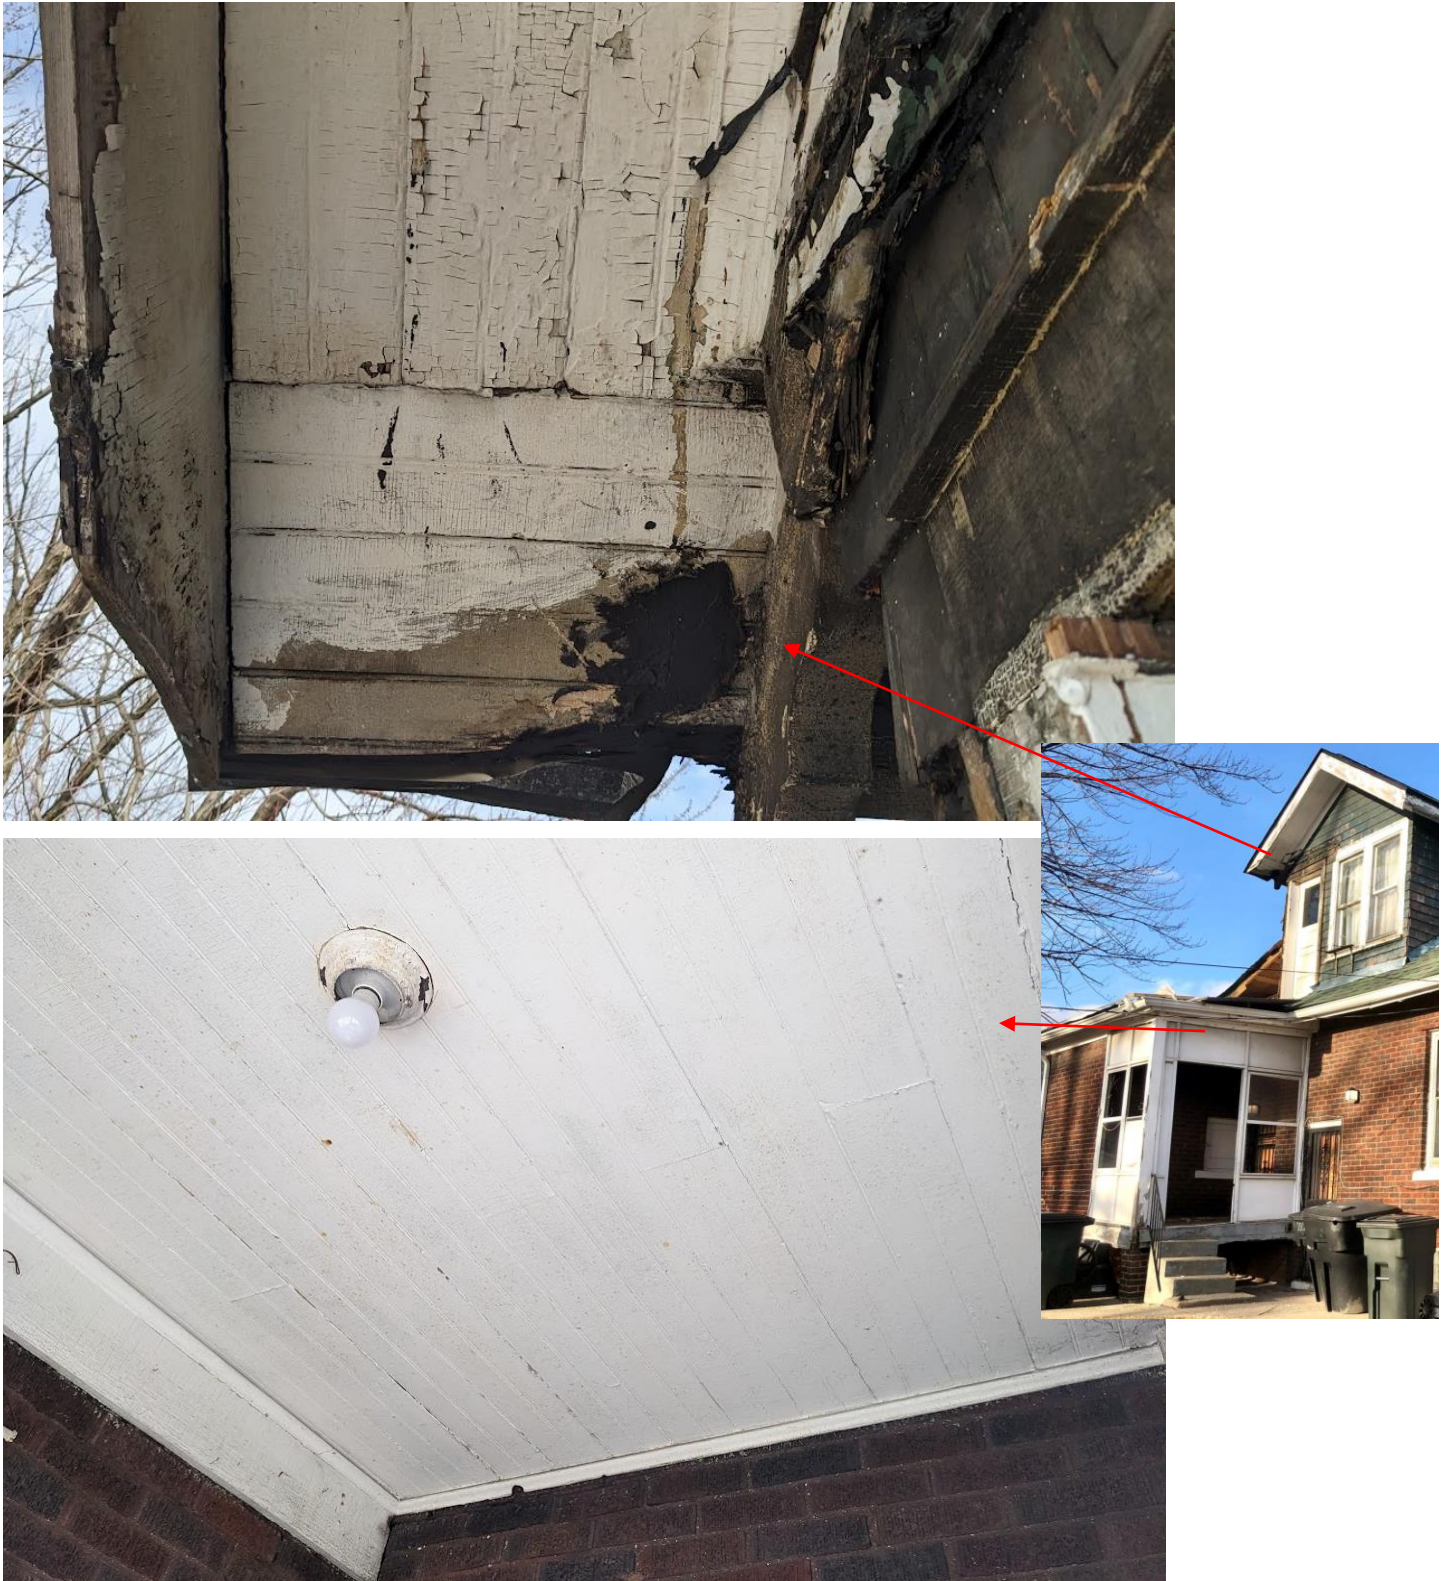
Staff photos, March 6, 2023. View of raised porch ceiling. Note the period pendant fixture.

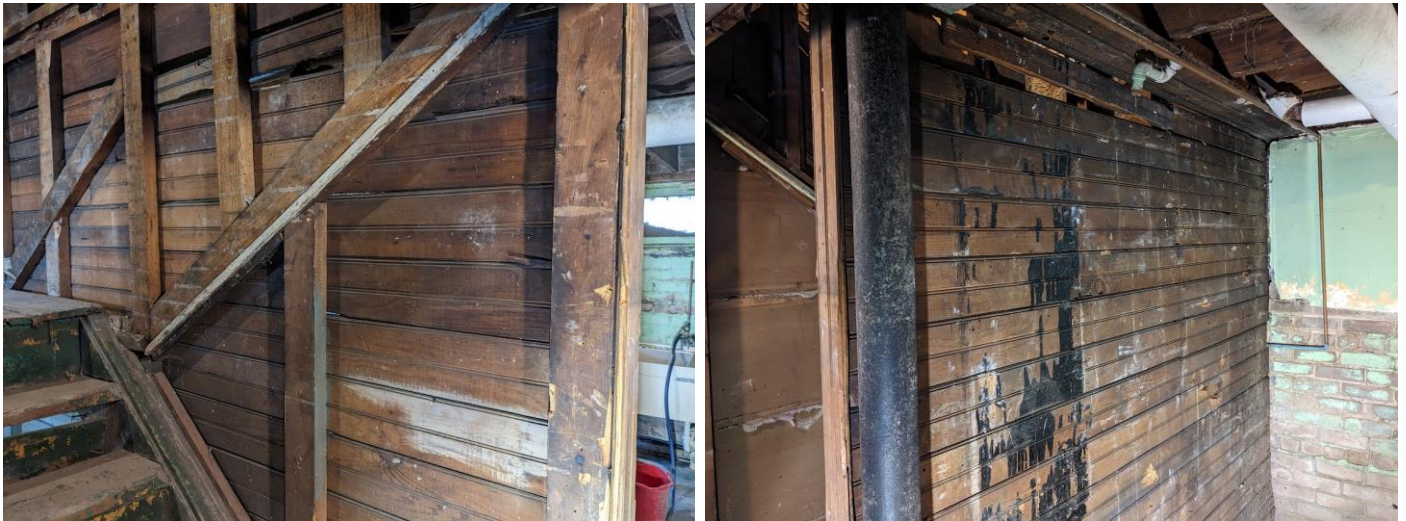
Beadboard - basement walls

- HDC staff visited the site on Monday, March 6, 2023 with members of Kraemer Design Group, HRD staff and the project contractor/HDC applicant. Staff documented multiple areas of the house in which matching beadboard was utilized. This offers possible support that the upper porch walls dated from the house's construction.

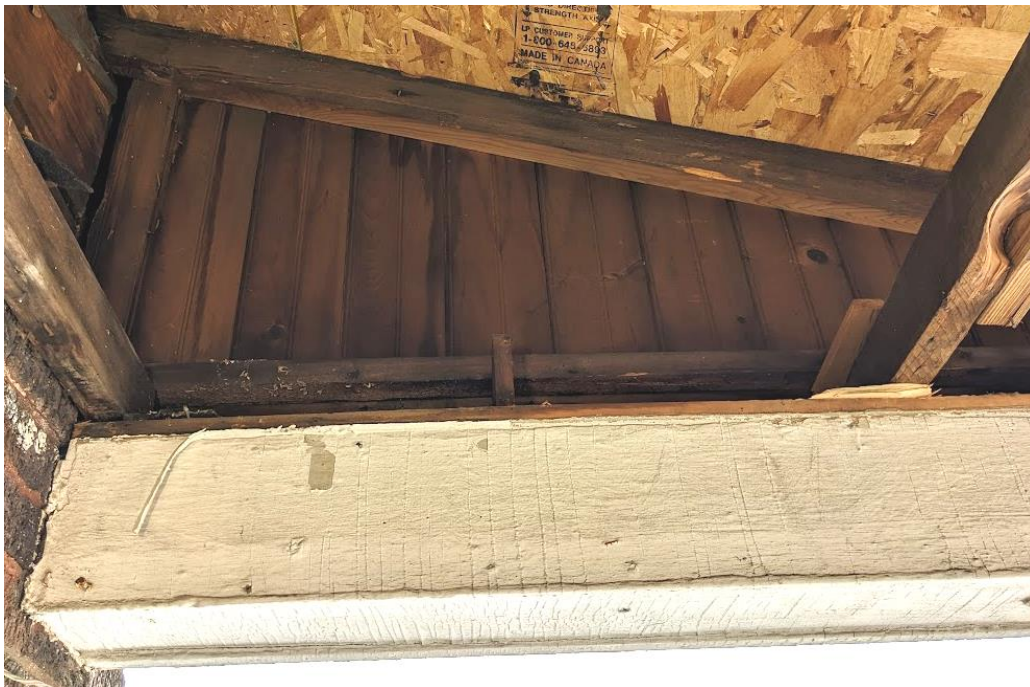
Beadboard – front porch

These are thinner types of beadboard.

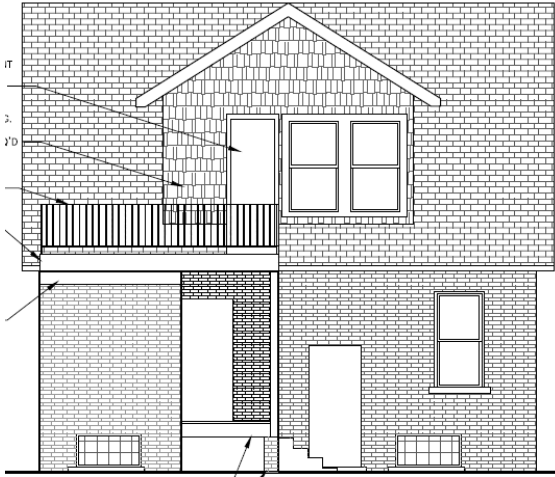
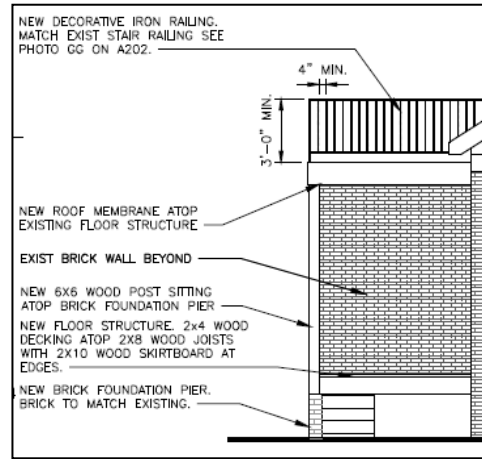
Above: Historic Structure Report drawings
Right: Staff photo

- It is staff's opinion the proposed iron railing was not a typical railing material for bungalow houses, and a 36" height is too tall for this historic setting and location. A traditionally and minimally designed painted wood railing with defined corner posts and balusters that are installed within a top and bottom rail, is a reasonable solution for this location (until the time a historic photograph is located and can be used as a guide to reconstruct the historic condition).

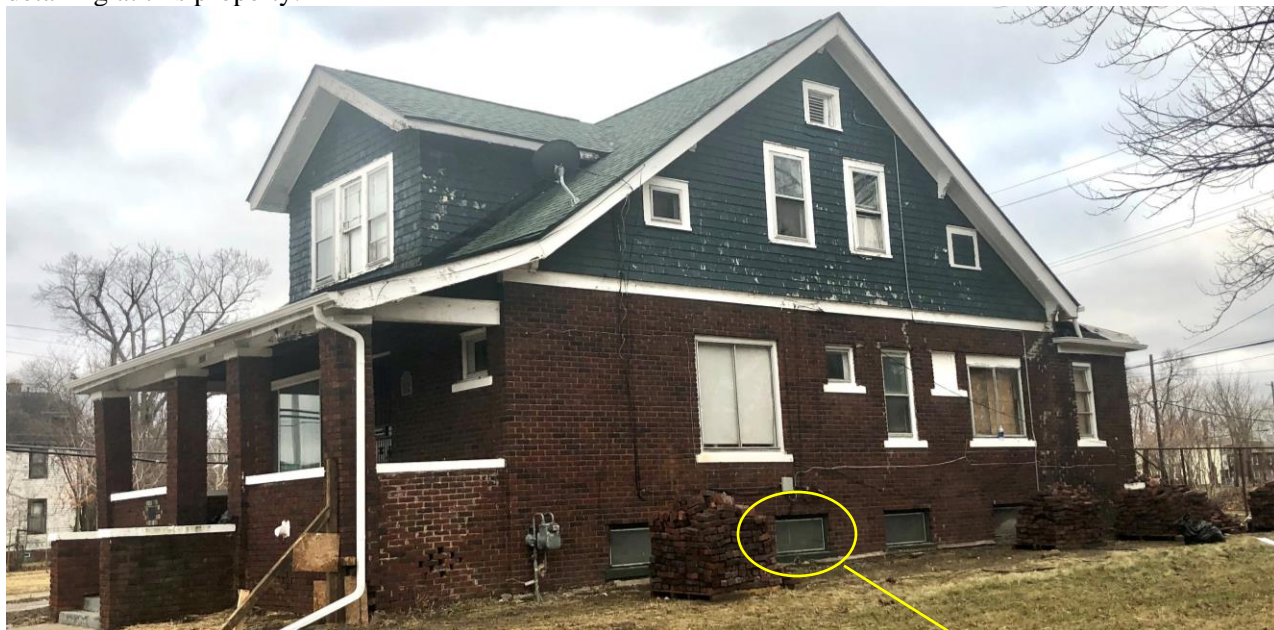
Above: Staff photo, February 28, 2023
Right: Historic Structure Report photo

Wood framed glass awning or hopper windows (with or without a central wood muntin bar) were commonly used in basement openings in the first half of the 20th century. As the period of significance for this property is 1925, and as a small property with major historic significance, the existing units should remain in place and the openings and sash be repaired. Even if the glass block is recessed within the opening and covered with a mesh screen, the busy patterning and exceptionally contemporary appearance of the glass block would still be visible and detract from the historic appearance of the house. Every effort should be made to retain and preserve authentic materials and detailing at this property.
