**STAFF REPORT: NOVEMBER 16, 2022 MEETING**  
**APPLICATION NUMBER: 23-8244**  
**ADDRESS: 2475 CHICAGO**

**HISTORIC DISTRICT: BOSTON-EDISON**  
**APPLICANT: MARTIN LEGER, CENTRAL DWELLINGS, CORP.**  
**PROPERTY OWNER: MARTIN LEGER**  
**DATE OF PROVISIONALLY COMPLETE APPLICATION: FEBRUARY 13, 2023**  
**DATE OF STAFF SITE VISIT: OCTOBER 25, 2022**

**SCOPE: REPLACE WOOD WINDOWS WITH ALUMINUM-CLAD WOOD WINDOWS,**

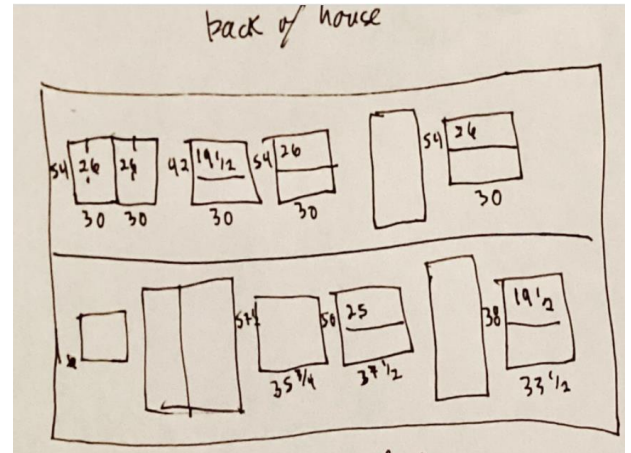
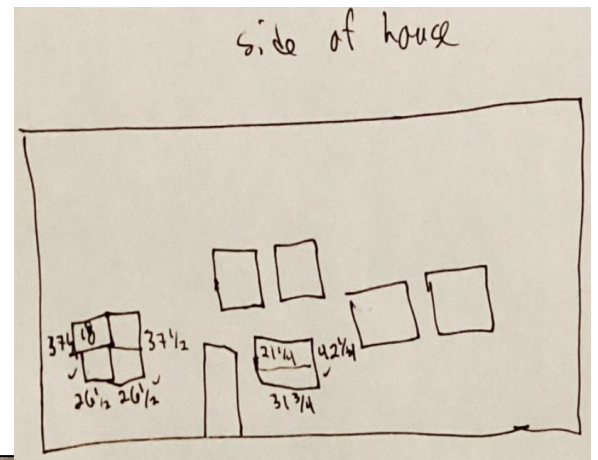
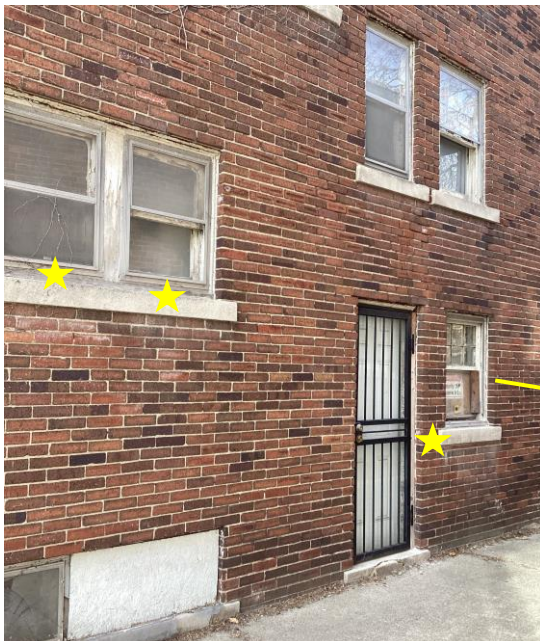
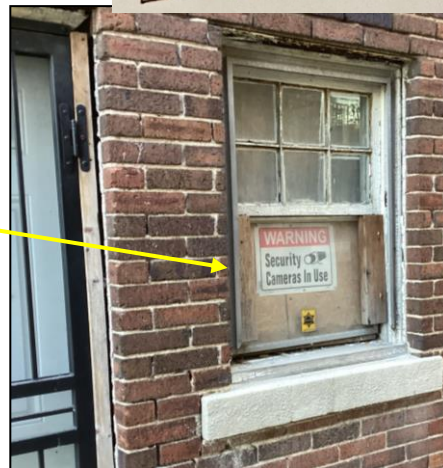
Above: Rear elevation.  
Below: side elevation

- It is staff’s opinion the photographs submitted by the applicant do not demonstrate that the windows are beyond repair. The frames need to be scraped and painted, and some wood filler/putty may be needed. Most of the openings have storm windows in place, sash are intact (understanding an occasional glass panel was broken), and appear dry.

It is staff's opinion the existing wood windows are not deteriorated beyond repair. The wood sash retains a level of materiality and dimensionality that offers significant architectural detail to the structure; installing the proposed replacement windows would alter features that characterize the property. Therefore, staff recommends the Commission deny a Certificate of Appropriateness for the work as proposed because it does not meet the Secretary of the Interior Standards for Rehabilitation and the Elements of Design for the district, specifically Standards:

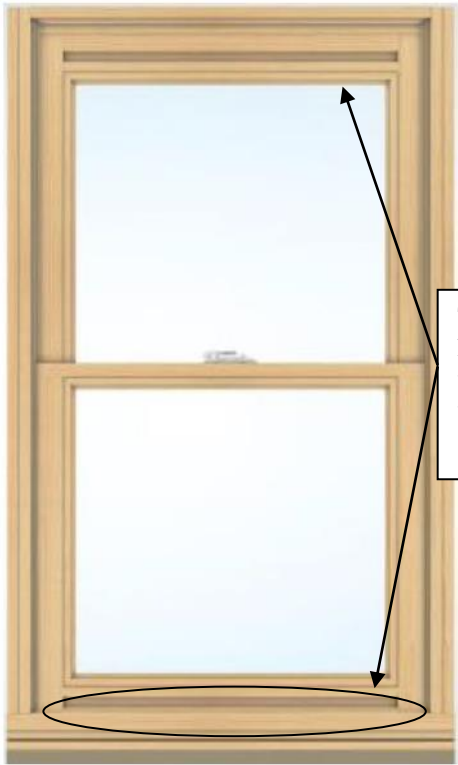
- Even though the measurements of the proposed window units are likely close to the existing wood frames, the dimensionality, materiality, and remaining details of the proposed units offer a significant contrast to the existing windows.

The top and bottom rails have inset areas within the framing to operate the upper and lower sash.

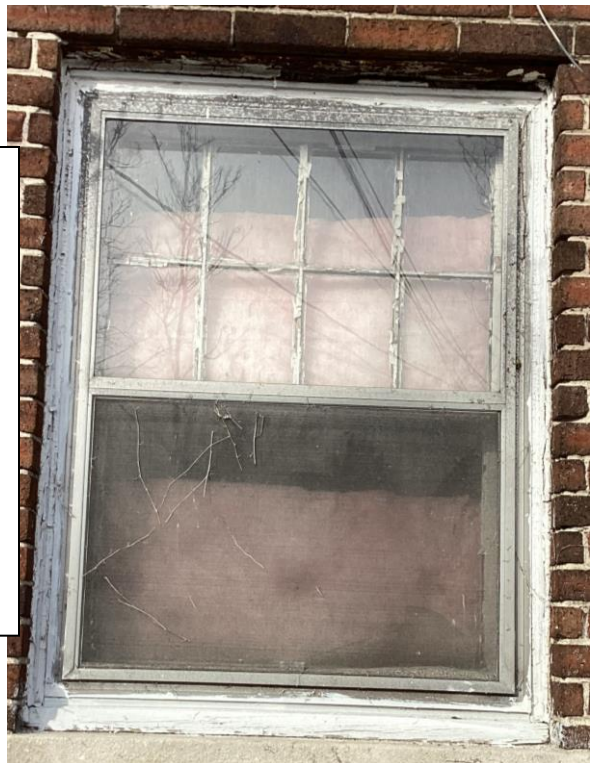
It appears as though this window line is fabricated with an integrated brick mould, which is flat in profile. This integrated unit doesn't offer the opportunity for an alternate trim color, which is common on historic structures.
