STAFF REPORT: APRIL 12, 2023 MEETING

APPLICATION NUMBER: 23-8284

ADDRESS: 10321 OUTER DRIVE WEST

SCOPE: REPLACE WOOD WINDOWS

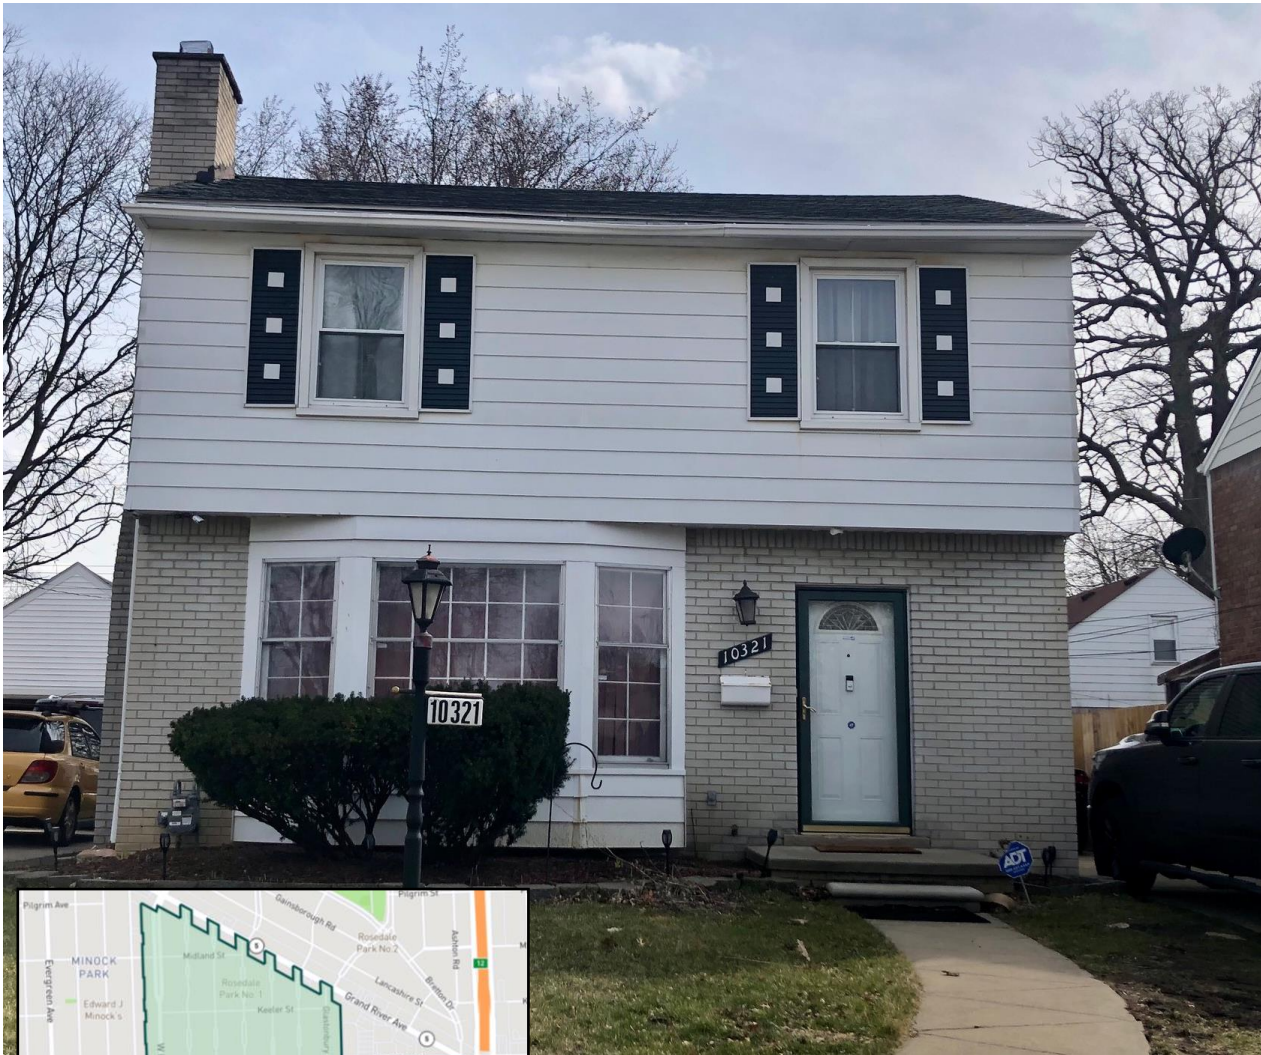
Above: Staff photo, March 28, 2023.

The house at 10321 Outer Drive West is located on the southern side of Outer Drive and is three houses east of the historic district’s western boundary. The two-story house was erected in 1954. The slightly overhanging second floor at the front elevation is a typical mid-century design that is reminiscent of colonial-era Garrison-style houses. Grayish-white brick, laid in a running bond pattern, covers the side and rear elevations and the first floor of the front elevation. Aluminum siding covers the overhanging extension of the second floor, as well as the window casings and lower framing of the front elevation bay window and the rear single-story extension.

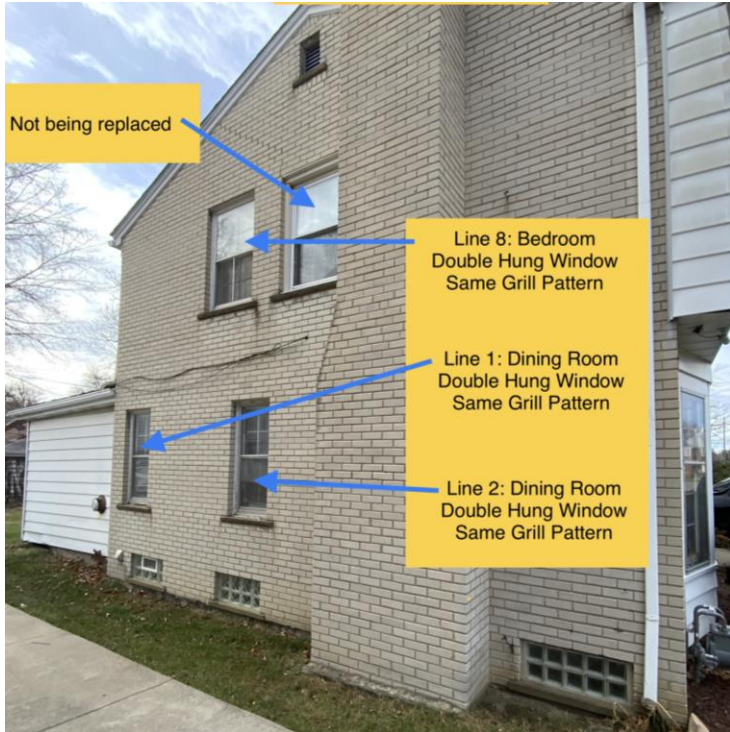
Applicant photos

- The applicant stated, “*We are replacing the current windows because they are old, the wood around each window is rotted, and they are loose and falling apart.*” However, it is staff’s opinion, based on the interior photos submitted by the applicant, the sash is intact within each window opening and the wood frames don’t show visible evidence of significant deterioration.

It is staff’s opinion that the existing wood windows are not deteriorated beyond repair and the wood sash at the front elevation retains a level of materiality and dimensionality that offers architectural detail to the structure. Therefore, staff recommends the Commission deny a Certificate of Appropriateness for the work as proposed because it does not meet the Secretary of the Interior Standards for Rehabilitation and the Elements of Design for the district, specifically Standards:

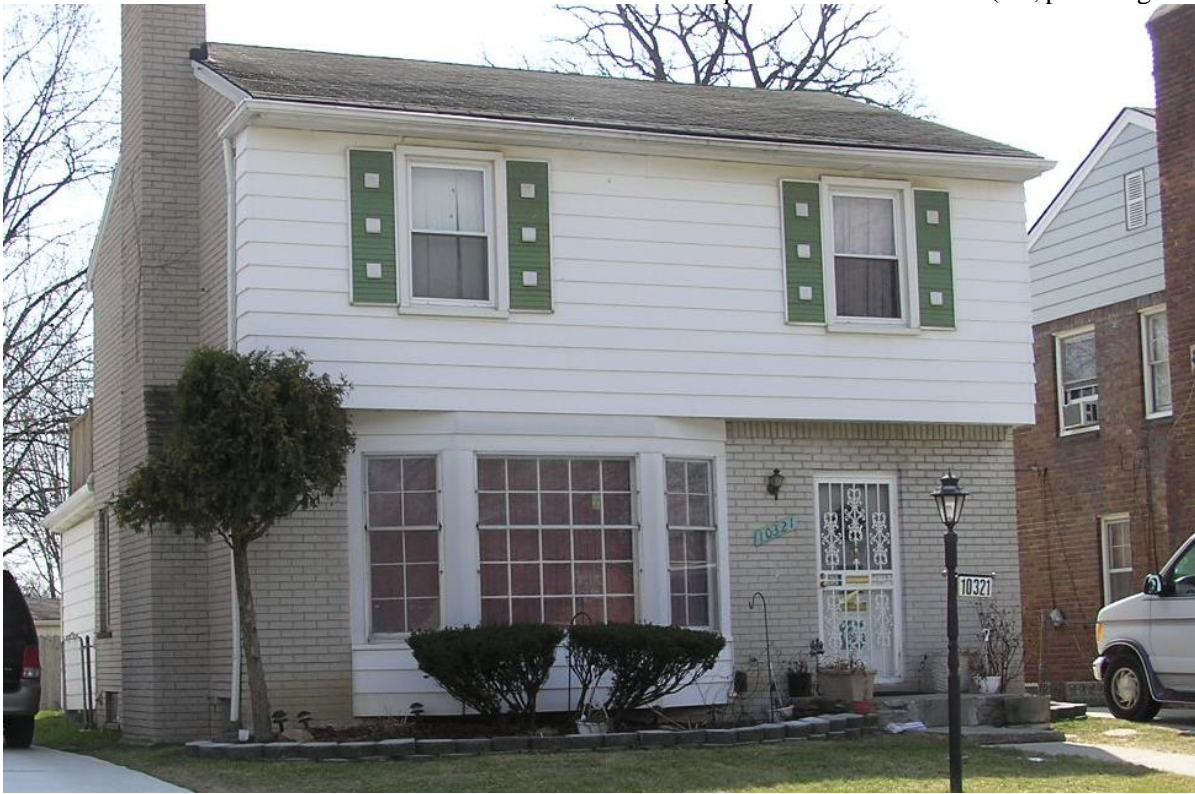
Designation photo, 2006, HDAB.

- The Rosedale Park Historic District was established in 2006.
- The designation photo shows replacement windows at the second floor, front elevation. The property owner confirmed the windows at the side and rear elevations were replaced at the same time (i.e., pre-designation).
