STAFF REPORT: APRIL 12, 2023 MEETING

APPLICATION NUMBER: 23-8285

ADDRESS: 1444 EDISON

HISTORIC DISTRICT: BOSTON-EDISON

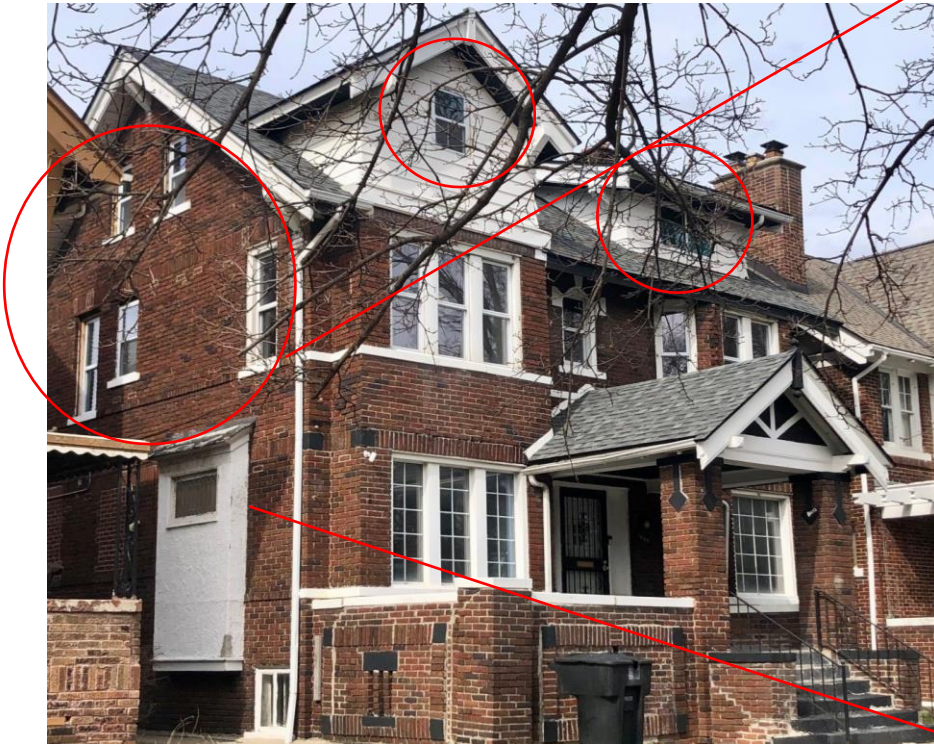
Staff photo, March 28, 2023

The close-up photo, above, shows unfinished work at the window openings. Wood framing at the second floor and insulation at the third floor are visible due to the original brick mould being removed and new brickmould (or coil stock as shown in the far-right window at the second floor) hasn't been installed.

One historic window sash remains intact, the leaded glass unit in the stucco covered extension.

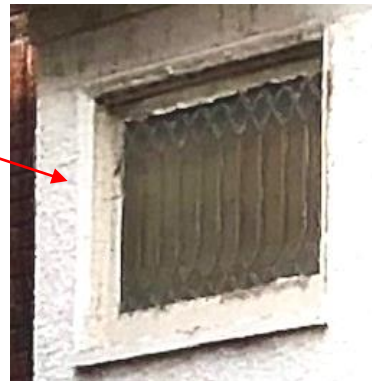
- During 2023 site visits for this application, Staff has confirmed that historic window units remain in place at the basement openings on each elevation, and at the second story on the rear elevation, and east side elevation at the first floor. Similar to the front elevation second and third floors, staff didn't find record of Commission approval for the existing vinyl windows at the first floor at the rear elevation, which encompasses the 16-over-16 sash as well as the adjacent one-over-one unit.

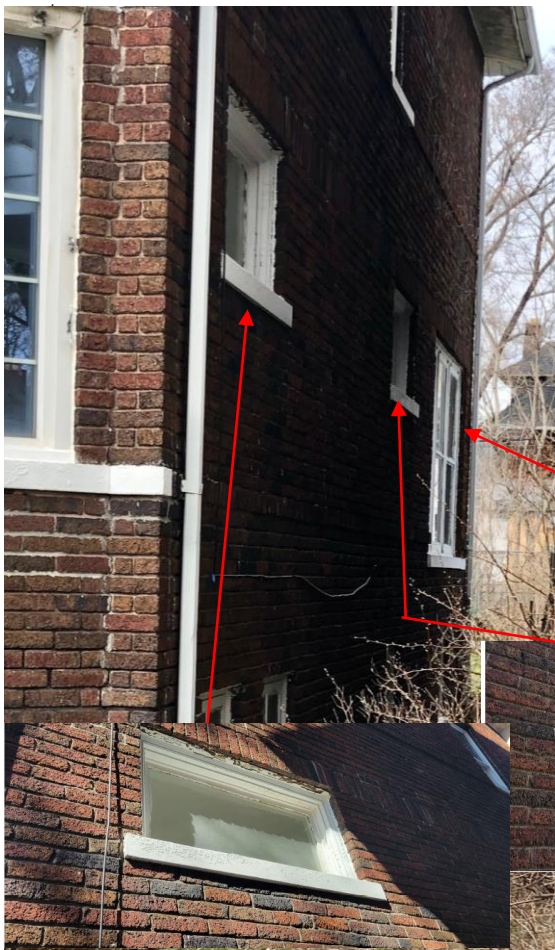
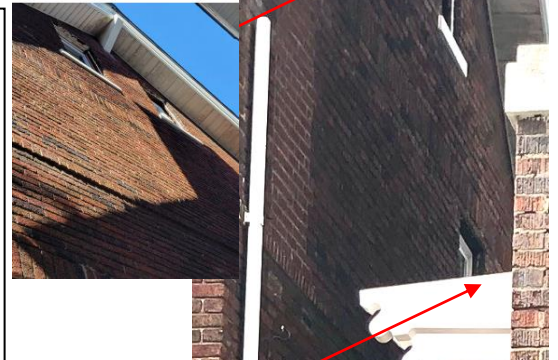
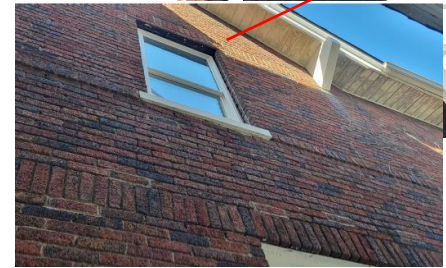
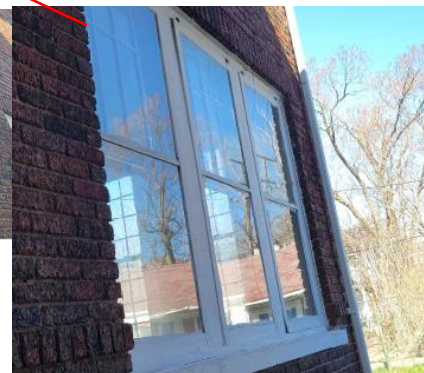
East Elevation
 Historic window units remain at the first floor which include two single opening, fixed windows and a mulled triple double-hung window opening near the rear elevation.
 Vinyl replacement windows are at the second and third/attic floors.

- The historic fixed/awning units at the first floor are minimally visible from the front of the property, while the windows at the second and third floor are only visible when standing at the side lot line, directly next to the neighboring house; only the sills are highly visible.
- The historic units at the first floor near the rear of the house, while not visible from the public right-of-way are distinctive character-defining features of the house due to their placement and relationship with the other mullioned window openings at the rear of the house (first and second floor) which offers a porch-like design (and possibly sleeping porch at the second floor) within masonry walls.

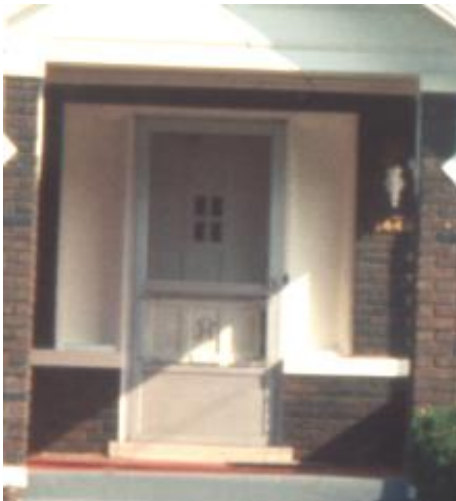
1974 designation photo

- The current front door appears to be a historic wood paneled door with small glass panels at eye level; it is painted white. The current door appears to match the door in place at time of designation. No information or photographs documenting the physical condition of the existing door was submitted. The proposed door is a steel and composite frame unit with walnut finish.

Recommendation One – Denial – Vinyl siding, vinyl windows, front entry door, red finish at porch ceiling
