**STAFF REPORT: JUNE 14, 2023 MEETING**  
**APPLICATION NUMBER: 23-8388**  
**ADDRESS: 1186 EDISON**  
**HISTORIC DISTRICT: BOSTON EDISON**  
**APPLICANT: LEON HUNTER, III**  
**PROPERTY OWNER: HB1 ALTERNATIVE HOLDINGS, LLC**  
**DATE OF PROVISIONALLY COMPLETE APPLICATION: MAY 22, 2023**  
**DATE OF STAFF SITE VISIT: MAY 30, 2023**

**SCOPE: DEMOLISH GARAGE, ERECT GARAGE, REPLACE WOOD WINDOWS**

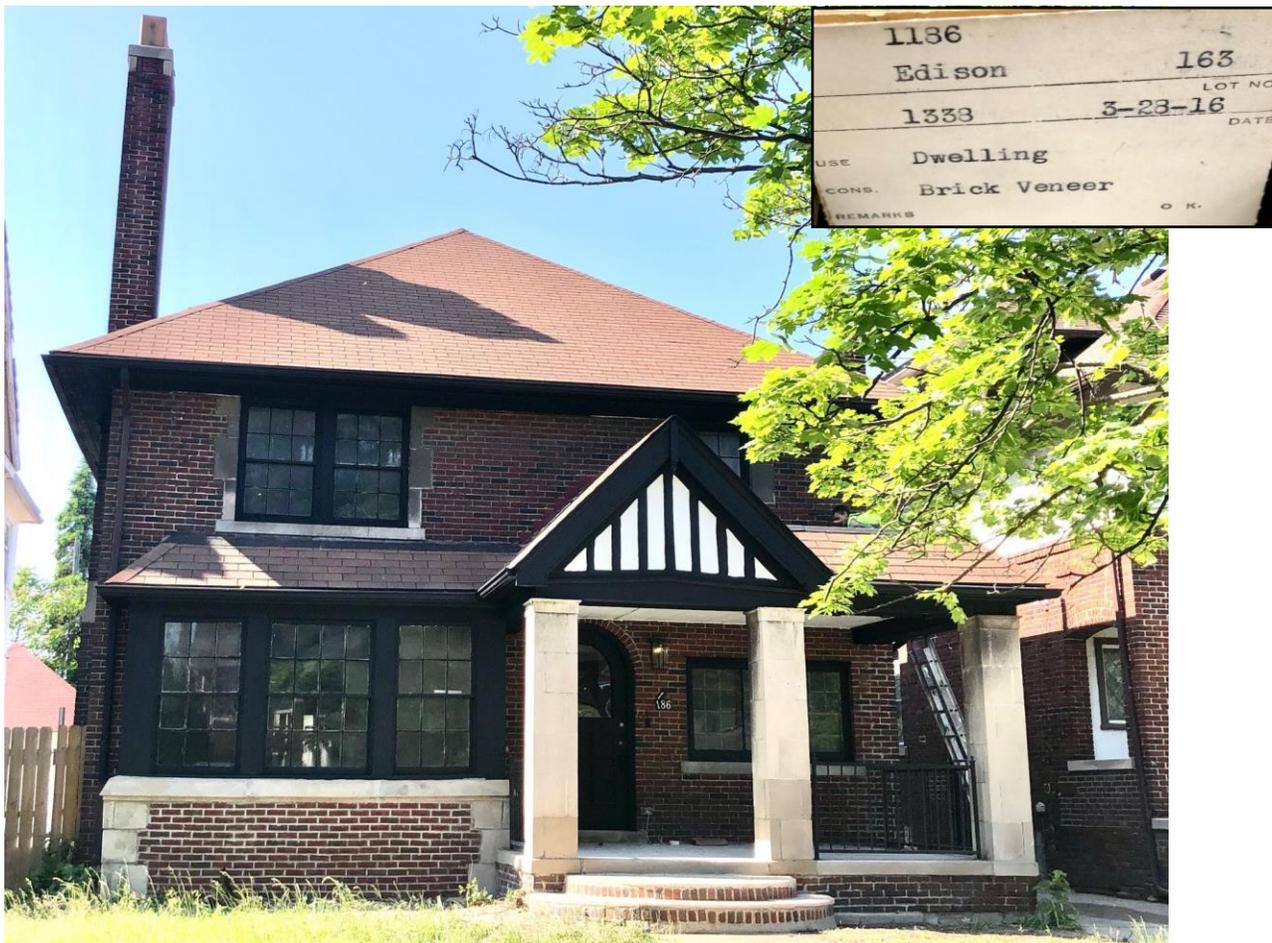
*Staff photo, May 30, 2023*

The two-story dwelling at 1186 Edison was erected in 1916. The rectangular massing is accentuated by extensions and decorative details at every elevation. The front facade features a box bay window and a covered, raised front porch. The dark brown brick veneer is contrasted with stone sills and quoins at the upper level window openings, and thick square stone (or cast concrete) columns support the porch roof and dormer.

The triple window opening at the front porch are leaded glass casements (twelve light pattern), while the wood double-hung units feature four-over-four (sides of box bay), six-over-six and one eight-over-eight pattern.

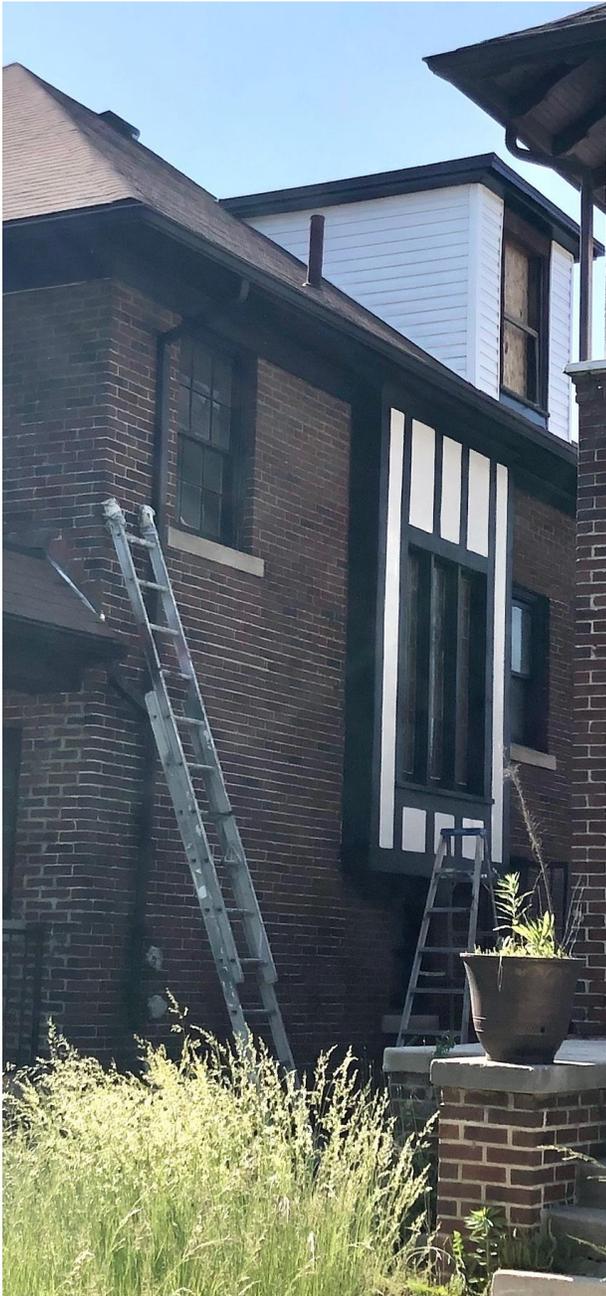
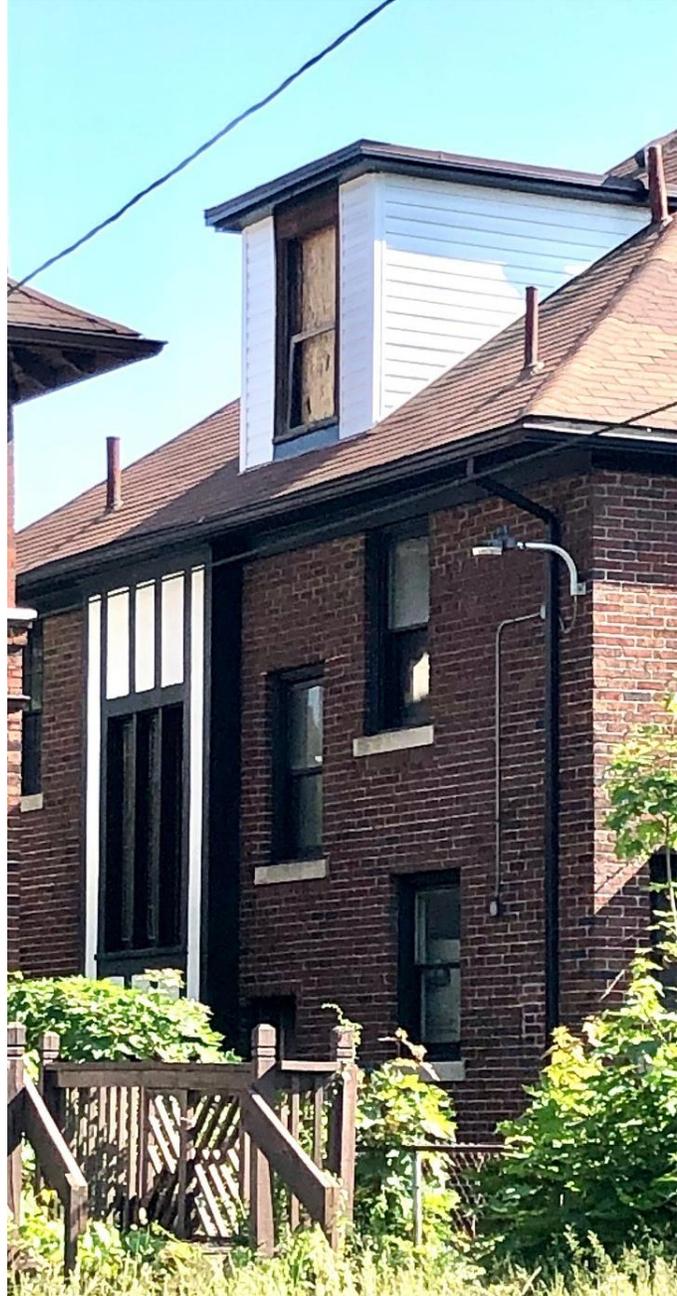
*View from sidewalk*

Standing at the sidewalk and looking direct at the house, the only roof projection that is visible is the chimney at the west wall. The east elevation shed dormer is not visible until you walk past the driveway, which enters off Edison at the right side of the property. The detached garage is at the northeast corner of the rear yard.

The east elevation features a slight extension that is covered with stucco and vertical timbers (similar to the front entry gable); decorative leaded glass fills the three tall and narrow window openings. The shed dormer is covered with vinyl siding.

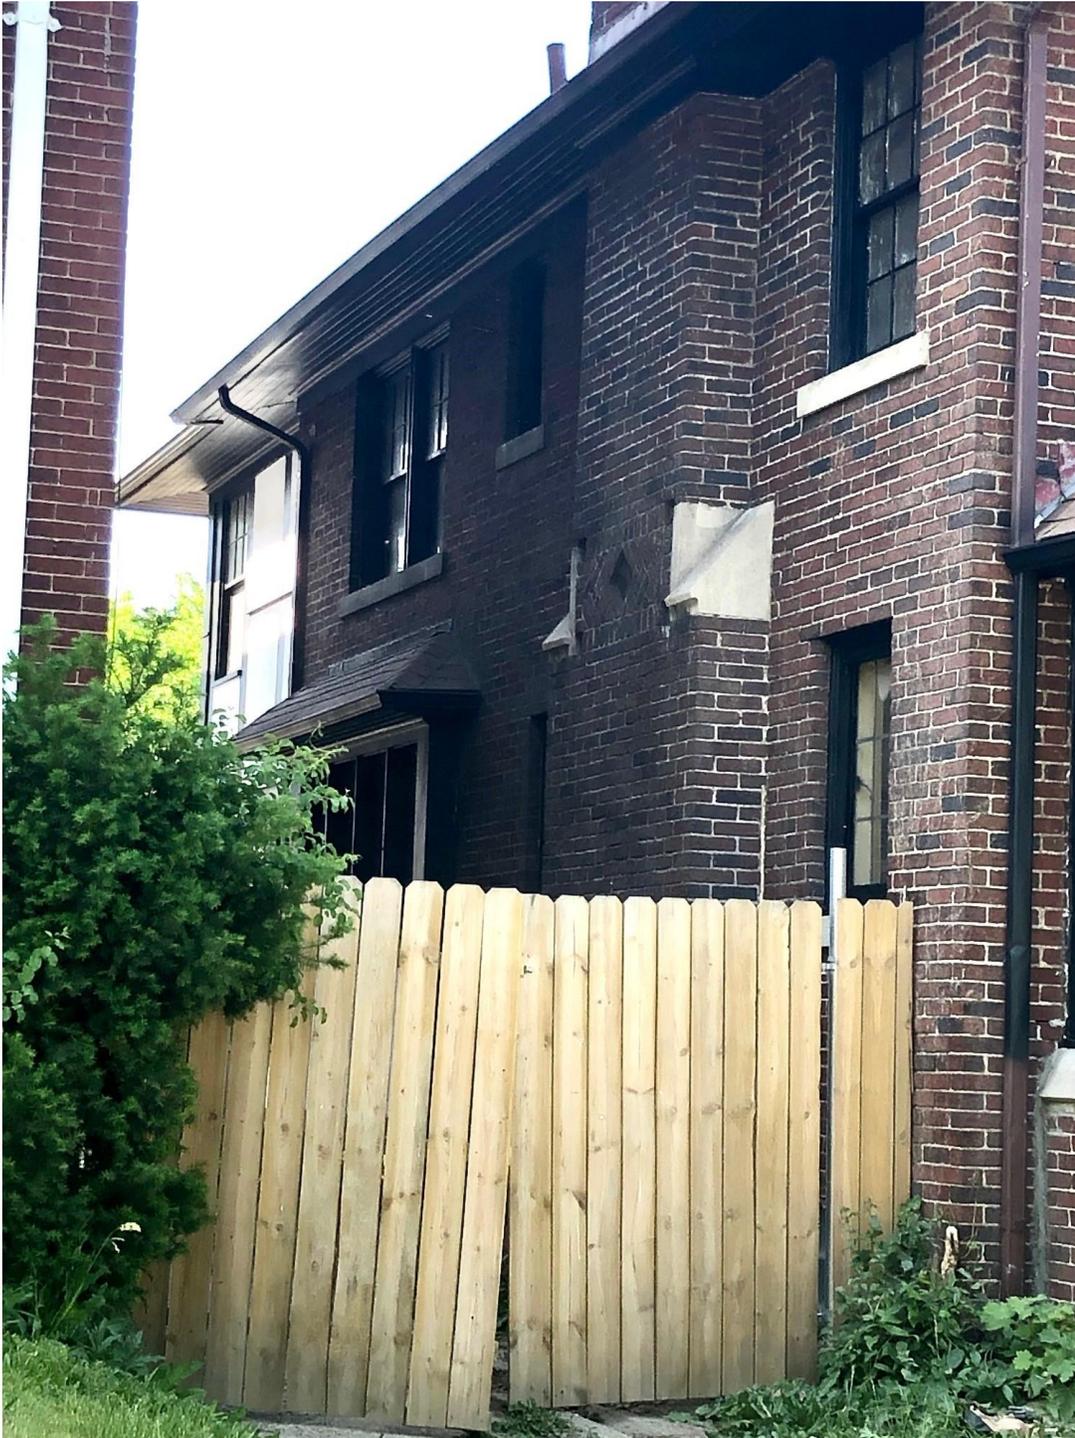
*West elevation, staff photo*

On the west elevation, leaded glass windows flank the chimney at the first floor, and the chimney features stone and decorative brick work between the first and second floors. Another slight extension beyond the chimney has four narrow window openings which is covered by a small roof. Due to the light reflecting off the stucco wall at the rear of the house, the linear pattern of the wood covering the deep overhanging eaves is highly visible on this otherwise dark house.

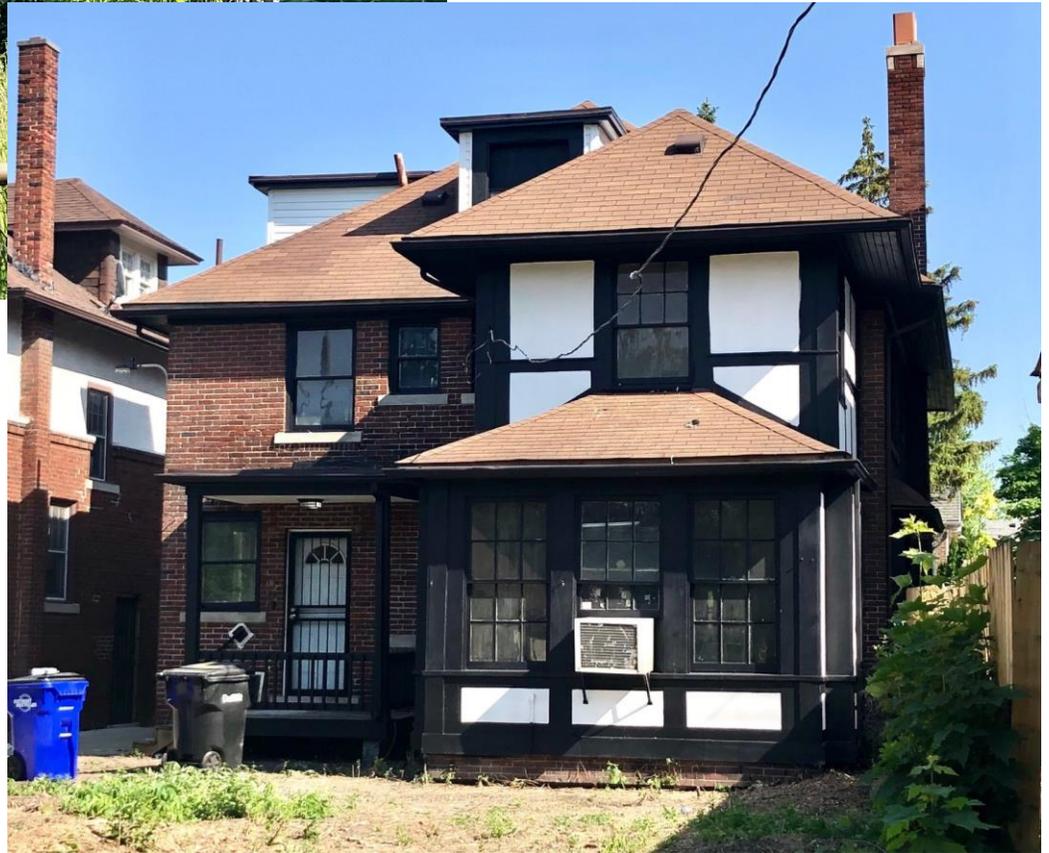
The rear elevation is remarkably intact. The historic window and door openings, and exterior wall surfaces (except for the vinyl siding at the shed dormers), appear to be unaltered and in very good surface condition. Only a few window openings have what might be replacement units (with one window opening boarded up). The design and color of the non-historic rear door is not appropriate for the age and design of the house.

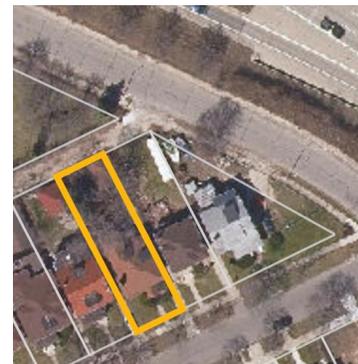
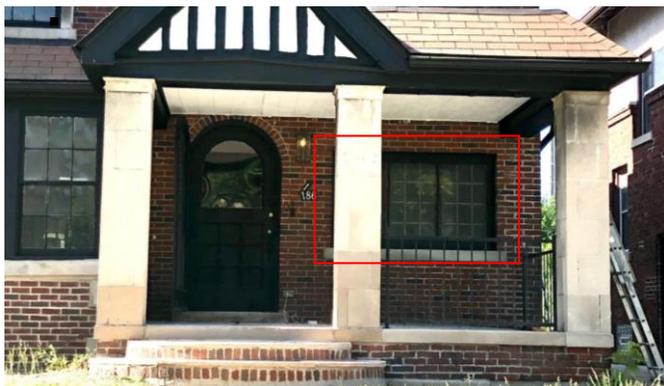
*Above: Detroit Parcel Viewer  
Left: Staff photo, leaded glass casement windows open to the porch*

- The Boston Edison Local Historic District was enacted on April 2, 1974.
- 1186 Edison is three lots to the west of the John Lodge Freeway, on the north side of Edison. Scrolling through Google street view from 2009 – 2022, it appears that 1186 Edison is one of the last houses on this block that hasn't had extensive repairs made to the exterior of the structure.
- The original front door and leaded glass windows are still in place at the front elevation.

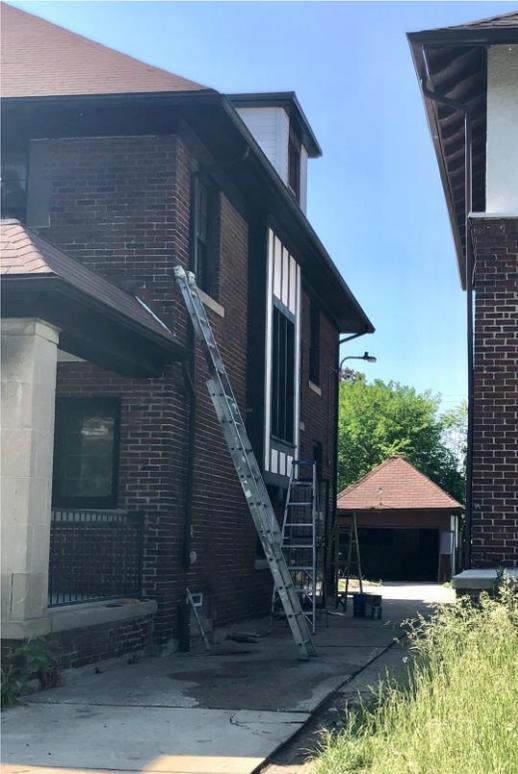
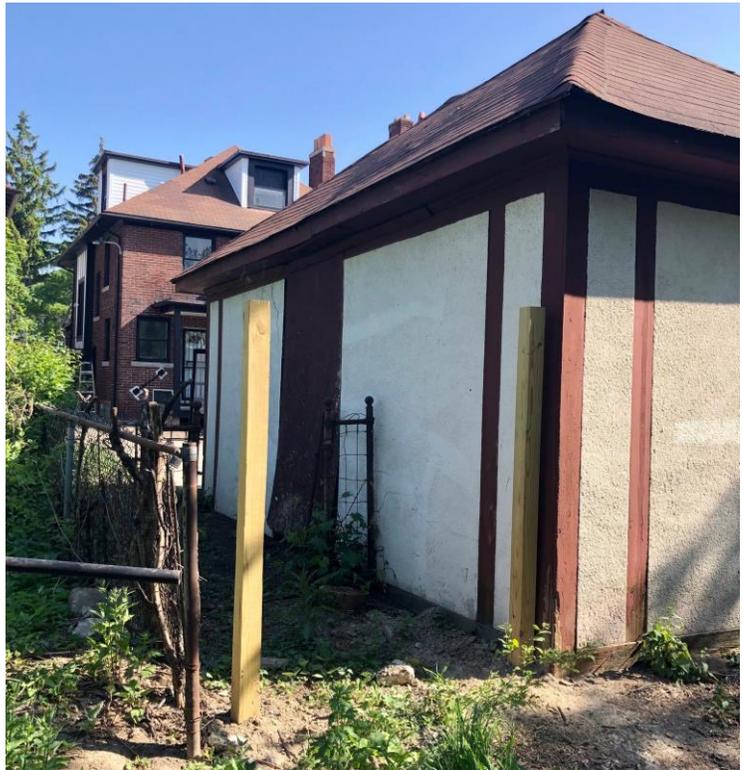
*Staff photos, May 30, 2023*

- No building permit was found to confirm the construction date of the garage. However, its size, design, and stucco/timber wall surface, suggests it was likely erected in the 1920s, and was designed to complement the house.

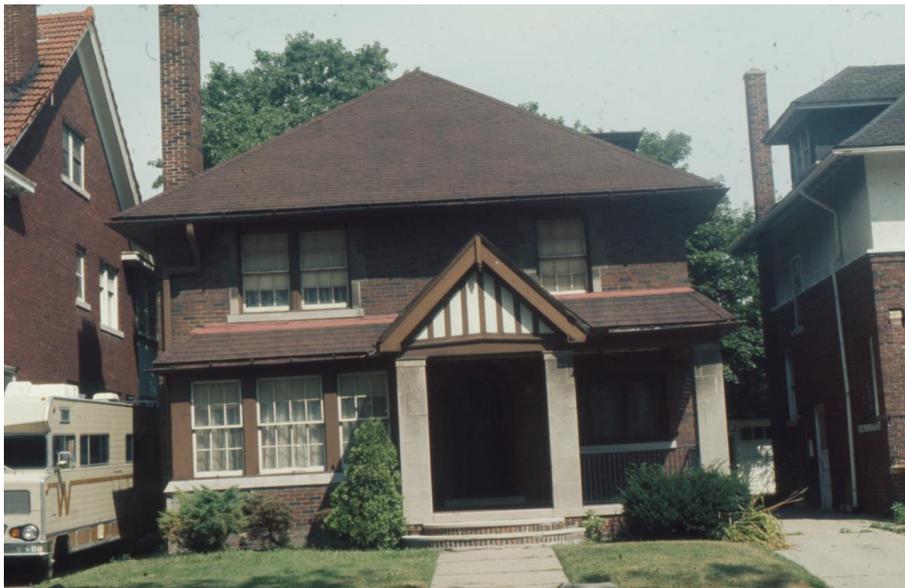
*1974 designation photo, HDAB.*

The designation photo shows a reddish brown and beige stucco color palette, similar to the existing colors on the garage.

- There was a painter at the house on the day of my site visit; the current color palette is off-white stucco and black windows and trim. The repainting has not been submitted to HDC staff for review.

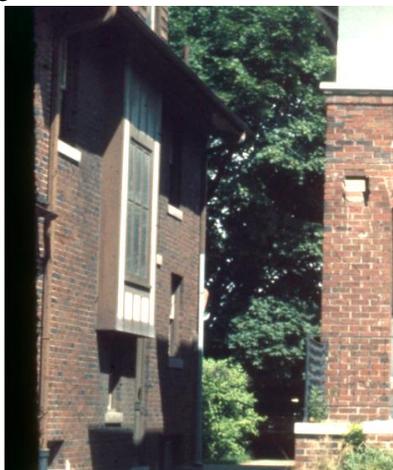
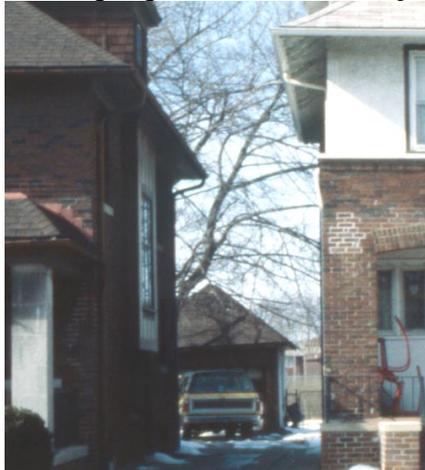
1974 designation photo for 1176 Edison

- The 1974 district designation photo shows an overgrown rear yard where a car is parked under the dense foliage (which is visible when zoomed into); a cleaned-up yard and garage are seen in a 1980 photo.

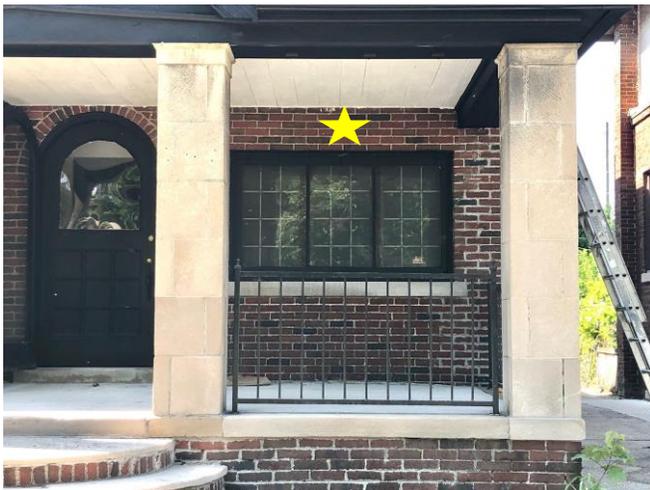
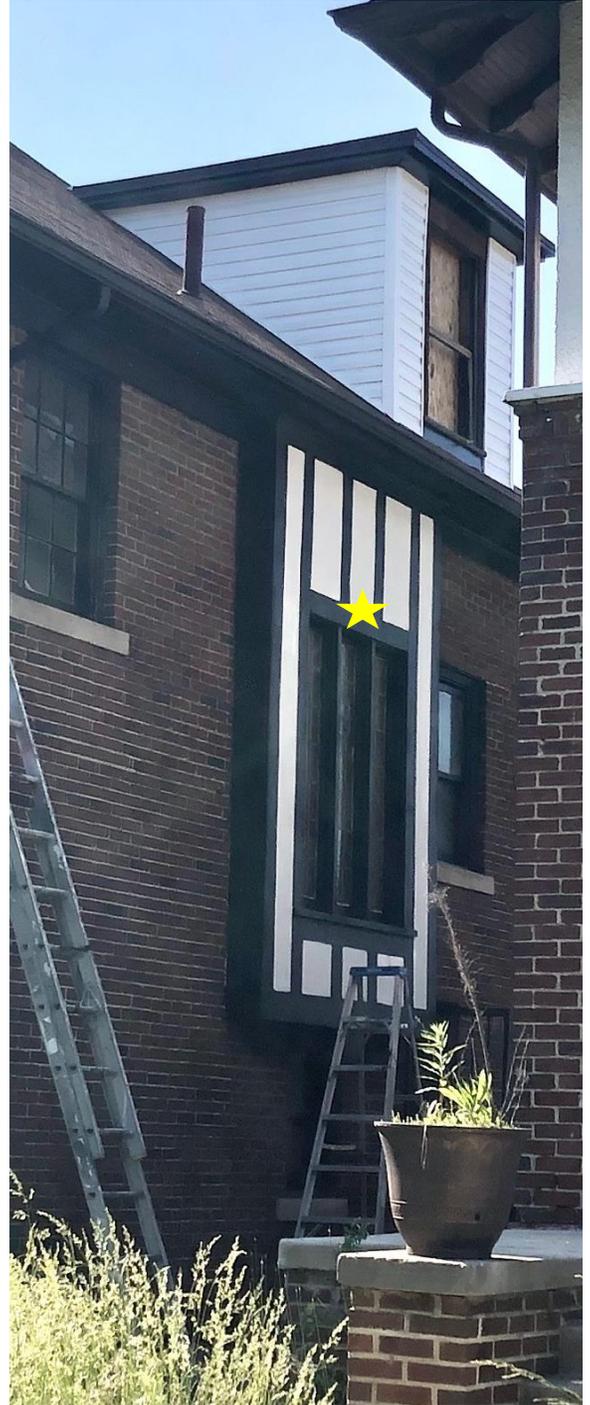
- The windows are distinctive character-defining features of the property. Standard Six states *“Deteriorated historic features shall be repaired rather than replaced. Where the severity of deterioration requires replacement of a distinctive feature, the new feature shall match the old in design, color, texture, and other visual qualities and, where possible, materials. Replacement of missing features shall be substantiated by documentary, physical, or pictorial evidence.”*

- The applicant has not proven the existing windows are beyond repair.
  - Dimensions of the historic window sash were not submitted to determine how closely (or not) the Pella product will match the wood double-hung windows.

- The Pella window order specifies that wood, aluminum-clad windows will be installed in each window opening. This means that leaded glass windows would be replaced with windows that do not match the dimension, texture, and visual qualities of the existing windows.

Staff therefore recommends that the Commission issue a Denial for the work as proposed, as it does not meet the Secretary of the Interior’s Standards for Rehabilitation, specifically Standards 2, 5, 6 and 9:
