**STAFF REPORT: JUNE 14, 2023 MEETING**

**APPLICATION NUMBER: 23-8404**

**ADDRESS: 8022 KERCHEVAL**

**SCOPE: REHABILITATE HOUSE, ALTER LANDSCAPE**

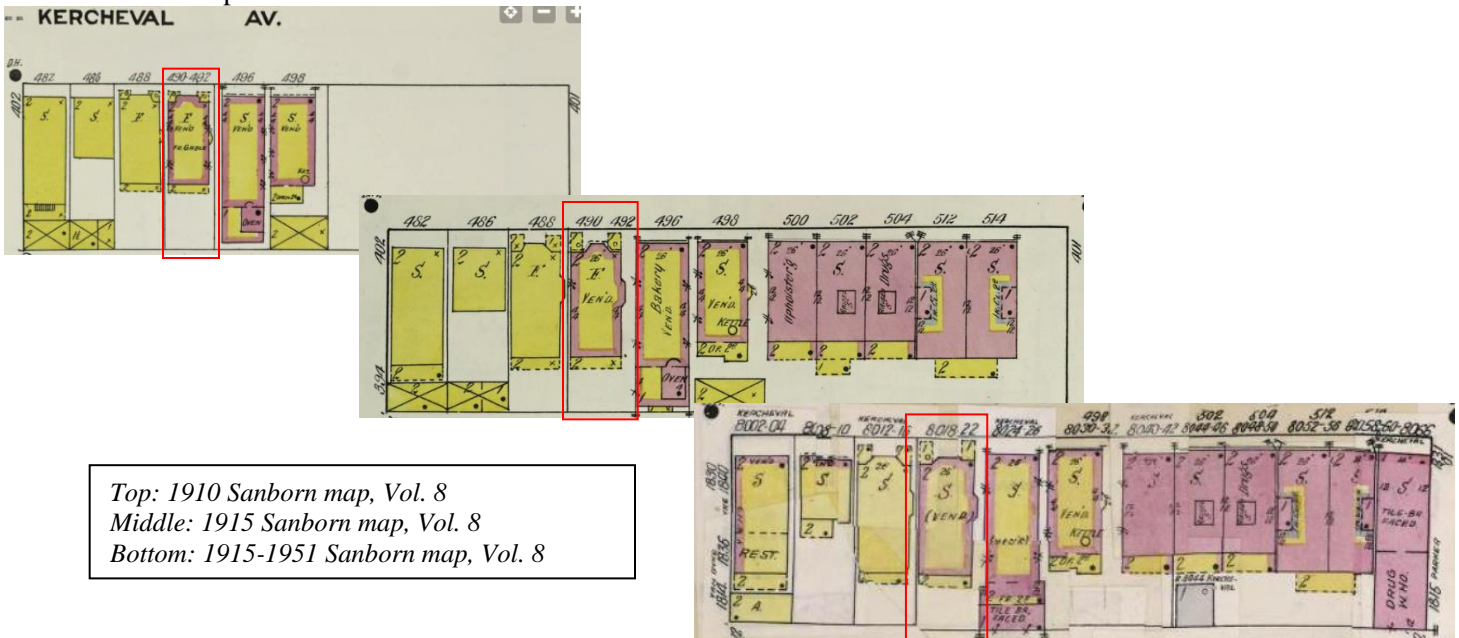
Top: 1910 Sanborn map, Vol. 8  
 Middle: 1915 Sanborn map, Vol. 8  
 Bottom: 1915-1951 Sanborn map, Vol. 8

- The West Village Historic District was established in 1983.
- The development story of the block of Kercheval between Van Dyke and Parker, as illustrated on the below Sanborn maps, shows that 8022 Kercheval (originally 490-492 Kercheval) and the neighboring structure to the west (8016 Kercheval, originally 488) were erected as residential two-story flats sandwiched between two-story commercial buildings. The block was built out by 1915; and all structures were identified as “stores” in the 1915-1951 map.

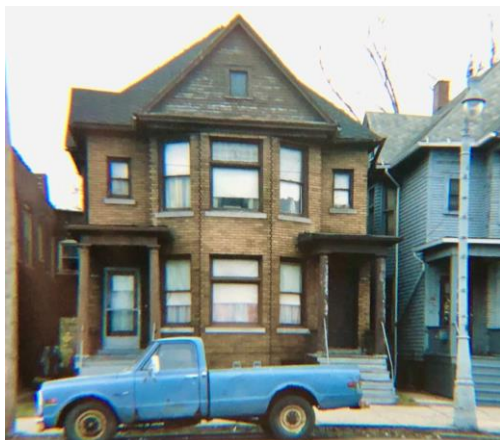
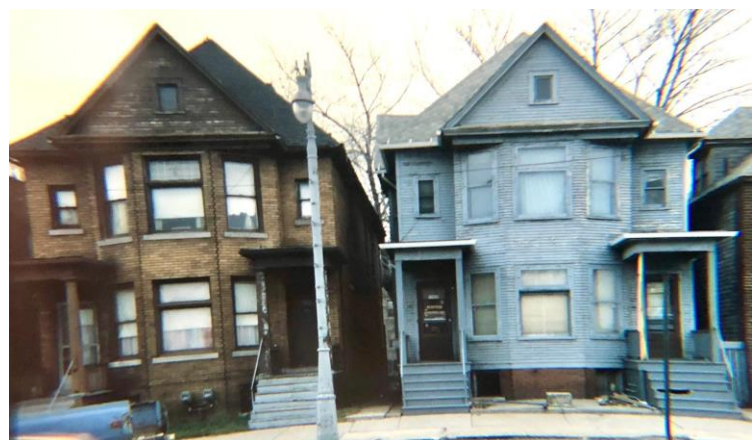
- Not only were 8022 and 8016 Kercheval erected as the only two residential structures on this block, the footprint and design of the two buildings are almost identical - the difference being the exterior wall surfaces (brick vs. wood lap siding, respectively).

District designation photos, 1983. Historic Designation Advisory Board

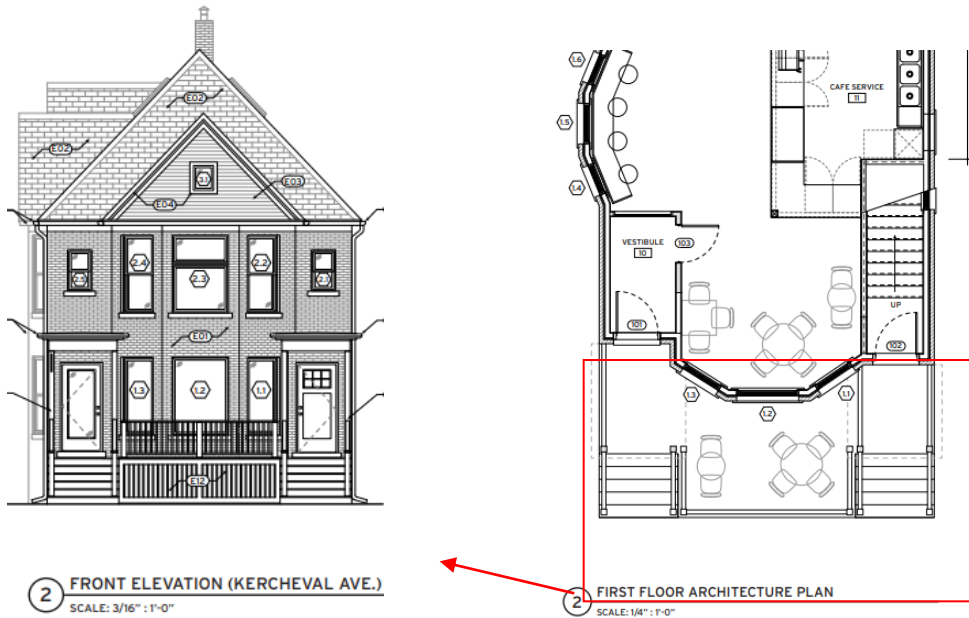
*Applicant drawings*

- Also, as the historic front doors do not remain, the proposal of differently designed doors, as shown on the below elevation, is another way to identify the new uses of the building (left door is full glass=public space / right is mostly solid door=private, residential space) in a way that doesn’t alter the intact historic openings.

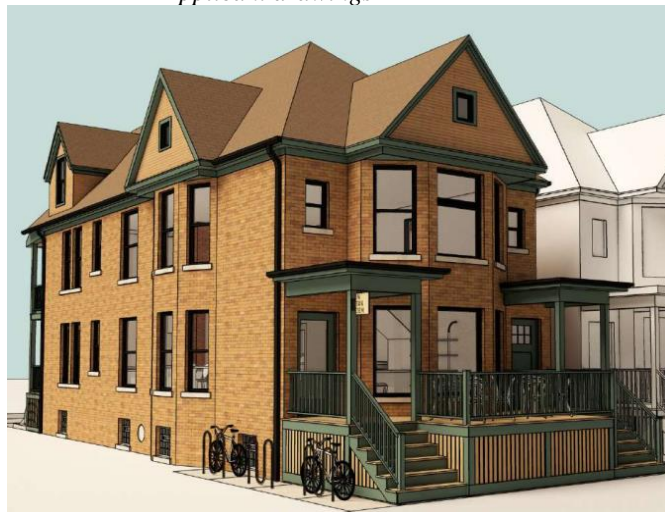
*Staff confirmed with the applicant that the side bay windows are drawn incorrectly on the rendering (transom and fixed window in central openings will remain)*

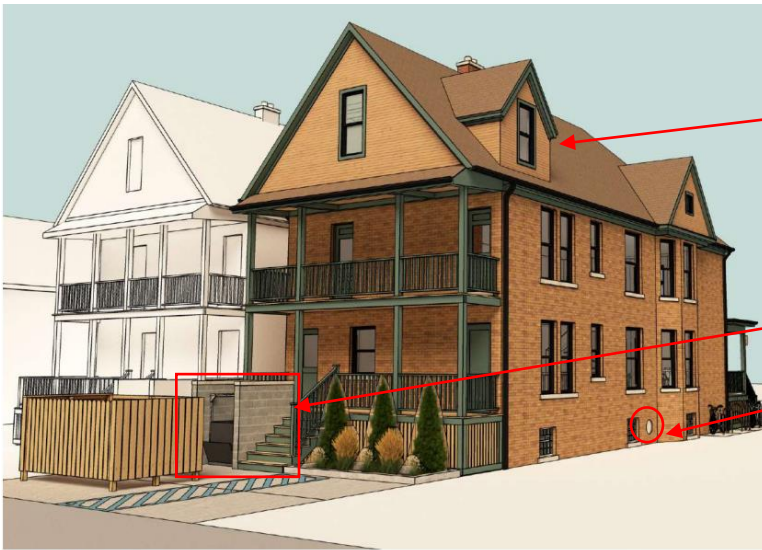
VIEW FROM REAR ALLEY

Applicant drawings and products, staff photo

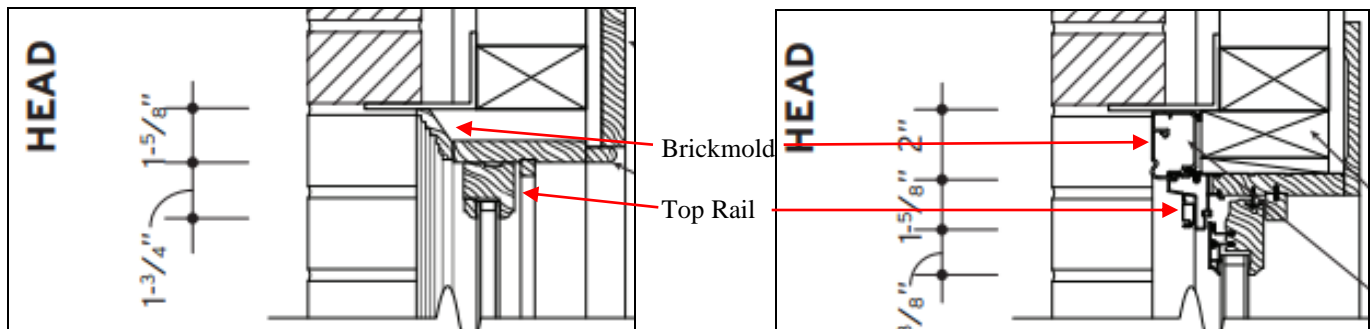
Alteration to first story front bay windows

- The most drastic increases in dimensions for the new window are with the brickmold (3/8" taller) and top rail (1-1/4" taller).
- The manufacturer's section shows a standard brickmold with only one small bend, so it has a mostly flat appearance, which is drastically different from the highly detailed existing brickmold. Although the applicant is working with the manufacturer to design a more detailed brickmold, staff is unsure if aluminum can be bent in such a way to match the existing profile and retain adequate strength.

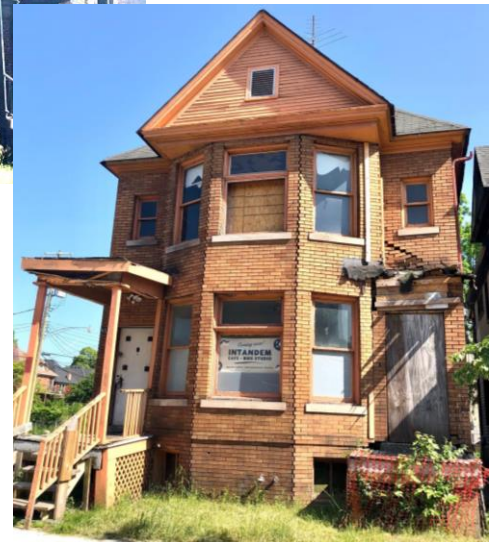
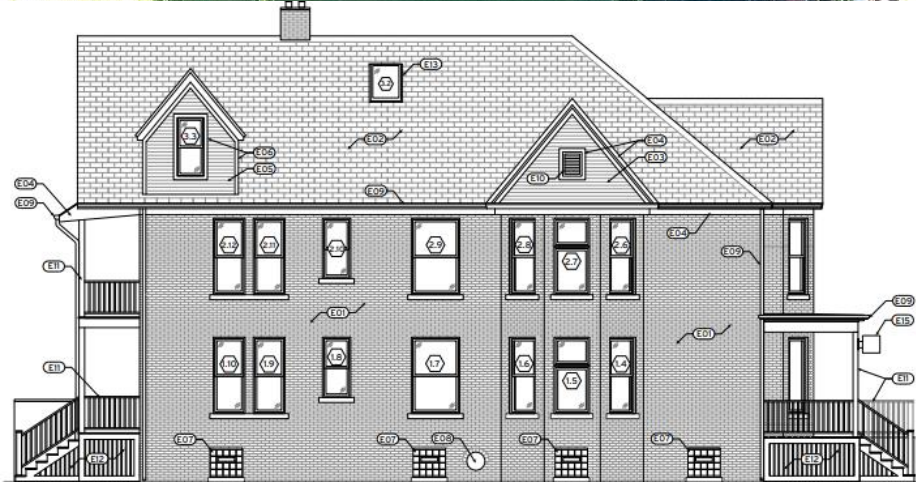
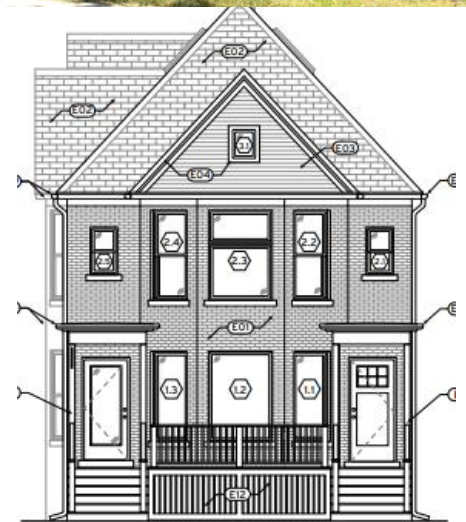
Applicant drawings

- The two family house was designed as a cohesive structure. Patterning is found in the symmetrical window openings, horizontal raked mortar joints, water table, and decorative brick, all of which is found on each side of the building.
- The two-story bay windows are distinctive character-defining features; the uniformity and relationship between the bay window openings on each floor and elevation is an important historic component of the structure and offers a visual clue as to its original multi-family residential use and era of construction.

### **Recommendation One – Denial – Replacement of front elevation masonry veneer, alteration of bay window, window and brickmold replacement**
