STAFF REPORT: JULY 12, 2023 MEETING

APPLICATION NUMBER: 23-8442

ADDRESS: 1419 SEYBURN

SCOPE: REHABILITATE DWELLING, REPLACE WINDOWS

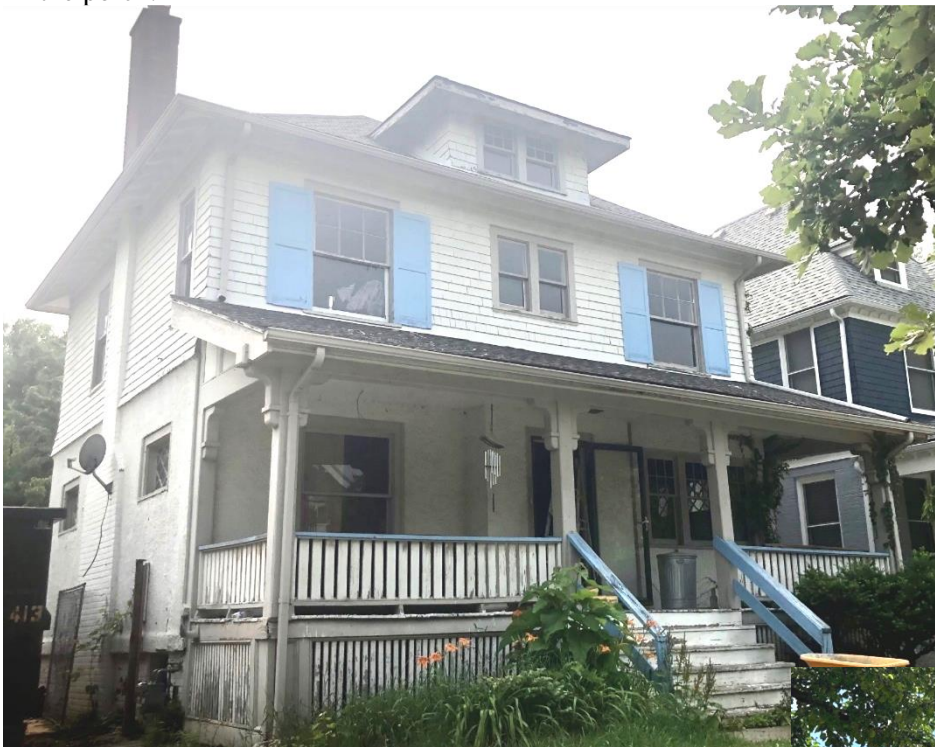
Above: Staff photo, June 30, 2023.

A raised and covered wood front porch extends across the front elevation and is accessed by a set of wood steps. Square posts with applied trim support the shed roof; a low wood railing with wide wood slats as balusters, enclose the porch.

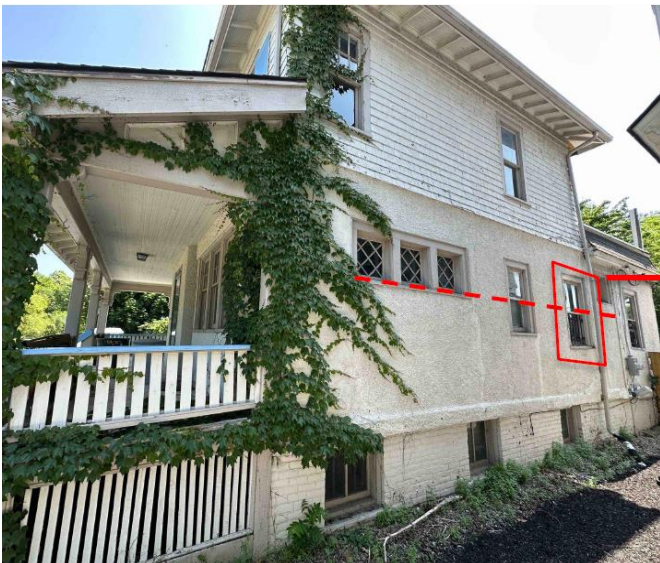
North elevation

- A mullied three window opening with square fixed windows with diamond shaped muntin pattern.
- Three single double-hungs with one-over-one pattern.
- One small non-historic slider.

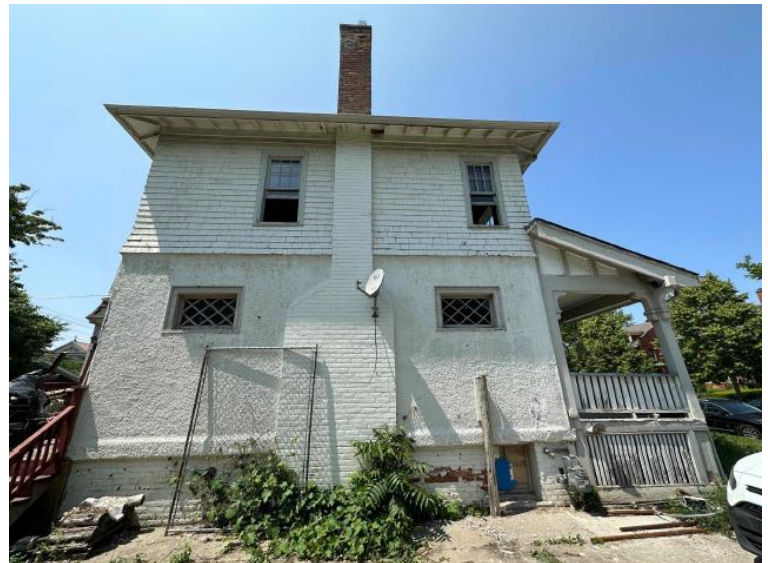
South elevation

- Two single, wider than tall, fixed windows with diamond shaped muntin pattern.

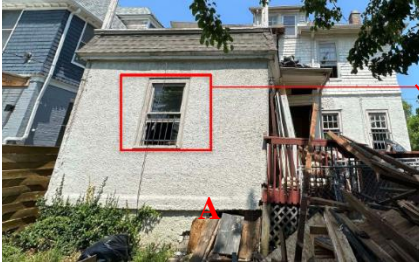
- One single double-hung with six-over-one pattern.
- One mullied double window opening with double-hung units with six-over-one pattern. (One window is missing and boarded over.)
- One single door opening with non-historic door.

Applicant photos. Far right photo is taken from upper porch, showing interior of knee wall. Bottom right is the north-side elevation.

- A. 53" h x 32" w window to be changed to 53" h x 60" w window.
- B. Replace door with new window, header height, size, and operation to match adjacent window.
- C. Replace small window opening with French Door – JELD-WEN 60-in x 80-in Tempered External Grilles Primed Steel Left-Hand Inswing French Patio Door.
- D. Install fiberglass double-hung (six-over-six) window due to new shower location. Marvin Infinity, Cottage 1-High Casement specified.
- E. Install new window where previous was removed.
- F. Remove eave and reopen full window opening (to match adjacent existing condition).
- G. Erect perimeter railing at second floor deck. Design to match front porch railing. install 12" railing at top of 24" knee wall.

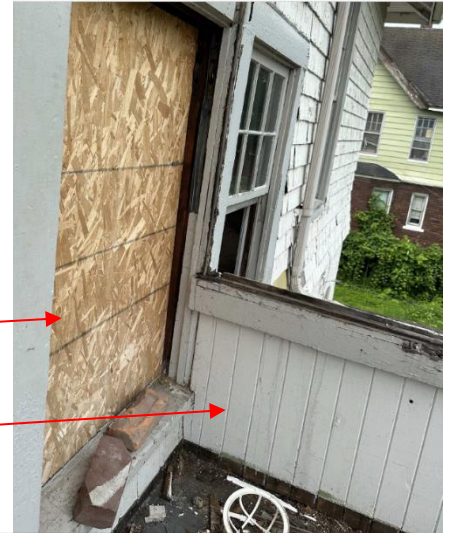
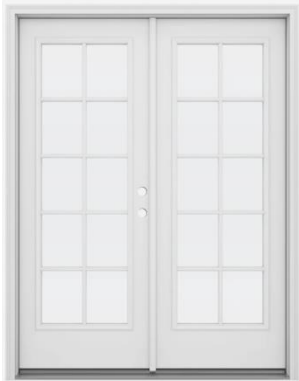
JELD-WEN French door and Marvin Infinity Casement Cottage 1-High window copied from applicant document. Staff photo of front porch railing.

- The existing railing is sympathetic in styling, height (taller than the historic railing, but likely lower than a contemporary 36-inch railing), material and finish, but doesn't meet Secretary of the Interior Standard 6, which requires exact replacement of deteriorated character-defining features.

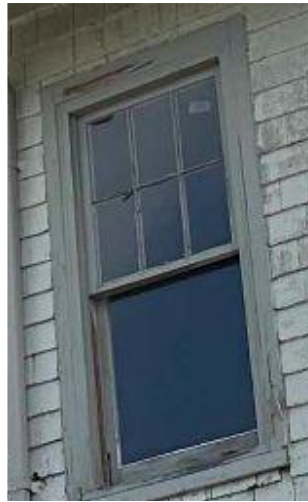
400 Series Double-Hung Window

- It is staff's opinion the wood windows are distinctive character-defining features. The materiality matches the historic wood siding; the cladding finish of the new windows would create a stark contrast to the wood and stucco walls. Additionally, the dimensionality of the existing windows cannot be matched by the full frame fabrication of a replacement window. The thicker meeting rail (and likely bottom rail) and muntins (thinnest width available is 3/4"), coupled with cladding joints at every exterior surface of the replacement window, create a highly noticeable difference from the historic windows.
