STAFF REPORT: AUGUST 9, 2023 REGULAR MEETING

APPLICATION NUMBER: 23-8483

ADDRESS: 2432 W BOSTON

SCOPE: REHABILITATE DWELLING AND GARAGE

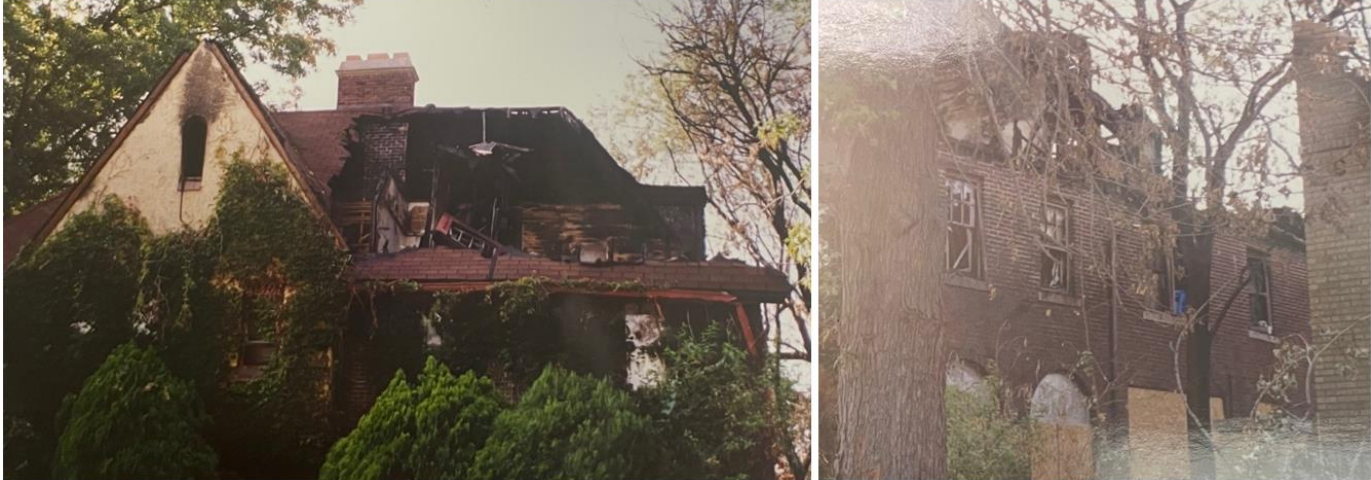
The twenty-first-century history of this property is one of extensive rehabilitation work, some of which has been appropriate, and some of which has been inappropriate. In 2003 a fire destroyed much of the second floor and attic story. The Historic District Commission issued a Certificate of Appropriateness on March 19, 2003, for repairs, including the replacement of three windows “to match the materials and configuration of the existing.” (Photos show that more than three windows were damaged; the treatment of the remaining windows was not specified.) On May 11, 2004, the property owner was issued a violation notice for the installation of an

Left: North elevation in 2003. Right: West elevation in 2003. Staff photos from Historic District Commission files.

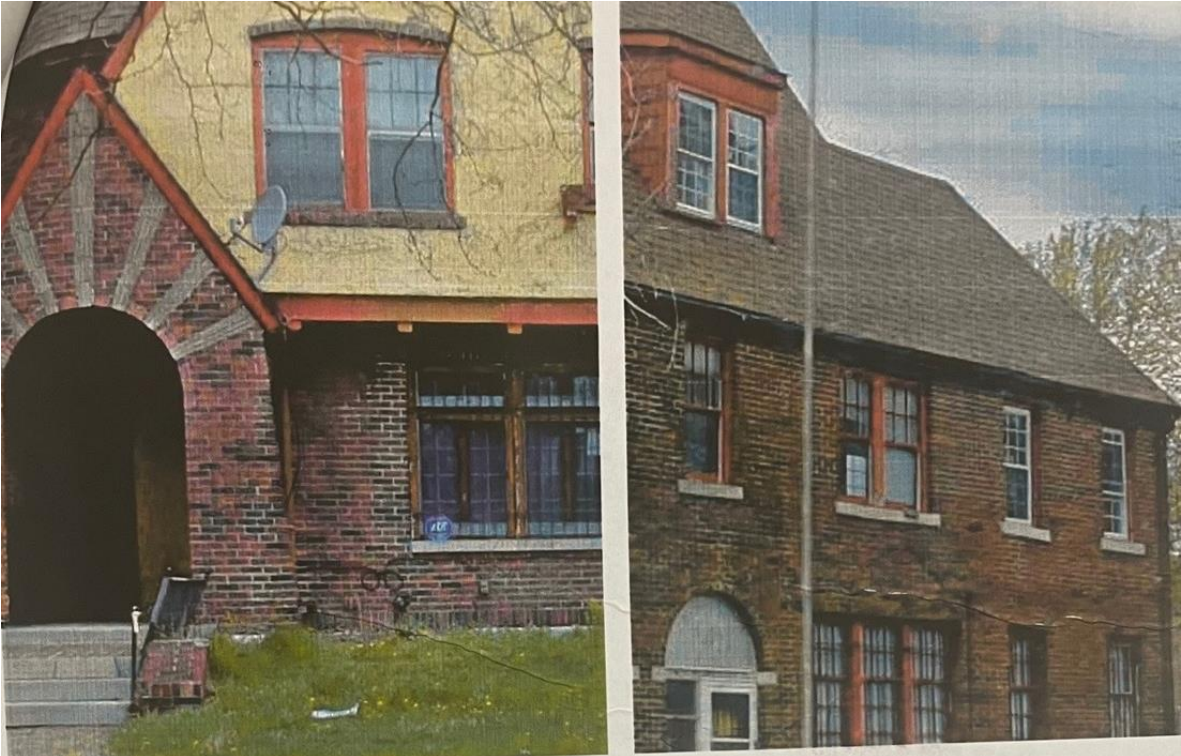
unspecified number of vinyl windows. A comparison of photos from that time with Google Street View images shows that several second-floor windows were changed, yet again, between 2018 and 2022. Historic District Commission records are unclear in that they do not specify which windows are the subject of the 2003 Certificate of Appropriateness, which windows are the subject of the 2004 violation notice, and which, if any of the windows replaced between 2018 and 2022 may have been subject of the 2003 Certificate of Appropriateness. Nonetheless, the property presently includes both inappropriate vinyl windows and recently installed, historically appropriate (but unfinished) wood windows, as described in greater detail below.

Left: North elevation in 2004. Right: West elevation in 2004. Staff photos from Historic District Commission files.

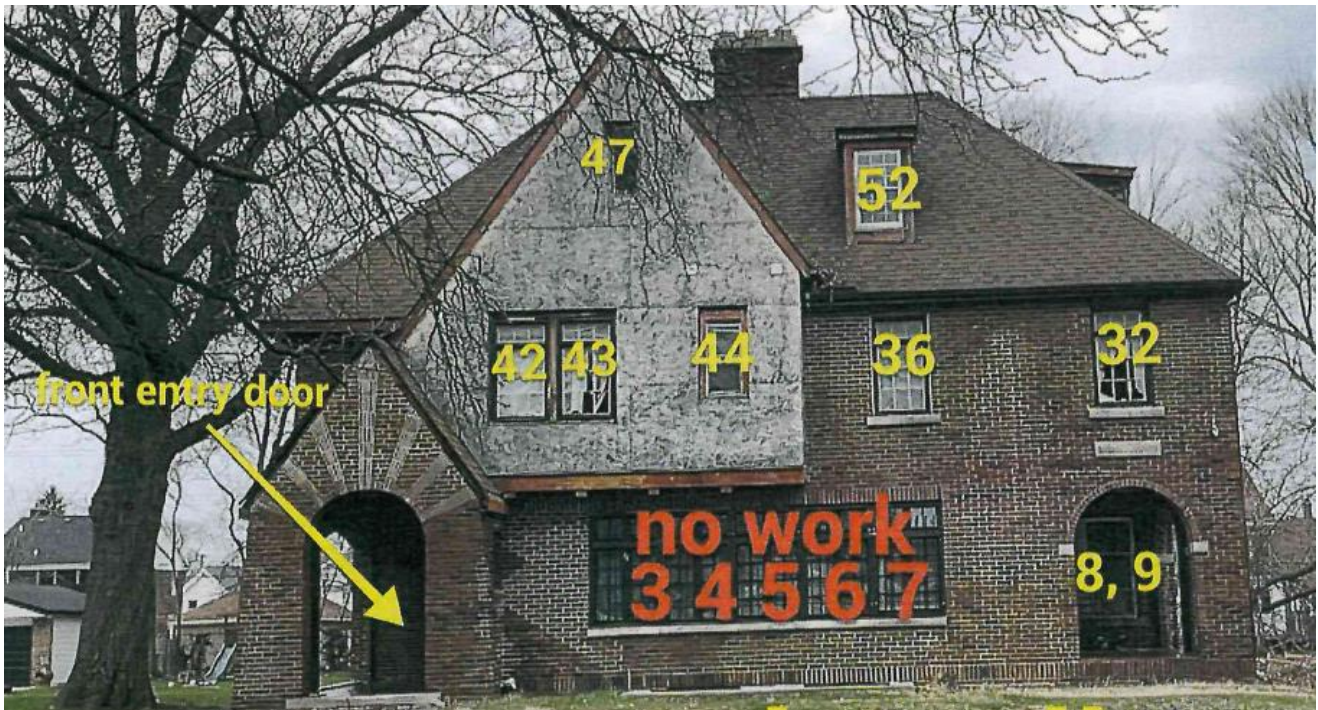
The applicant proposes to install 49 windows on the house and two on the garage. The existing window openings, numbered 1 through 58 and G1–G2 in the provided window schedule, are presently a mix of historic wood windows in varying conditions, vinyl windows, non-historic wood windows, and boarded-up openings from which windows are presently missing.

North elevation. Illustration by applicant. Note that “32” is a typo; it should be “37.”

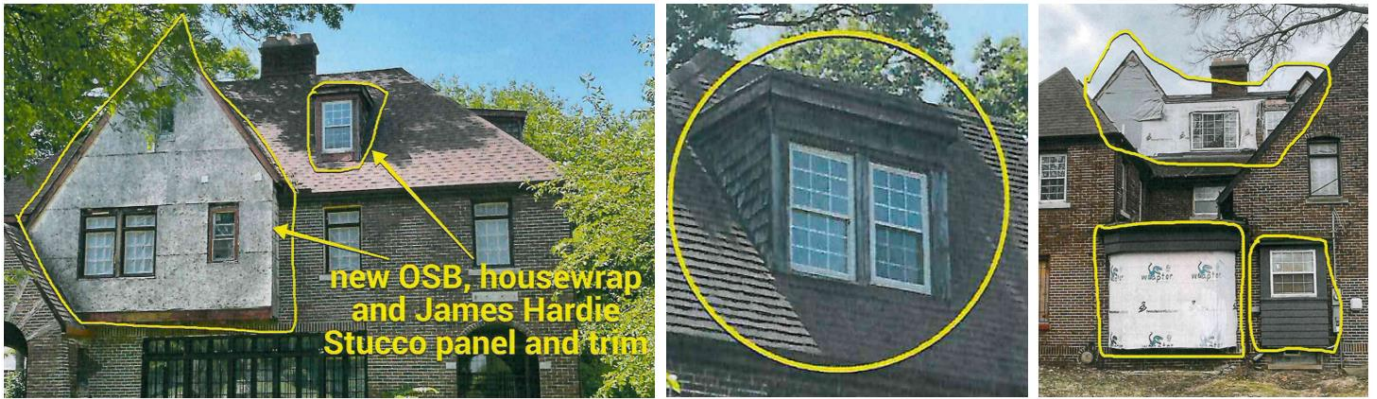
Proposed HardiePanel locations. Left to right: North elevation, west elevation, south elevation. Images by applicant.

- The areas of the south (rear) and west (side) elevation, proposed for replacement with HardiPanel stucco, historically are presently clad in wood shingles. Based on the age and architectural style of the house, this is presumed to be a historic material and is certainly a character-defining feature. Standard #2 states that “the removal of historic materials ... shall be avoided.” If the historic materials are deteriorated beyond repair, Standard #6 states that the replacement features must “match the old in design, color, texture, and where possible, materials.” Thus, the existing wood siding must be retained, or, if deteriorated beyond repair, be replaced in kind.

- The proposed HardiePanel stucco installation is likewise inappropriate for the same reasons mentioned in the previous bullet point. It replaces a missing historic material with a new material that differs in appearance and texture from traditionally applied stucco. In staff’s opinion, the material, texture, and detailing of fiber-cement siding panels and siding, as well as their propensity to weather and age differently from traditional materials, makes them inappropriate for repairs on historic buildings. True applied stucco remains technically and financially feasible.

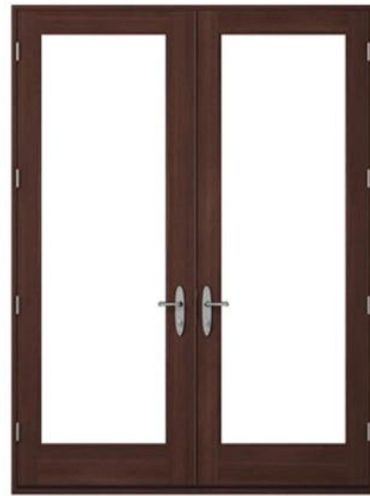
Left: Existing porch doors, photos from application. Right: Pella Reserve Traditional door (shown without simulated divided lights), image from product website.

- The proposed rear (south) door and storm door replaces a non-historic door with a compatible new door.
- The existing porch doors do not appear to be intended for exterior use and may date from the era when the porch was enclosed. Due to their recessed, west-facing location, they are minimally visible. Staff suggests that their replacement is appropriate.

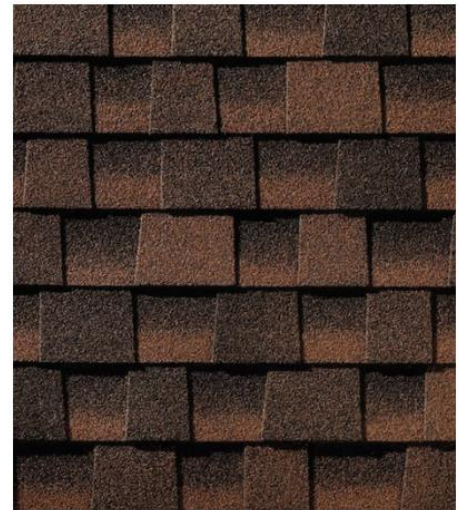
Left: photo of garage from application. Right: Timberline hickory shingles. Image from product website.

- The proposed garage shingle work replaces a worn, historically appropriate material with matching material.
- The garage doors are not a historic feature; the Secretary of the Interior's Standards do not require that they be retained. However, the new doors must be compatible in materials and visual qualities.
