STAFF REPORT: 9/13/2023 REGULAR MEETING

APPLICATION NUMBER: #23-8515

ADDRESS: 3515 SHERBOURNE

SCOPE: DEMOLISH ADDITION, ERECT REAR DECK, REPLACE WINDOWS, REPAIR DRIVEWAY, PAINT TRIM (WORK COMPLETED WITHOUT APPROVAL)

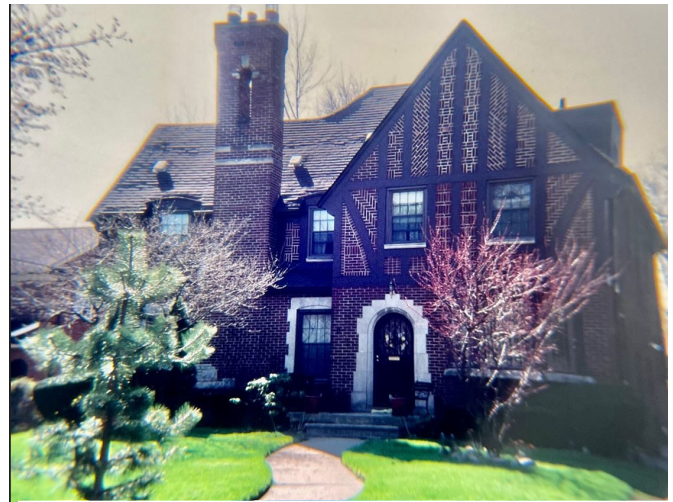
Designation photo April 2002: (North) front elevation of the house.

- From designation until April 2023, photos and documents show the presence of foundation plantings around the front and side elevation of the house. Staff observed that the removal of these foundation plantings without approval has exposed utilities, an air conditioning unit, and the deck at the rear. (See photos 1, 3, 7 and designation photo.)

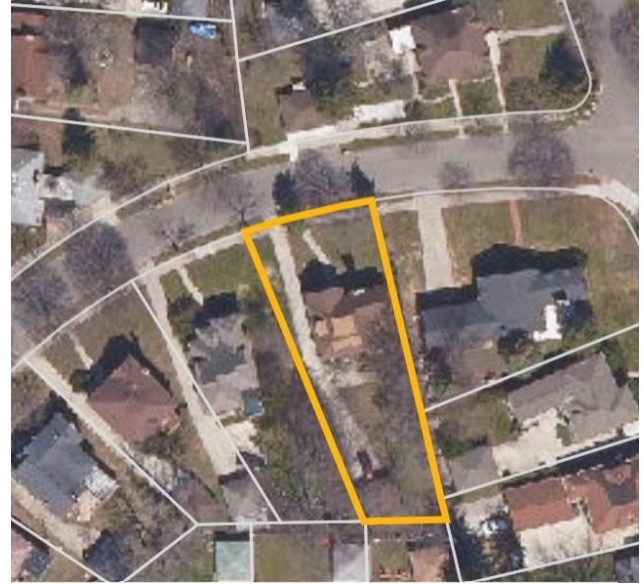
Aerial 2, by Detroit Parcel Viewer of Parcel # 02004890.
