STAFF REPORT: SEPTEMBER 13, 2023 MEETING

APPLICATION NUMBER: 22-7665

ADDRESS: 715 VAN DYKE

SCOPE: ALTERATIONS TO PREVIOUSLY APPROVED PORCH DESIGN (WORK COMPLETED WITHOUT APPROVAL)

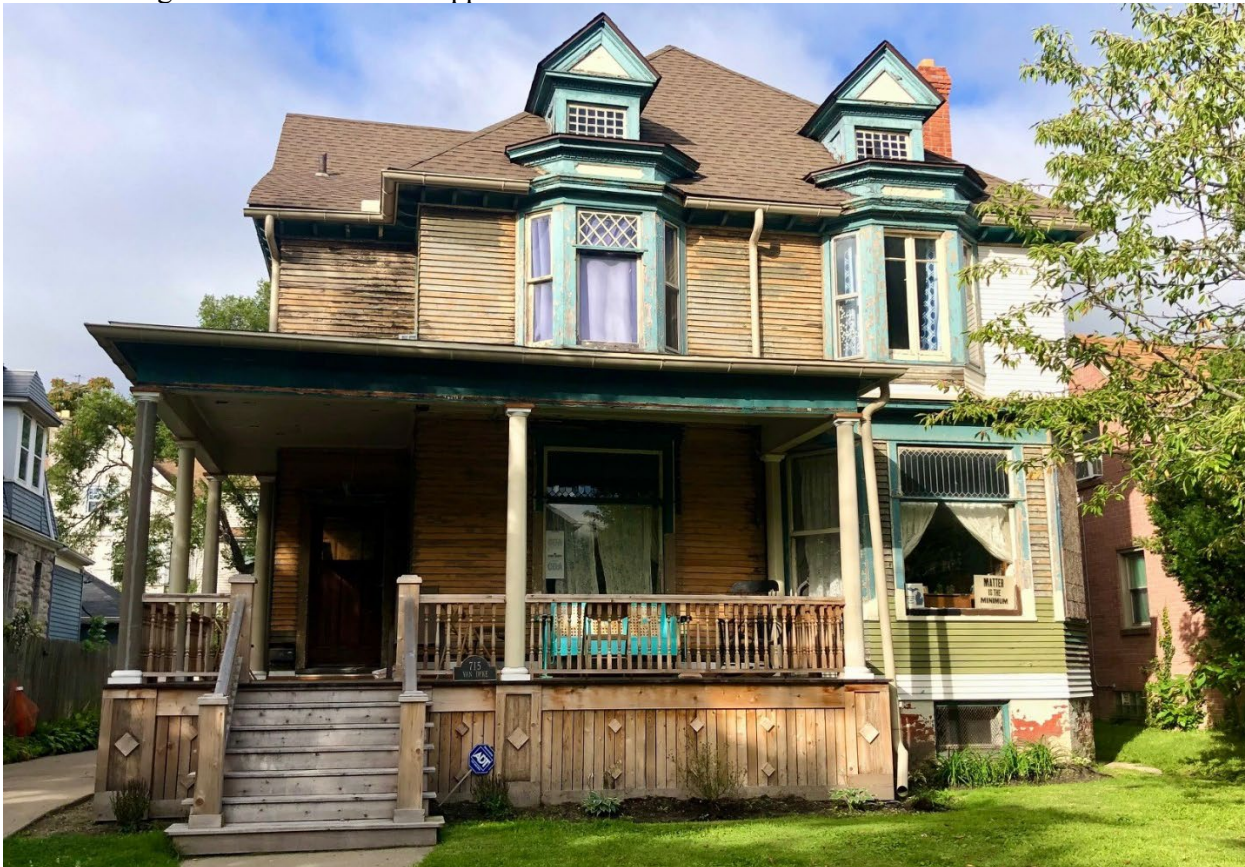
A one-story, covered wood porch extends south from the front elevation bay window and wraps around the southeast corner of the dwelling, ending just past the recessed front door. The raised porch is enclosed by wood skirting and round columns support the flat roof.

Staff photo, August 30, 2023.

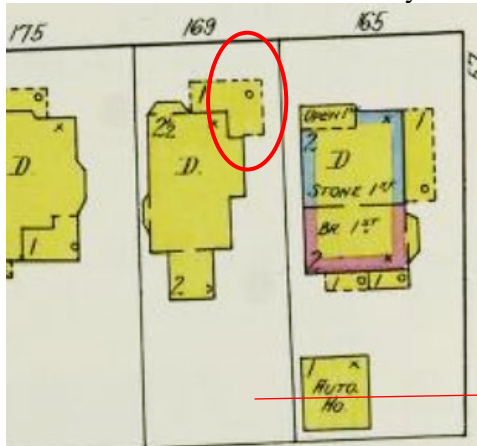
Vol. 8, 1910, Image 7

- The West Village Historic District was established in 1983.
- Per the below Sanborn maps, between 1910 and 1915 the southern end of the front porch was reduced in size for the introduction of a driveway which led to a detached garage (no longer present).

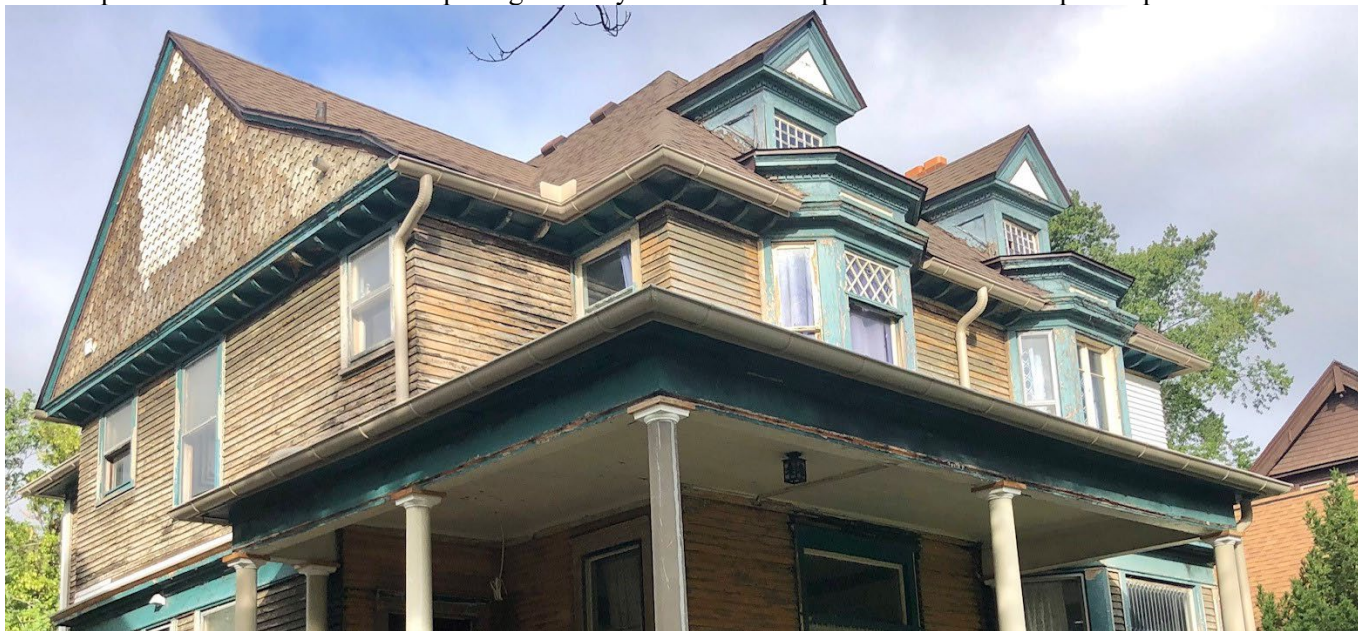
- The house displays Colonial Revival features through the pedimented dormers (and previously through the porch's Tuscan pilasters); Queen Anne details include differing wall textures/profiles, multiple glass patterns within the window openings and asymmetrical front porch and house shape/footprint.

HDC staff photo, August 30, 2023.

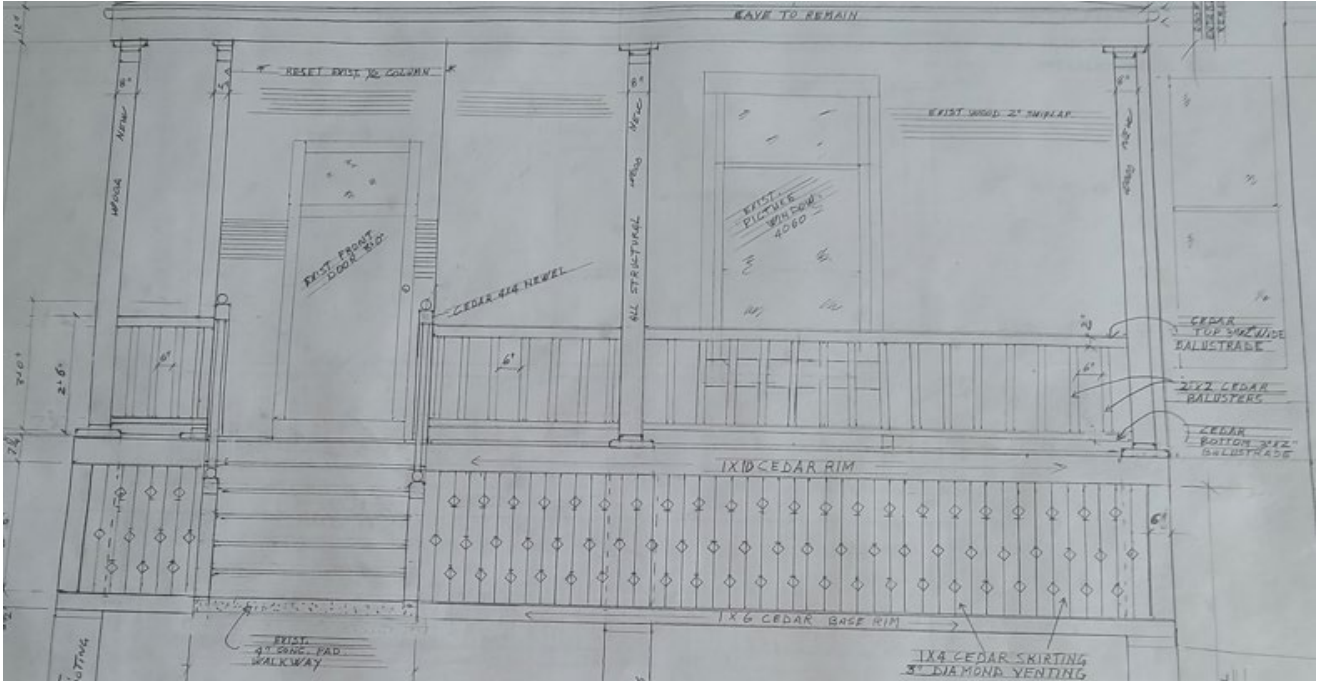
- The Commission reviewed and approved an application to rebuild the front porch at the February 2022 meeting. A copy of the approved front elevation, shown on the following page, includes a lower height railing, straight spindles, diagonal-shaped cut-outs in the porch skirting, and round columns (that would replace the non-historic square columns); two historic half-round pilasters remained on site and were to be re-installed at the walls of the house at the north and south termination points of the porch.
- It is staff's opinion that the most common profile used for early 20th century porch railings was square

- The historic pilasters were replaced with round columns. Additionally, taller turned spindles were used for the porch railing, thick square newel posts were used at the stairs and a "solid" (i.e., no cut-outs) skirting with diamond medallions was installed.

Applicant drawing, February 2022.

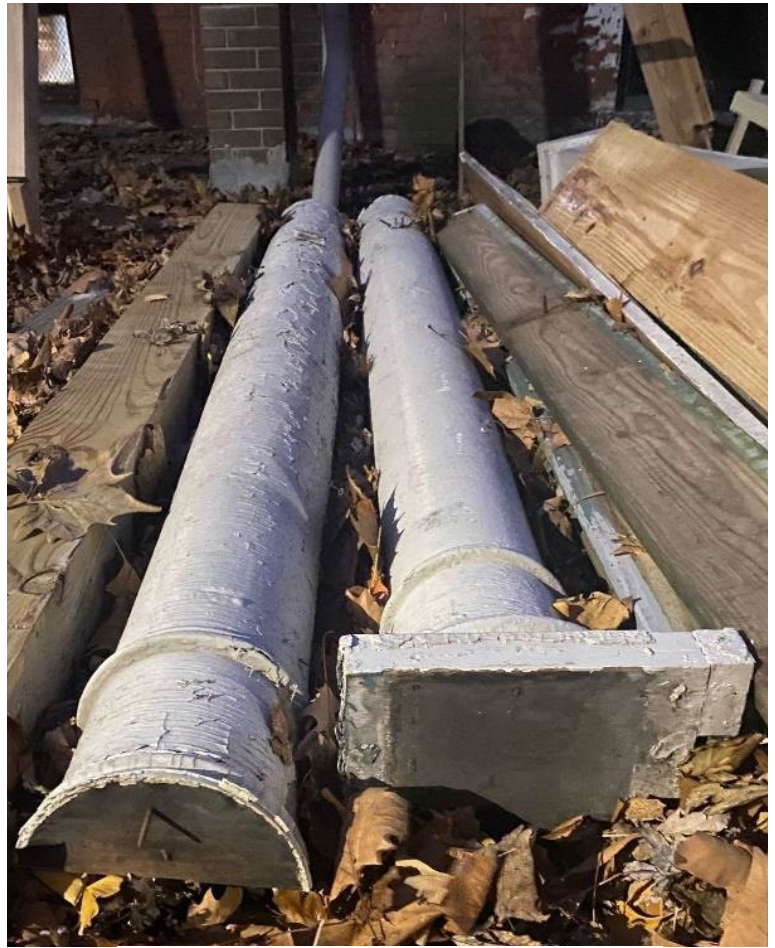
- Based on the photographs provided by the applicant within the February 2022 application, the wood pilasters remained on site and appeared to be solid and not deteriorated beyond repair.

Applicant photo, February 2022.

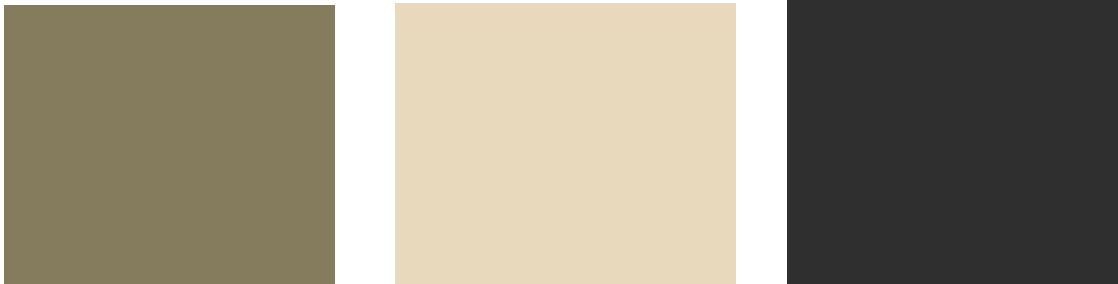
- In March 2023, HDC staff issued a Certificate of Appropriateness (23-6270) for the exterior painting of the dwelling.
 - Body/Siding: Sherwin Williams, SW2861 Avocado
 - Trim: Sherwin Williams, SW2833 Roycroft Vellum
 - Windows: Sherwin Williams, SW6258 Tricorn Black

Color samples from Sherwin Williams website

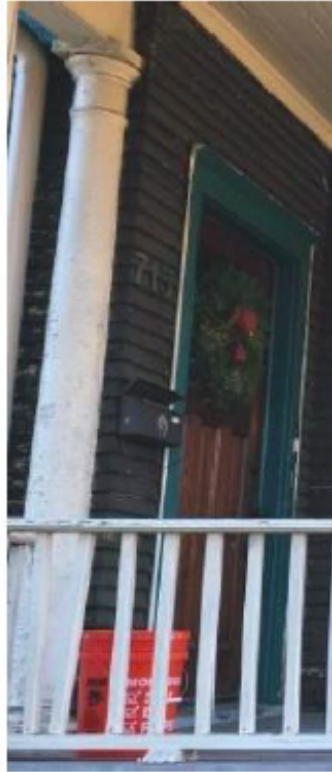
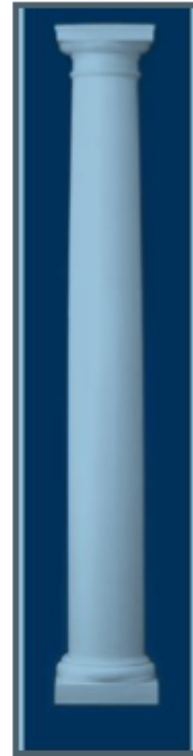
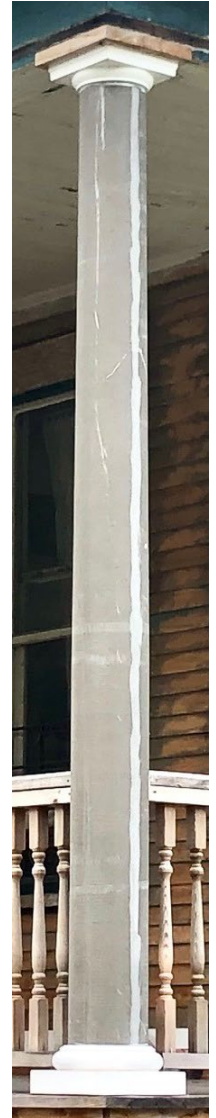
- The best and most appropriate replacement would be a turned-wood column to match the existing prototype. However, it is staff’s opinion the replacement column, while not a perfect match, is similar to the design and proportionality of the historic column and therefore, is reasonable and feasible.

Photo and catalog images supplied by applicant.
The original pilaster appears to have a slightly tapered smooth shaft.
The proposed fiberglass column has a similar Tuscan capital (with slightly different dimensions) and a smooth tapered shaft. The diameter at its widest point will be 8”, similar to the wood pilaster’s width.
