STAFF REPORT: NOVEMBER 8, 2023 MEETING

APPLICATION NUMBER: HDC2023-00072

ADDRESS: 7908 – 7912 ST. PAUL

SCOPE: REMOVE WOOD SIDING (WORK COMPLETED WITHOUT APPROVAL), INSTALL WOOD SIDING, REPAIR/REPLACE WINDOWS

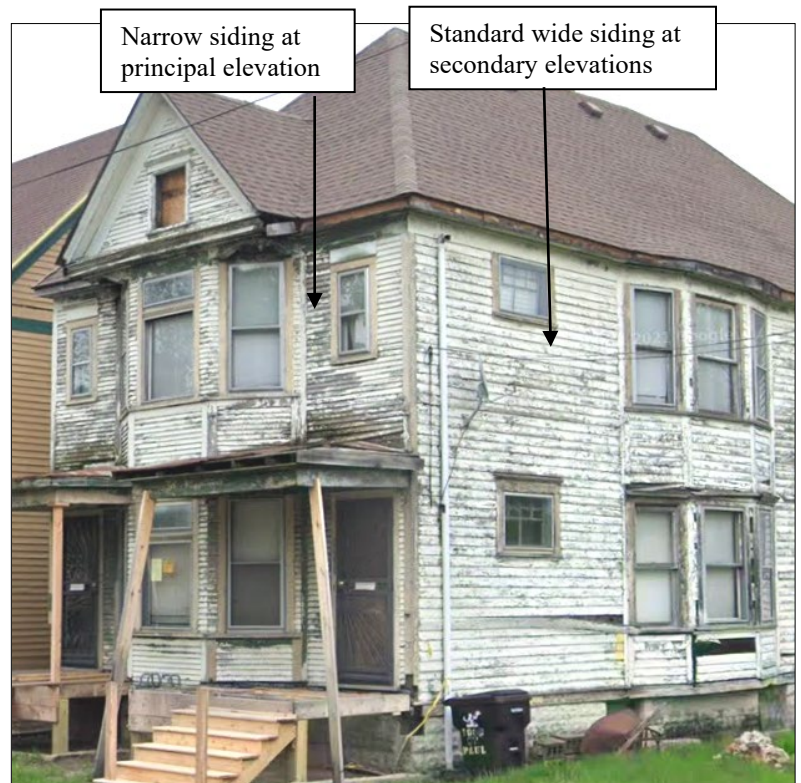
7908 - 7912 St. Paul - Google street view, May 2019.

- The current application proposes to install new wood clapboard siding on each elevation. The front elevation's siding will have a three-inch exposure and the side and rear elevations' siding will have a five-inch exposure, similar to what is shown in the May 2019 photograph on the preceding page.

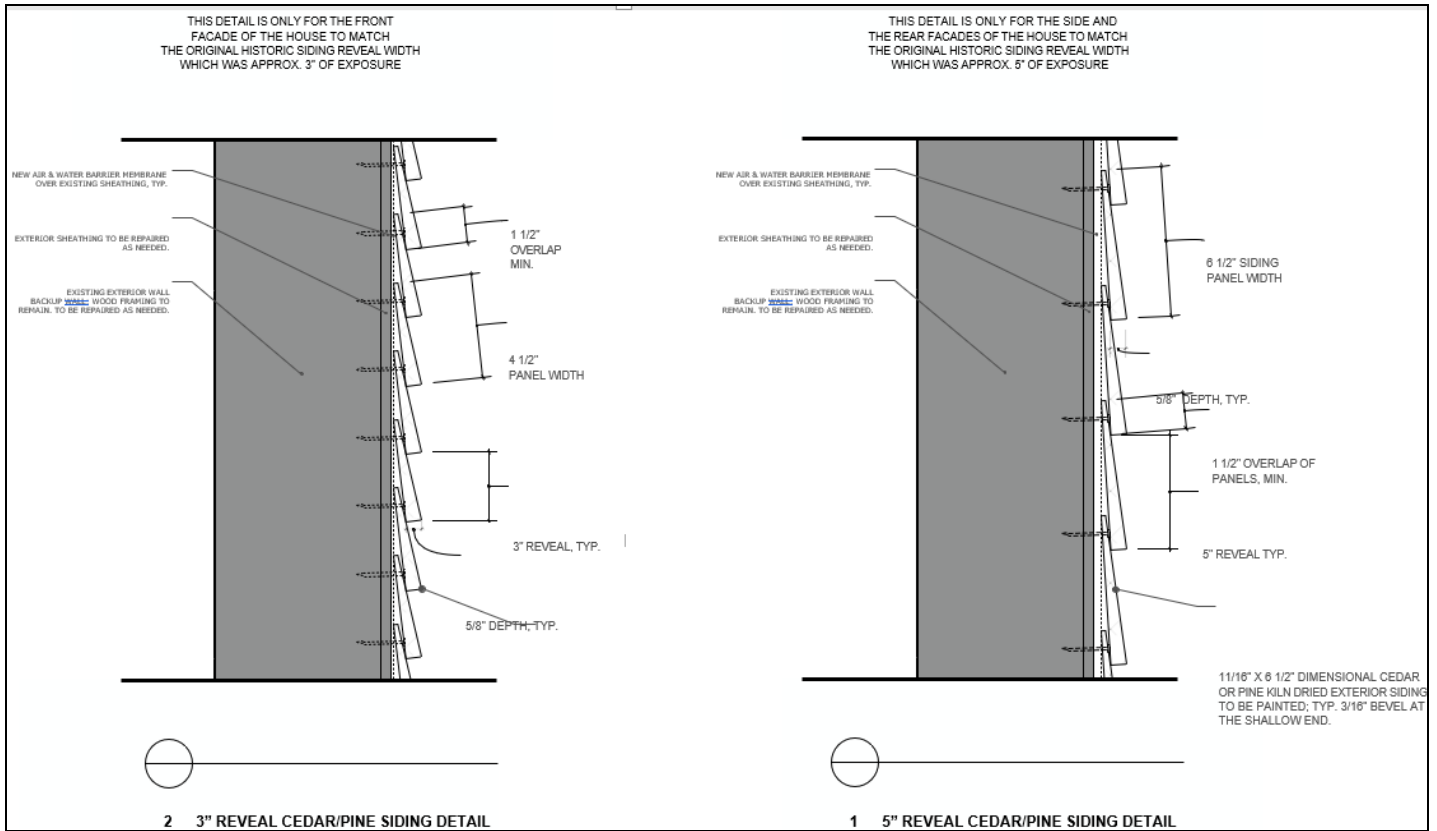
Applicant drawing.

- The recreation of trim and wood siding at the front/north and side/west elevations are shown on drawings submitted by the applicant. Photo of the historic condition at the west elevation is on the following page.

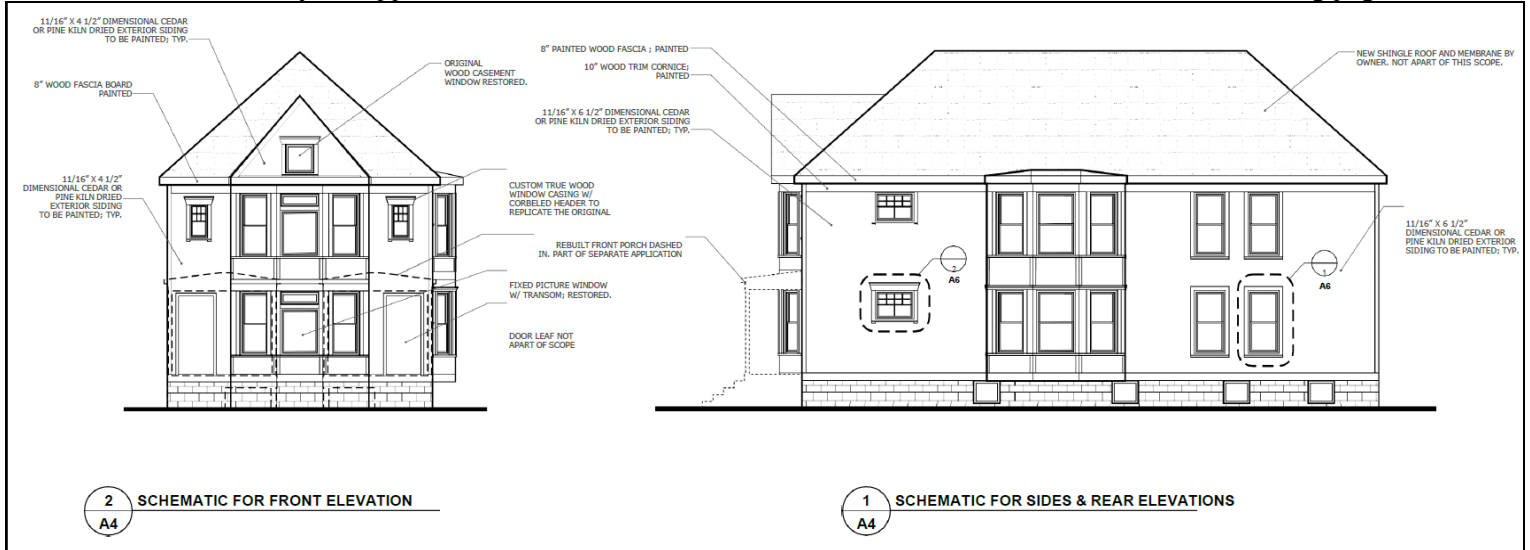
Applicant drawing.

- The drawings show window casings will be constructed in a similar way to the historic condition.

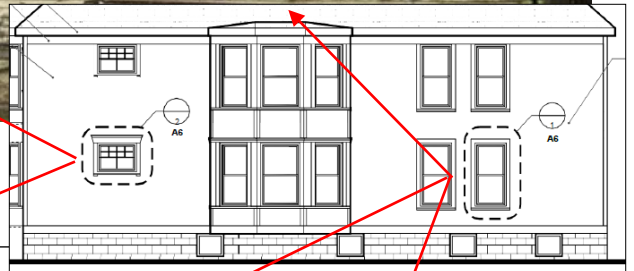
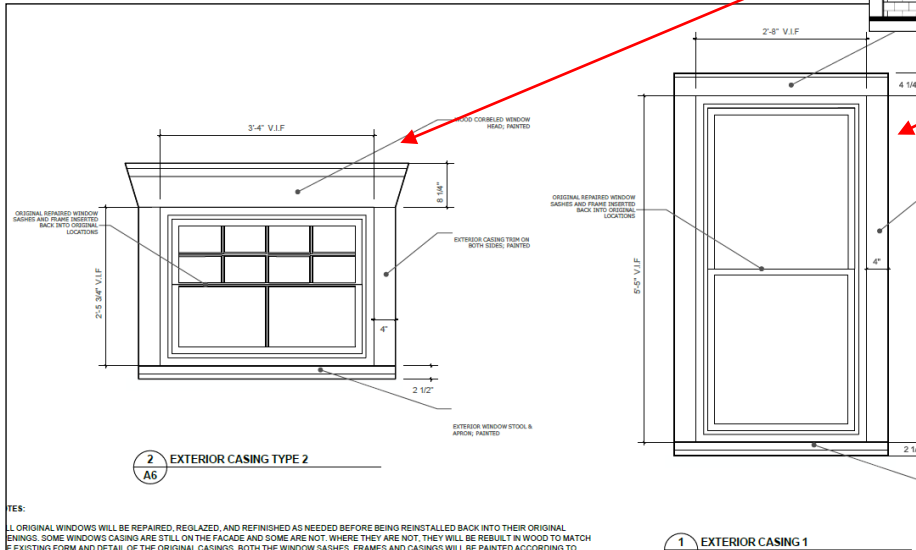
Applicant drawings.

- The drawing for the window casing for the small windows is not drawn accurately: it doesn't show the trim directly above the window opening (black arrow), the flat trim is shown to angle outward (green arrow) rather than only the decorative trim above the casing extending outward on an angle (blue arrow). Additionally, the protruding dimension for the sill and the header's decorative trim isn't noted on either drawing (orange star).

- Elevation drawings for the east and south elevations will be created and will document all related scope of work (including trim, wall, and porch details).
- The window casing drawings will be corrected to accurately reflect the existing conditions and dimensions.
- The front elevation drawing will be revised to include notations of the retention of trim within and below the gable.
- A site plan will be submitted to confirm placement and dimensions of rear stairwell (if one is being erected).
- Manufacturer’s or fabricator’s information, including sash dimensions, for the new wood windows will be submitted. The elevation drawings will note the window openings that will receive new window sash.
- Revised plans noting all the above conditions will be submitted for staff review prior to pulling a permit.

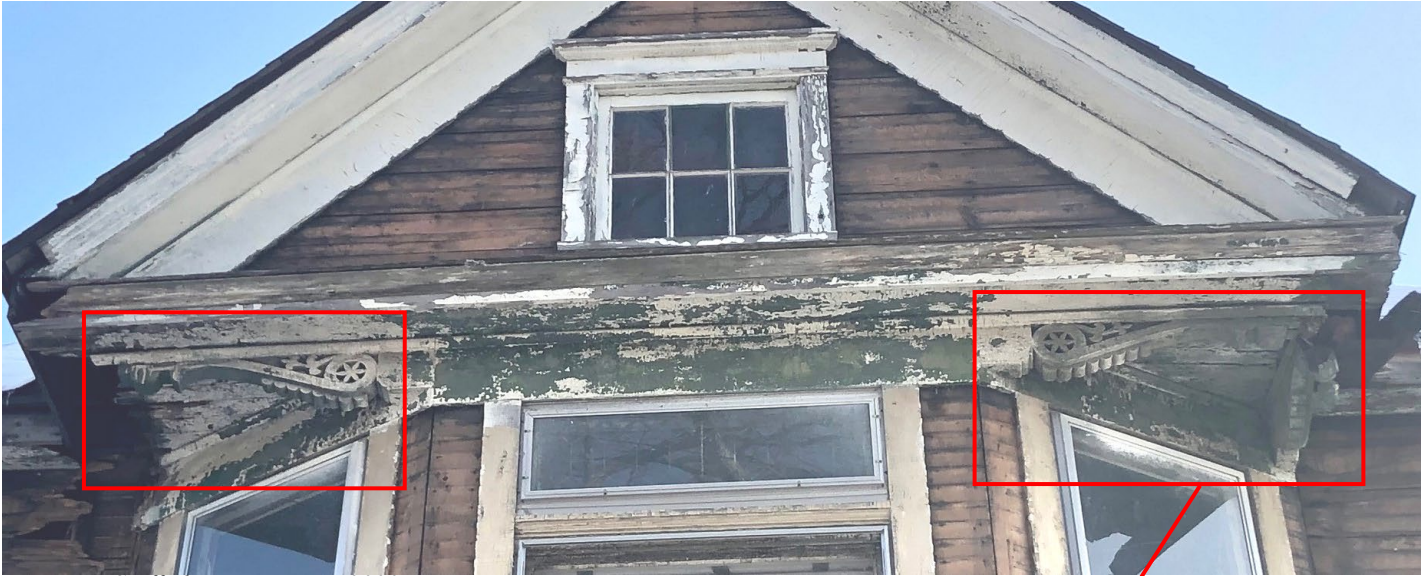
Staff photos, January 2023

- The existing loss of detail and character on the dwelling is substantial. The elevation drawings must confirm that removal of additional detail will not occur. The below pictures show ornament that remains in place below the front façade’s gable. One bracket is missing from the left side, but three remain intact. The decorative trim is unique to 7908-7912 St. Paul and is a distinctive character-defining feature. Depiction of these brackets, including the leaded glass windows in the central openings of the two-story bay window need to be added to the elevation drawing.
