**STAFF REPORT: NOVEMBER 8, 2023 MEETING**

**APPLICATION NUMBER: HDC2023-00082**

**ADDRESS: 1257 LONGFELLOW**

**SCOPE: REMOVE WOOD WINDOWS (WORK COMPLETED WITHOUT APPROVAL), INSTALL VINYL WINDOWS**

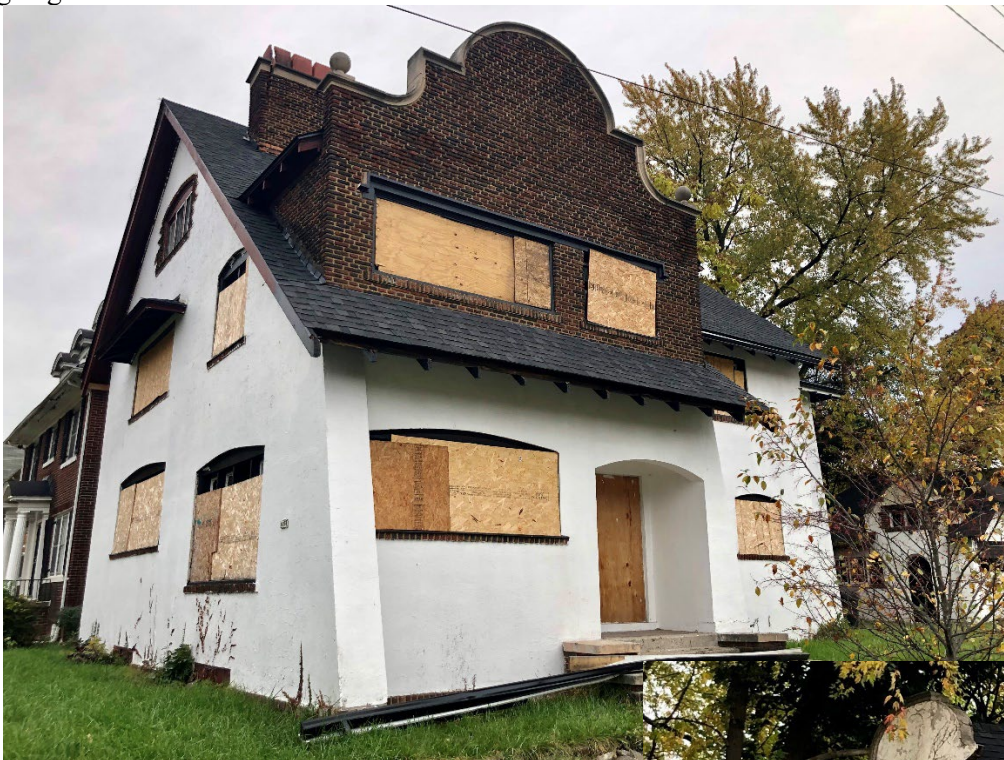
*HDC staff photos, October 25, 2023.*

The majority of the window openings on the house and garage are rectangular in shape, however many of the openings on the house have flat curved trim above the windows to create an arched appearance. Currently most of the window openings within the house are empty, however some historic windows remain in place on the north, west and south elevations. At the garage, three of the four casement windows remain in place; the remaining window openings are empty. Prior to removal, the window openings were comprised of mullied vertical, true-divided light wood casements of varying heights.

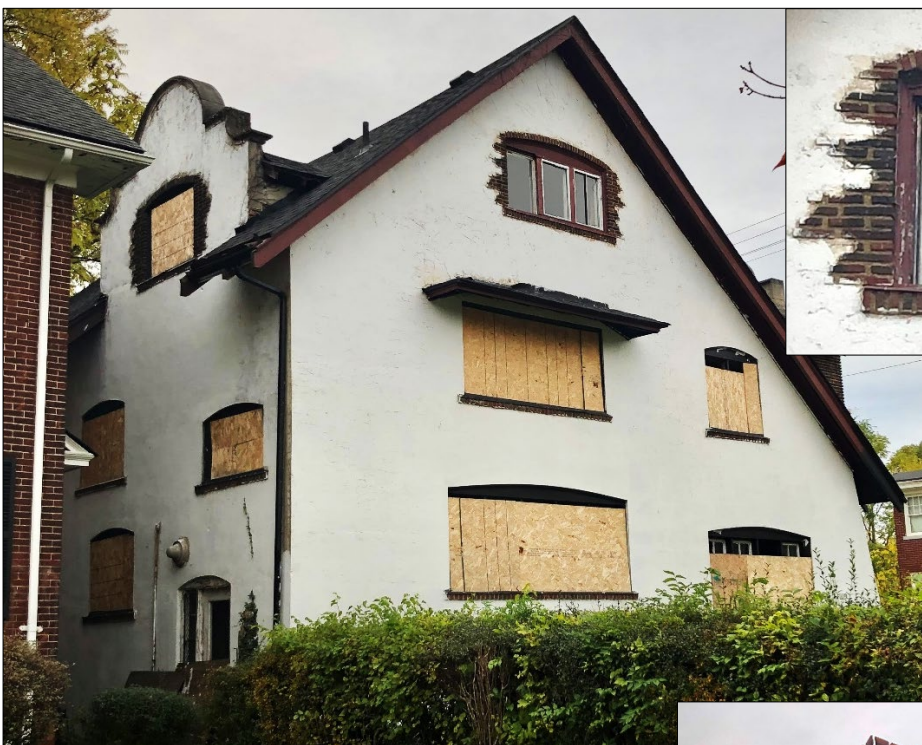
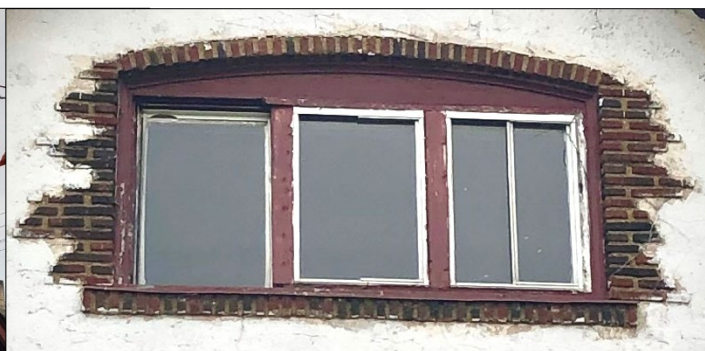
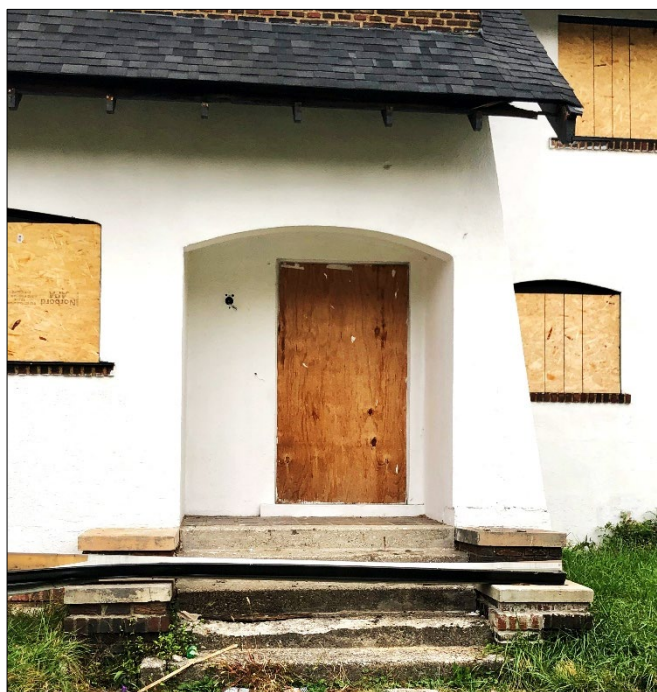
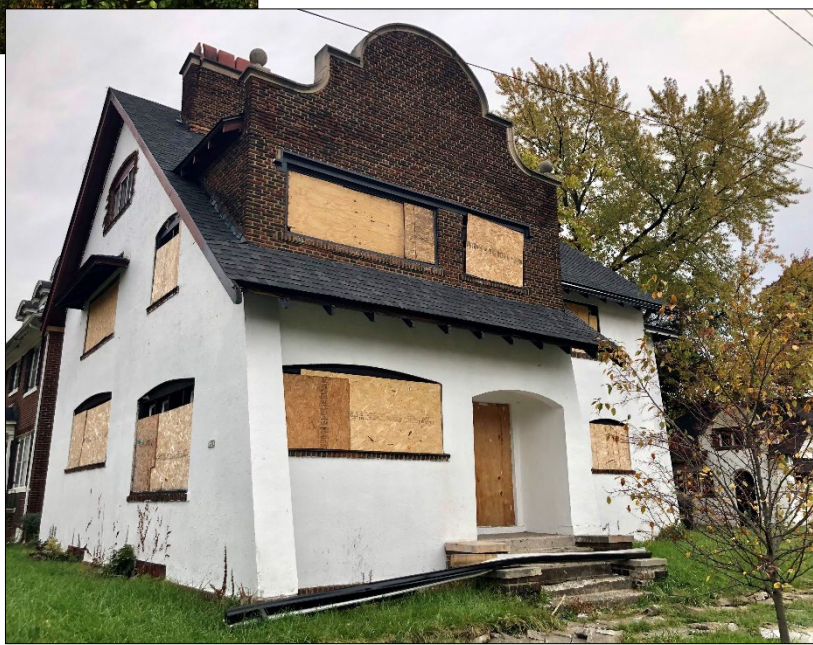
*Staff photos, October 25, 2023.*

*Above: brick detail at third floor (north and east) elevations.*

*Below right: Northwest corner, chimney in partial view.*

*Below left: Front entrance, arched opening to porch and exposed rafters visible.*

*Upper left: Dutch gable at east/side elevation, and similar arched opening at side entry.*

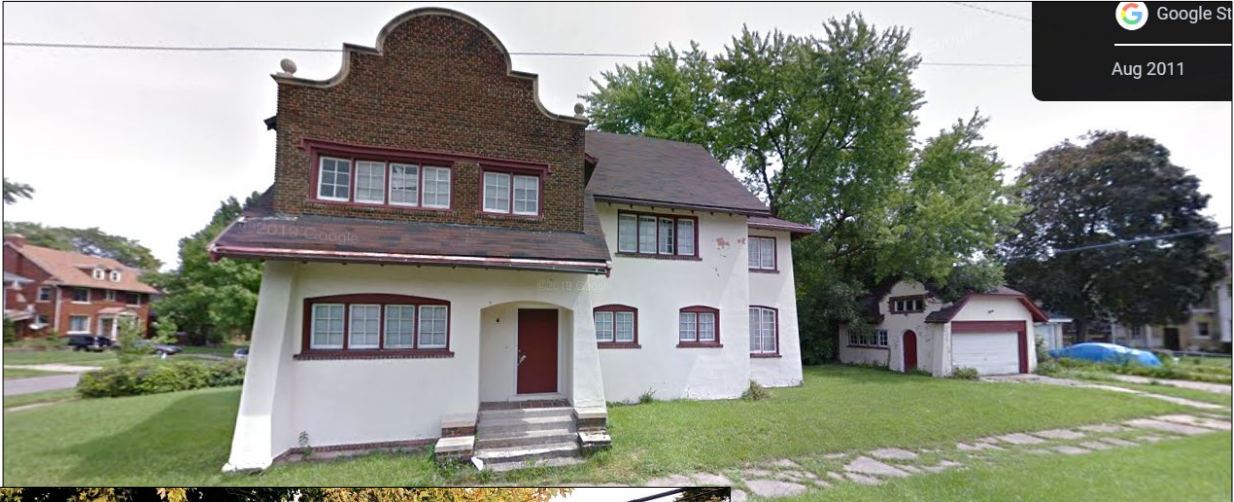
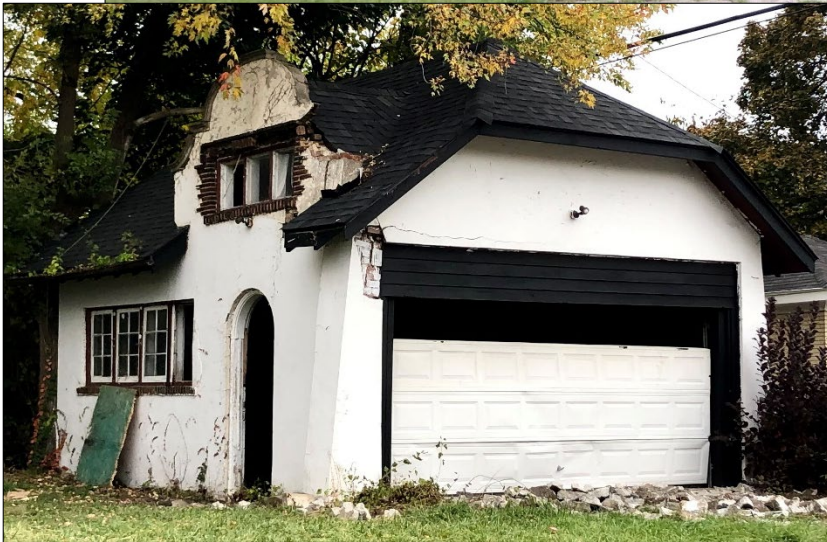
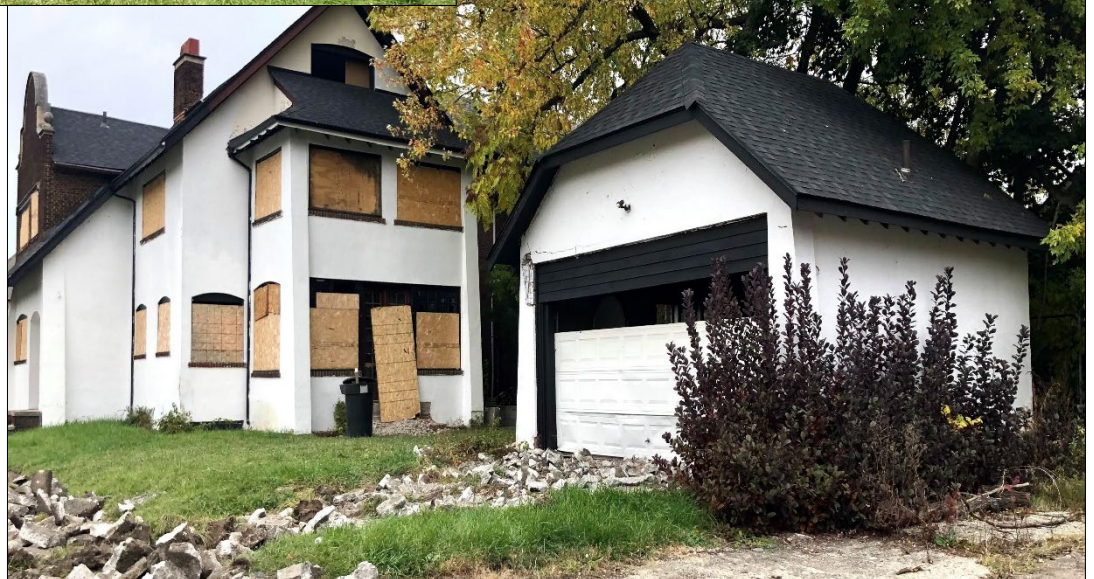
- The garage matches the house in design, materials, and patterning. Therefore, the structure has many distinctive character-defining features, including smooth stucco walls, Dutch gable, brick sills, arched door, mullied windows, jagged masonry surround for upper window opening, angled walls flanking the overhead door, rafter tails, and a clipped gable roof. The garage is an integral structure to the property and district.

*Above: Google street view, August 2011, shows the physical and architectural relationship between the dwelling and garage.*

*Left: Staff photo, October 2023.*

*Below: Staff photo, October 2023. Take from alley.*
