STAFF REPORT: DECEMBER 13, 2023 MEETING

APPLICATION NUMBER: HDC2023-00139

ADDRESS: 19245 PARKSIDE

SCOPE: REPLACE ORIGINAL WINDOWS WITH VINYL WINDOWS, REHABILITATE EXTERIOR (WORK COMPLETED WITHOUT APPROVAL)

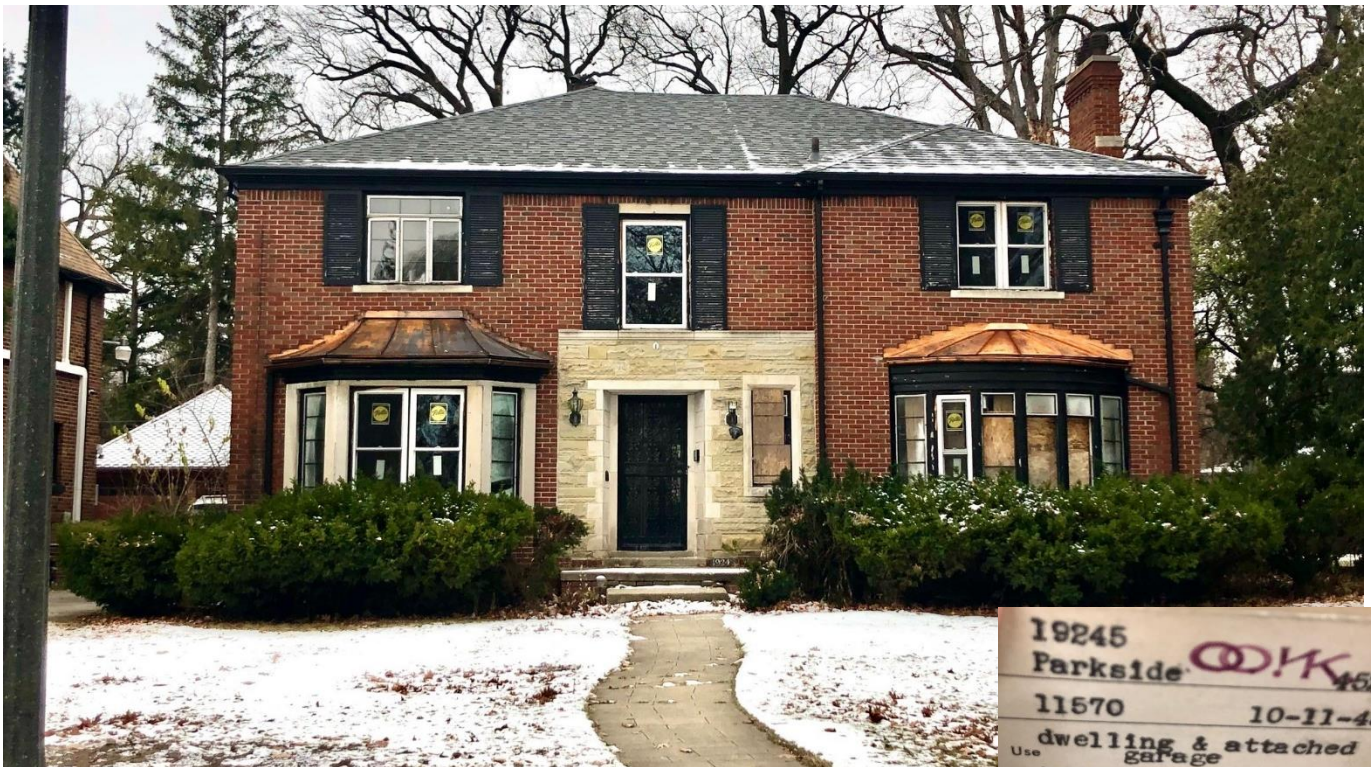
Staff photo, November 29, 2023.

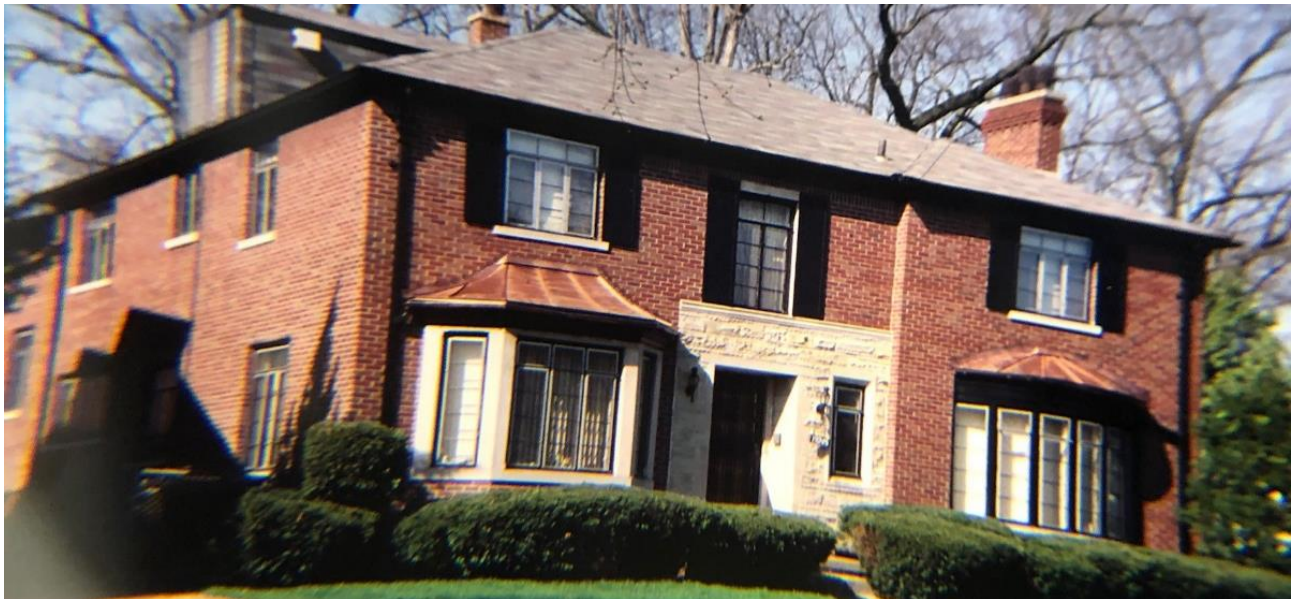
Designation photo, 2002. Historic Designation Advisory Board.

- It is staff's opinion the overall style of this house displays "Neo-Georgian Vernacular" forms and features, but the asymmetrical placement, lack of applied ornament, and use of vertical casement windows and multi-windowed openings, strongly roots this house as a midcentury design.
- The designation photo shows how each window unit, regardless of its vertical or horizontal orientation, creates a uniform horizontal, rectangular glass pattern.

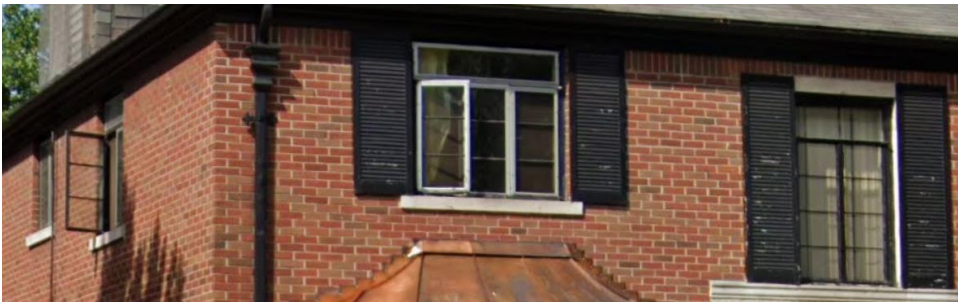
Google street view, July 2018.

- Individual aluminum storm sashes are affixed to the metal window sashes. This created an insulating air pocket between the two glass surfaces while allowing for operability of the casement units. The window opening over the front entrance did not have storm sash attached, so the thin metal frames are clearly visible.

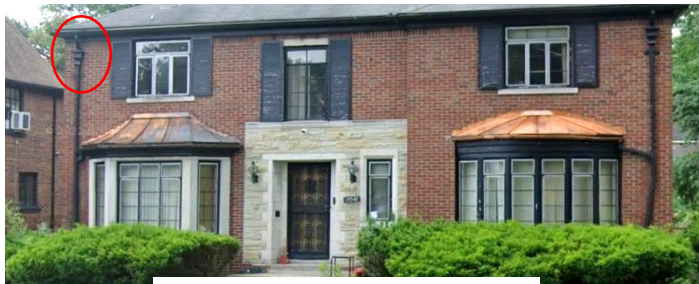
Google street view, June 2022.

- While writing the staff report, staff noticed that the collector box and downspout at the left/south end of the front elevation were removed between June 2022 and June 2023. *The collector box, and its accompanying downspout bracket, are a distinctive character-defining feature. Although small in size, when compared against the massing of the front façade, their profile and detailing are an impactful and interesting component to the otherwise utilitarian-designed downspout. The applicant stated in a 12/10 email that the collector box was damaged after a fire and removed, and there is no plan to repair or replace it.*

- BSEED’s electronic permit system, Accela, notes a fire insurance claim was made in the summer of 2022. Evidence of a fire is circled in the below photo. The south-facing dormer is gone, a small hole is in the front roof, and it appears one of the casement windows units at the south-side elevation was severely damaged.

- *The applicant stated the collector box was removed due to it being damaged by the fire. However, the below June 2022 post-fire Google street view images show the collector box and decorative downspout bracket intact. Standard Six states, “Deteriorated historic features shall be repaired rather than replaced. Where the severity of deterioration requires replacement of a distinctive feature, the new feature shall match the old in design, color, texture, and other visual qualities and, where possible, materials. Replacement of missing features shall be substantiated by documentary, physical, or pictorial evidence.” Even if the bracket and collector box were damaged beyond repair, Standard Six requires in-kind replacement of historic features.*

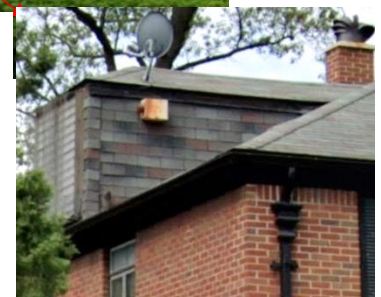
Right: Google street view, May 2019. This partial close-up view shows the previous condition of the dormer. It had been covered with asphalt shingles prior to the district’s designation.

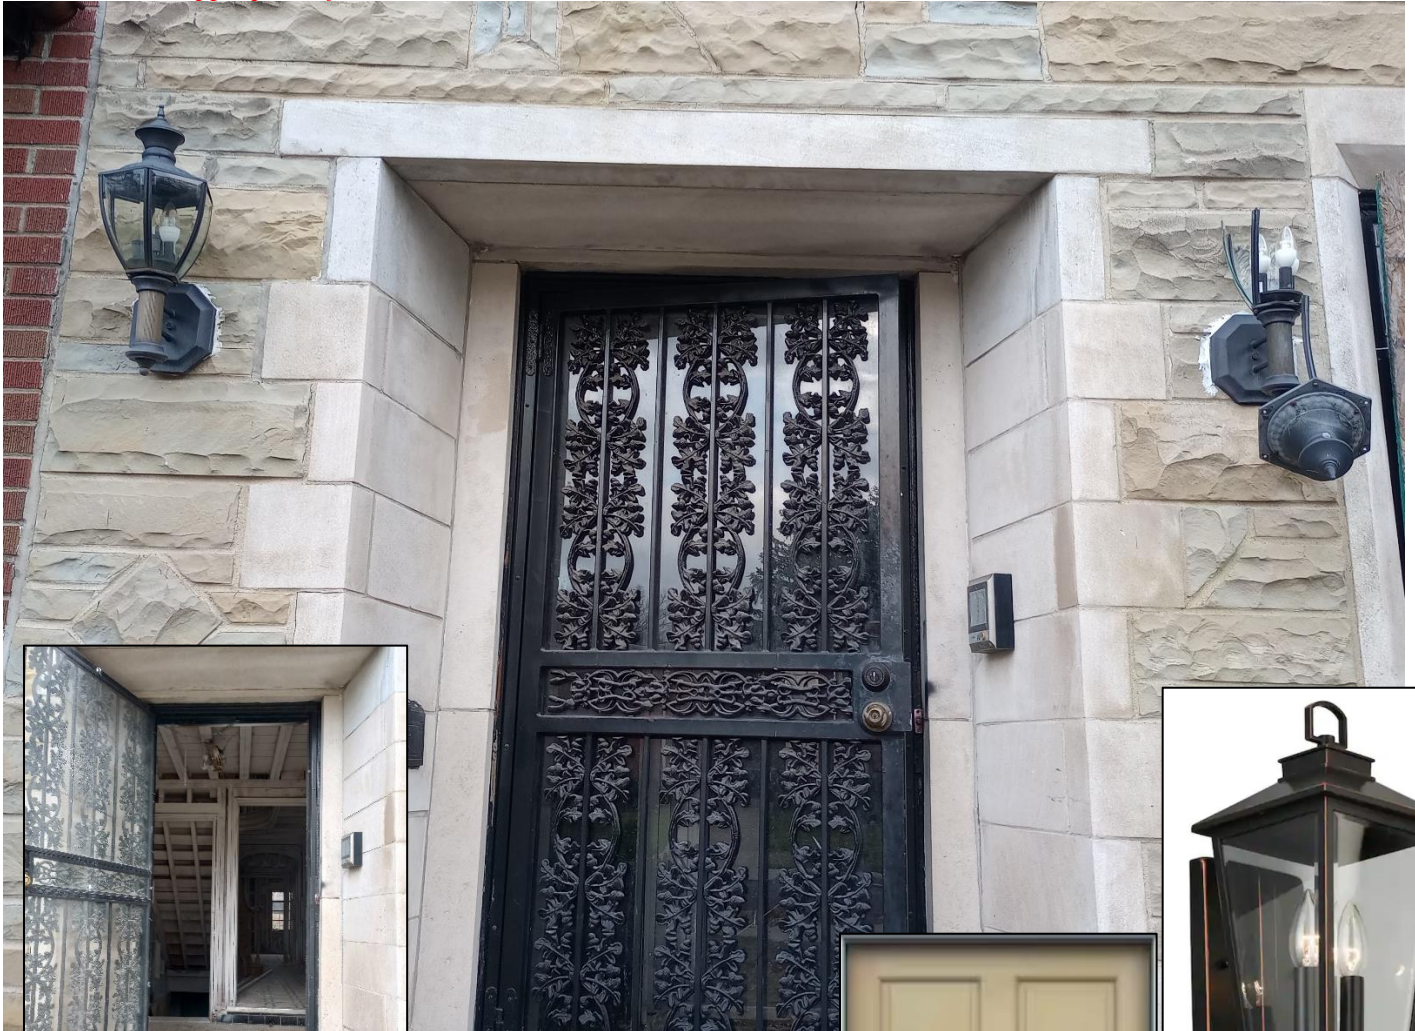
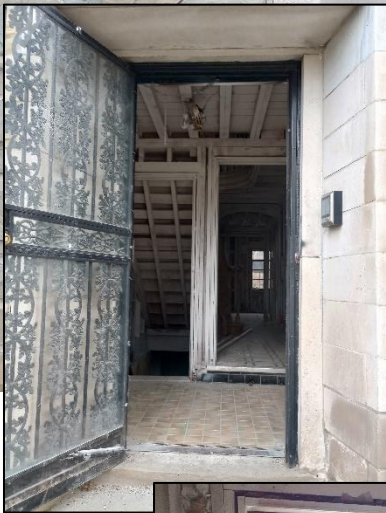
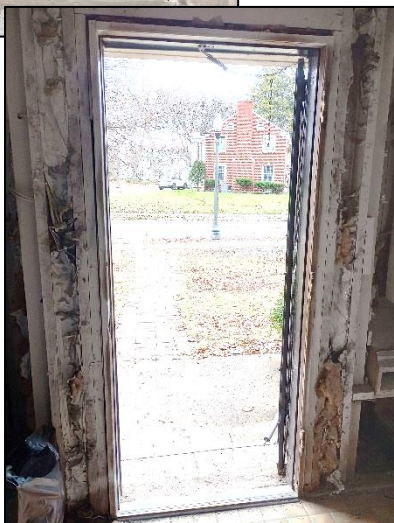
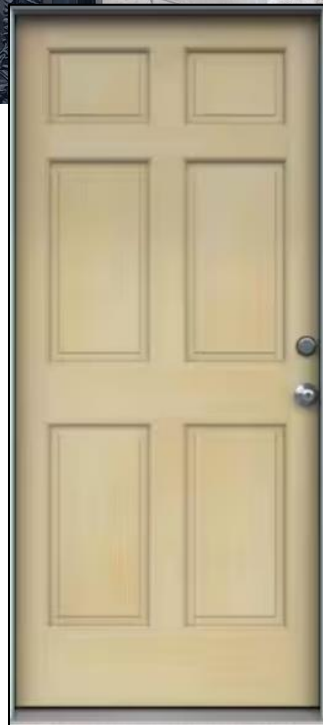
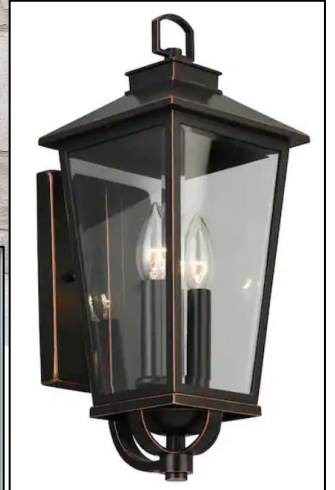
- *On 12/10, the applicant submitted photos of the front entrance and photos with the storm door open showing there is no front door in place.*
 - *The proposed door is minimal in design with vertical panels; it is not demonstrably inappropriate. Made of engineered wood, it can be stained or painted. The finish and color have not been confirmed.*
 - *The existing entrance light is complimentary to the house's design. It is staff's opinion that the fixtures are likely not original nor of historic age. The design of the proposed new light fixture is similarly appropriate for the house.*

Applicant photos and cut sheets.

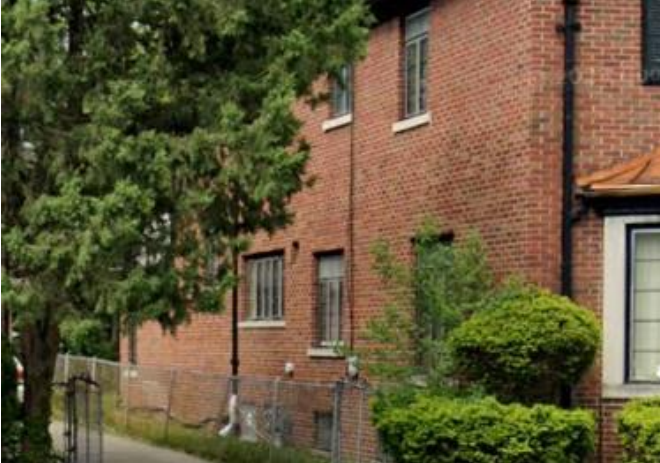
South-side elevation

Google street view, May 2019.

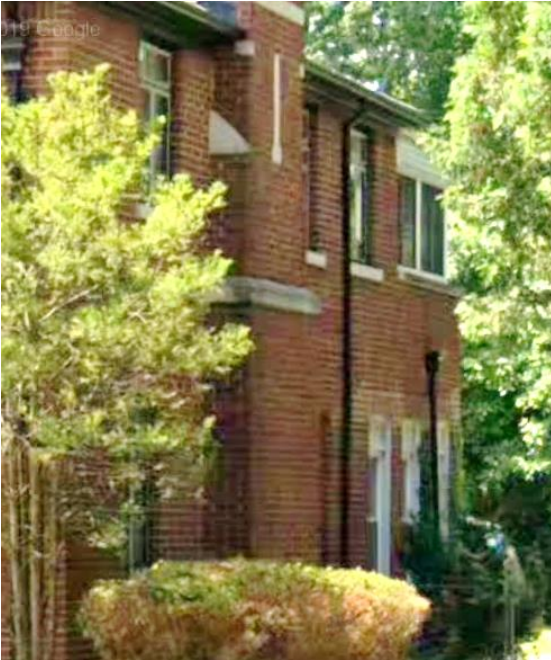
North-side elevation

Google street view, July 2018.
