STAFF REPORT: FEBRUARY 7, 2024 MEETING

APPLICATION NUMBER: HDC2024-00022

ADDRESS: 14500 ARTESIAN

SCOPE: DEMOLISH GARAGE, ERECT NEW GARAGE, REMOVE TREES AND ALTER LANDSCAPING, REPLACE FENCE, PAINT HOUSE

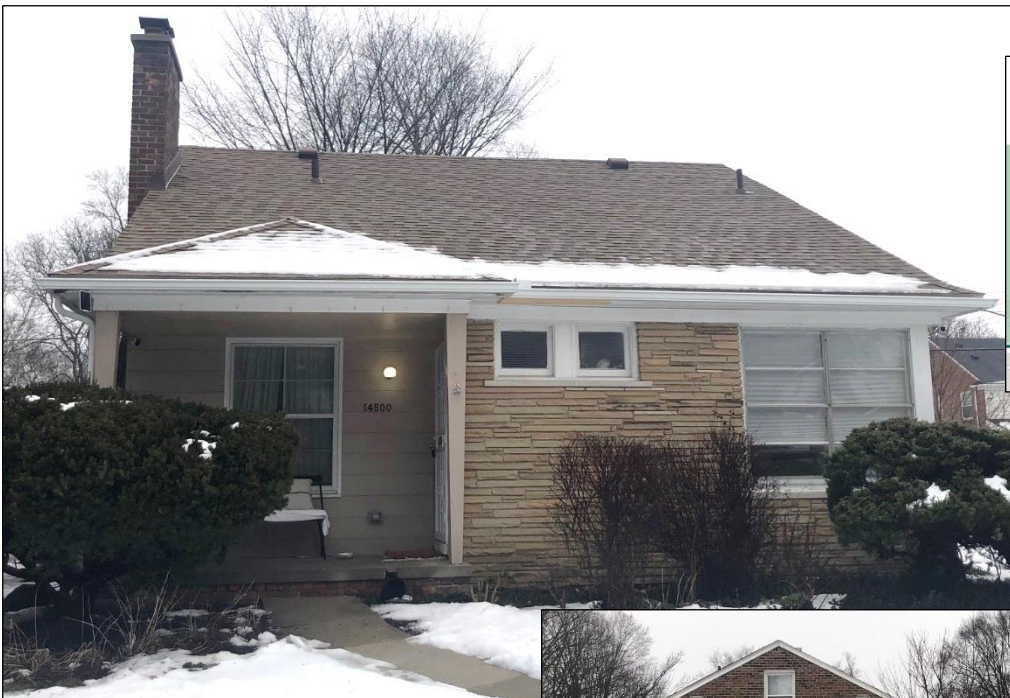
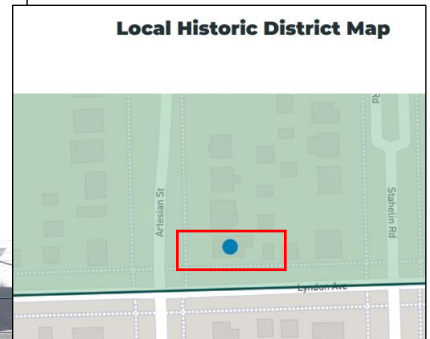
A raised four-season porch extends from the rear elevation, and a side entrance faces Lyndon. A 1-1/2 car garage is located at the southeast corner of the rear yard and is accessible from Lyndon. A chain link fence extends to the sidewalk from the southwest corner of the garage and southeast corner of the house and encloses the rear yard from the public walk.

Staff photos, January 25, 2024. HDC map showing southern boundary of Rosedale Park Historic district.

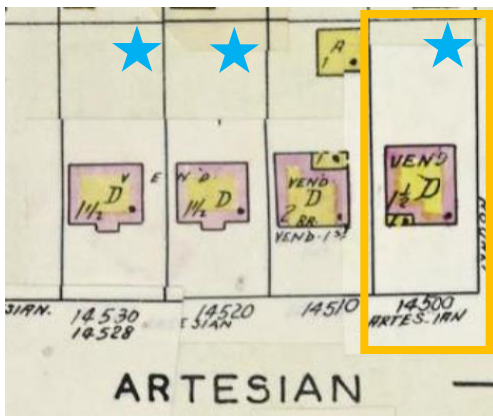
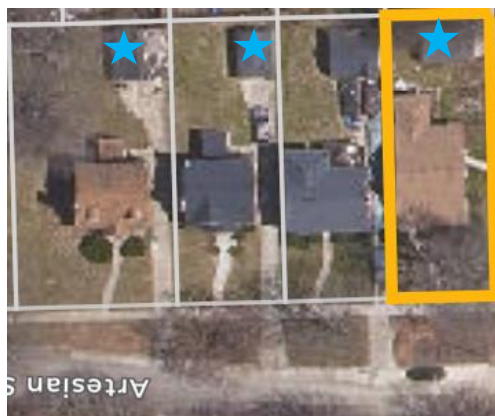
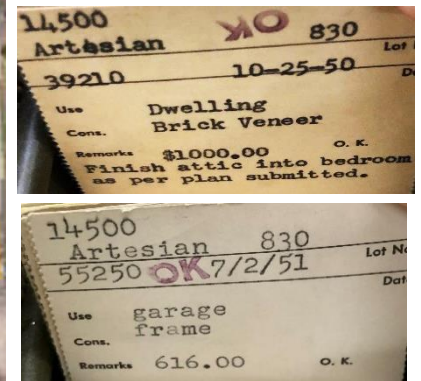
1938-1950 Sanborn map.

Aerial view, Detroit Parcel Viewer

Building Permit Cards, BSEED.

15123 Artesian is identified with the orange box. The blue stars show that only one of the four houses on this part of Artesian had a garage prior to 1950.

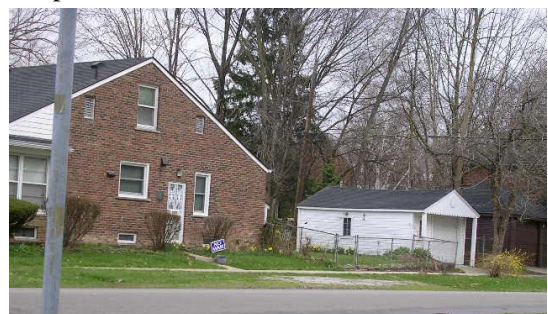
Staff photo.

- Using the recently issued (January 2023) National Park Service document [Evaluating Garages and Outbuildings in Historic Districts](#) as a guide, the freestanding garage at 14500 Artesian retains much of its physical and architectural integrity. The garage is intact and retains the original exterior wall materials, ornamental detailing, window opening and sash, and a single garage door opening (although the door itself is not original).

- The extended, angled trim at the window headers, Dutch lap siding, and front-facing asymmetrical door/window placement add dimensionality and clean-lined profiles to each elevation.

- The roof extension with supporting posts and fenestration of the front gable reflects a mid-century architectural styling that is residential in design (i.e., the extended roof and columns create a front porch-like element, and the scalloped edge is similar to trim often used above window openings in kitchens). It is staff’s opinion that these details “softened” the appearance of the garage within the residential district.

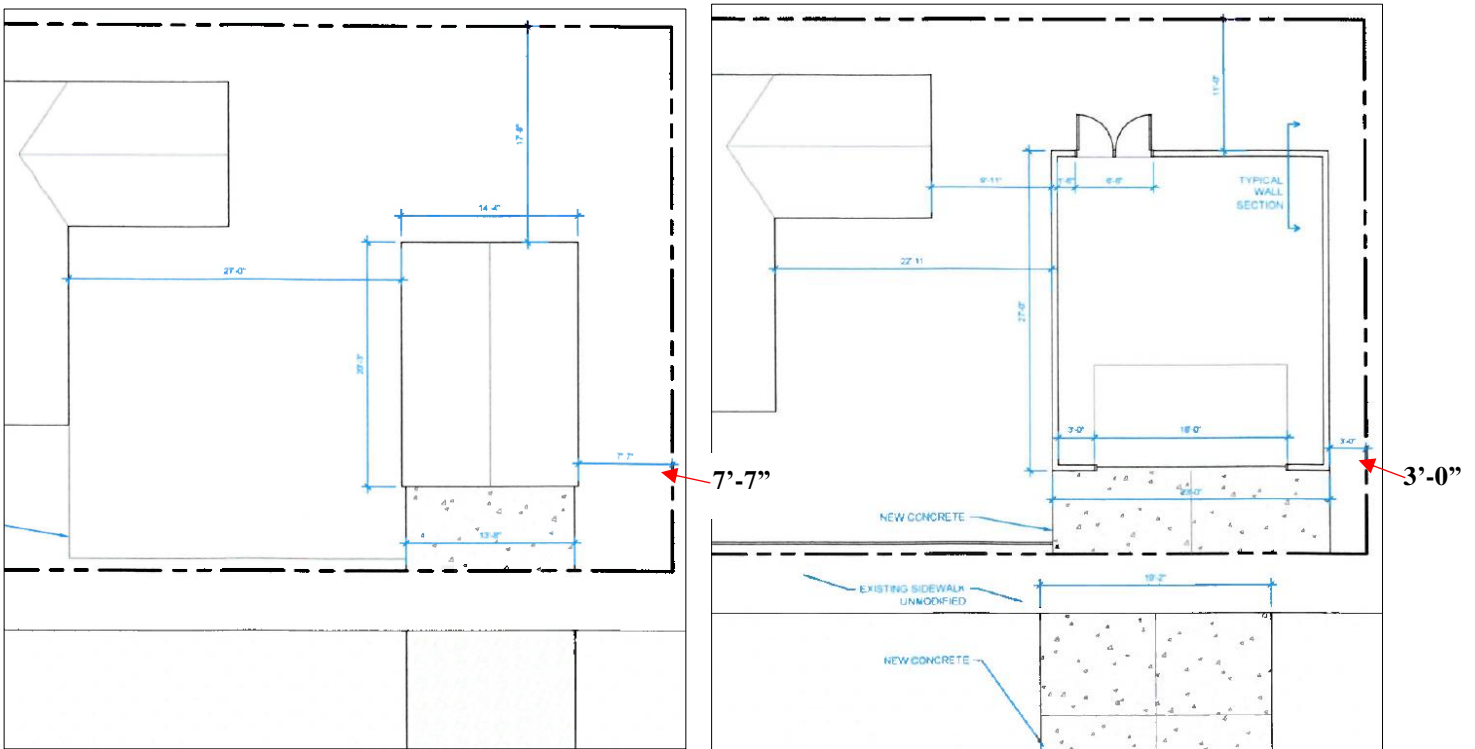
Applicant site plans. Left is existing; right is proposed.

- According to the site plans, the width of the new garage will be 8’-4” wider than existing (14’-4” existing - compared to 23’ proposed) and 6’-9” deeper (20’-3” existing – compared to 27’ proposed).

- The existing site plan states that there is a distance of 7’-7” to the property line, which would be reduced to 3’-0” with the new garage. However, as the photo shows on the following page, it appears as though there is about seven feet between the garages, not seven feet to the applicant’s property line.

- Staff isn’t clear on why the concrete drive between the sidewalk and street doesn’t line up with the wider concrete pad proposed at the garage itself.

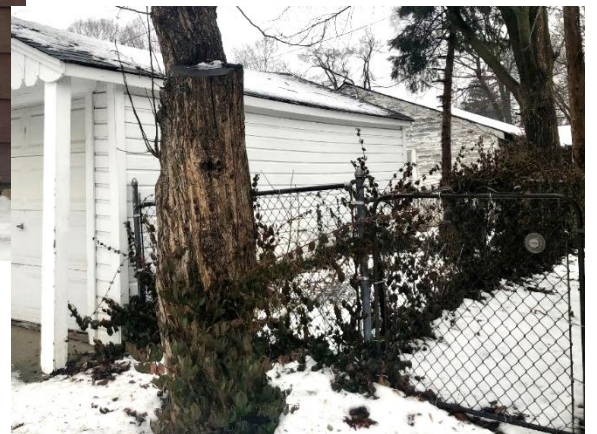
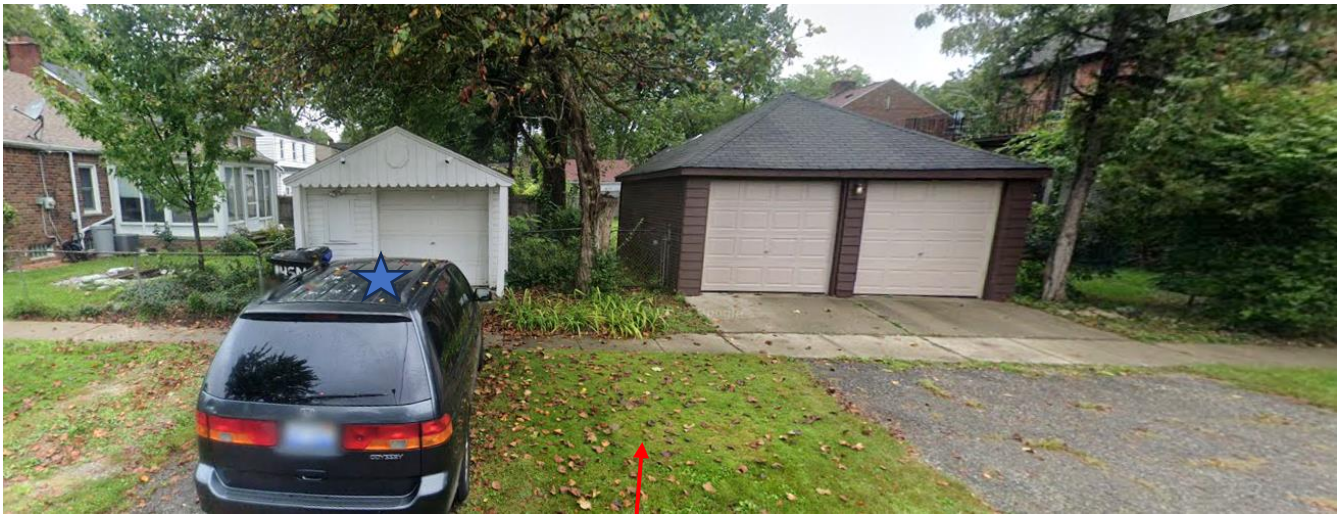
Existing conditions at adjacent front-facing garages. 14500 Artesian is identified by a star.

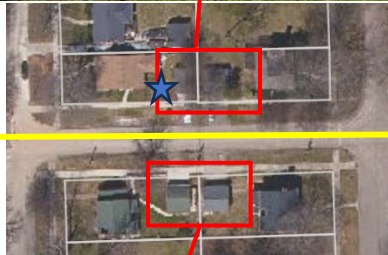
Google street view photos, Sept. 2023. Detroit Parcel View aerial photo. The yellow line denotes historic district boundary.

These houses are on the south side of

Lyndon and are not in the historic district.

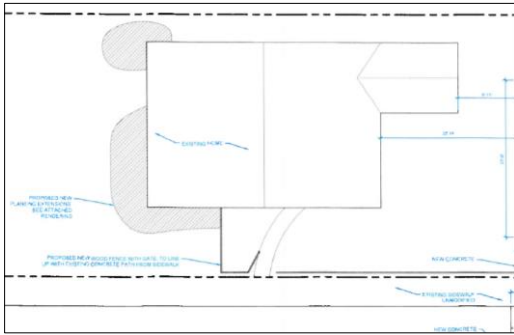
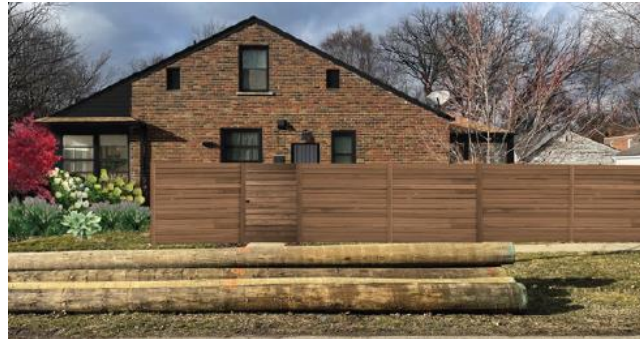
Applicant documents

The applicant should submit confirmation that the rear of each panel has an intermediary vertical support. A solid/opaque stain must be used, and a color sample of the “medium” brown must be submitted for staff review.

- One tree will be planted on the property to replace the formerly substantial shade tree located adjacent to the rear yard sidewalk and garage. The location and tree species will be submitted for staff review.
- A revised landscape plan will be submitted for staff review.
- Confirmation of the physical support for the fence, along with a color sample and specification for the opaque fence stain, will be submitted for staff review.
