**STAFF REPORT: FEBRUARY 7, 2024 MEETING**

**APPLICATION NUMBER: HDC2024-00064**

**ADDRESS: 640 W. WILLIS, AKA "WEST WILL"**

**SCOPE: REPLACE WINDOWS**

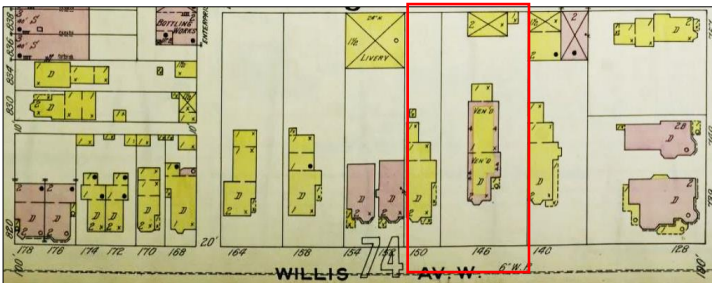
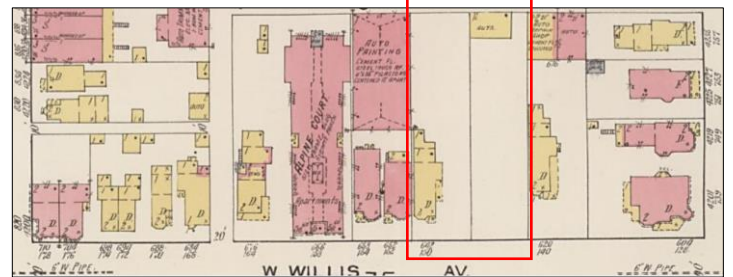
1921 map shows a still dominantly residential street. However, a large apartment building and an auto painting building have taken the place of one dwelling and the livery, outbuildings are now identified for autos, and one empty lot (outside of the remaining auto garage) is now present.

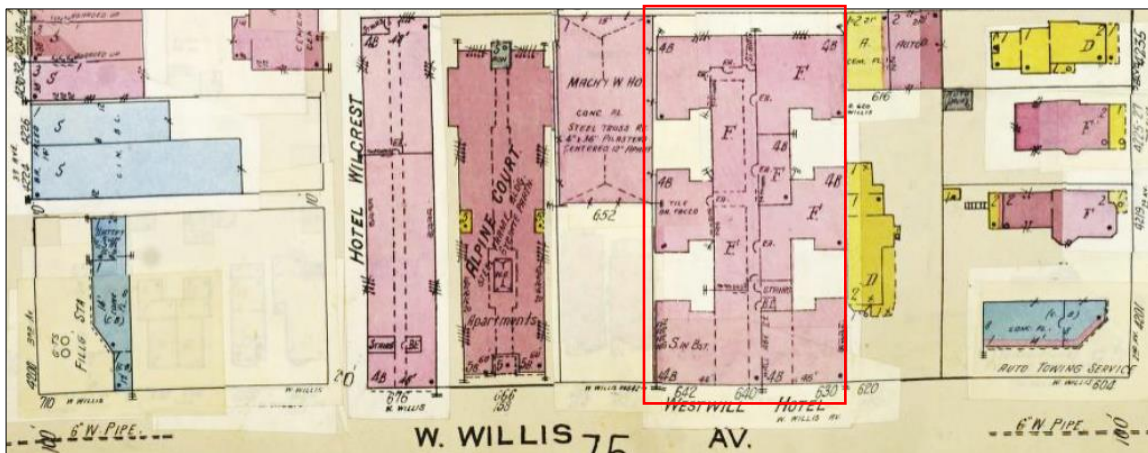
1950 map shows there was a tremendous physical and usage change on this block since 1921. Only one 19<sup>th</sup> century dwelling remains, two “newer” large buildings, identified here as hotels – and one being 640 W. Willis, coupled with the existing “Alpine Court” and a “machinery warehouse” dominate the street, and a number of empty lots are now near Third.

The houses that were immediately to the west of 640 were demolished in the 1930s. The remaining dwelling at 620 W. Willis held on a few more years; the garage was demolished in 1959 and the dwelling demolished in 1960.

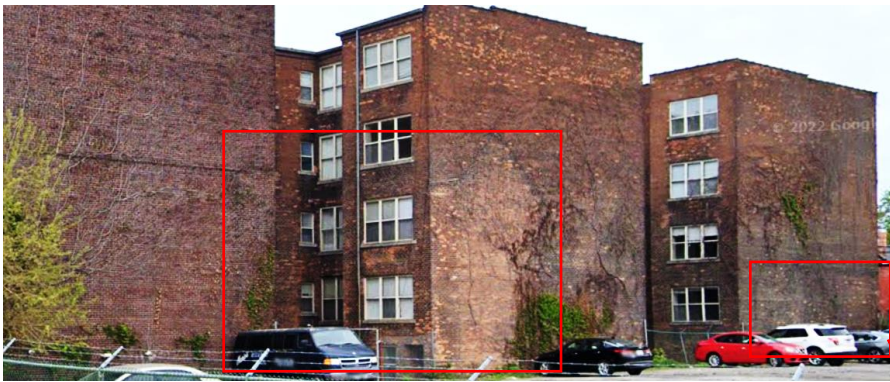
Google street view, May 2019.

As noted in the previous map, the garage and house immediately to the right/east (620) was demolished in 1959 and 1960, respectively. Ghost lines remain visible in the walls of 640 W. Willis.
