STAFF REPORT: MAY 10, 2024 MEETING
APPLICATION NUMBER: HDC2024-00170
ADDRESS: 4428 SECOND AVENUE

HISTORIC DISTRICT: WILLIS SELDEN LOCAL
APPLICANT: MARC GRASSI, PUSH DESIGN
PROPERTY OWNER: SCOTT LOWELL, LOWELL CONSTRUCTION MANAGEMENT
DATE OF PROVISIONALLY COMPLETE APPLICATION: APRIL 15, 2024
DATE OF STAFF SITE VISIT: APRIL 19, 2024

SCOPE: REPLACE WINDOWS, INSTALL FIBER CEMENT SIDING AT REAR

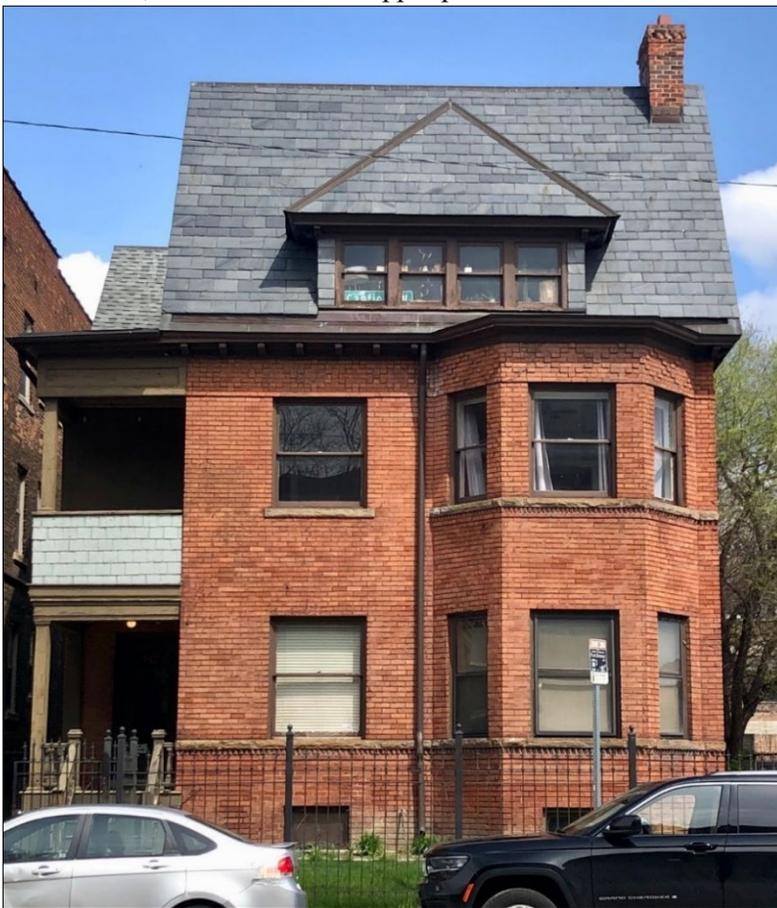
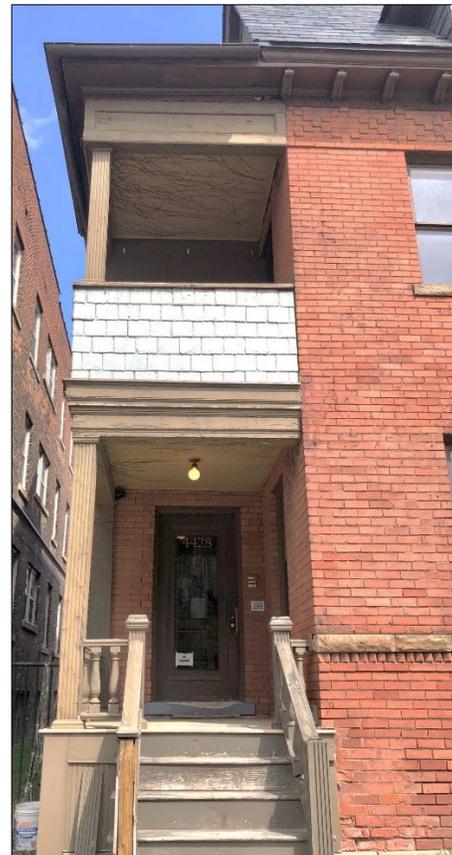
Façade, west-facing wall. Staff photo, April 19, 2024.

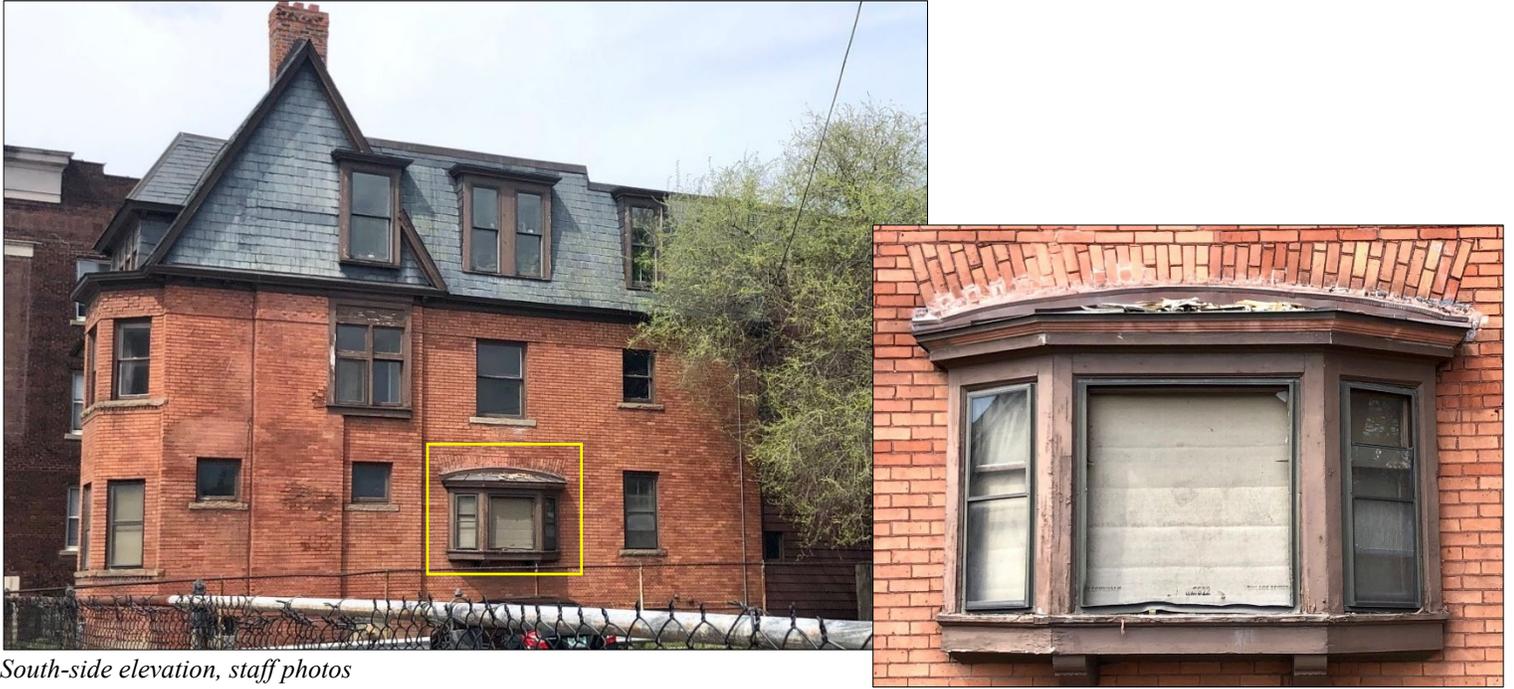
The south-side wall has window openings and masonry details similar to the façade. The steep roof line of the back side of the gable intersects a steeply pitched mansard roof which extends the depth of the building. An oriel window is centrally located at the first floor. The window is covered by a rounded metal standing seam roof, and two small decorative brackets are below the window.

South-side elevation, staff photos

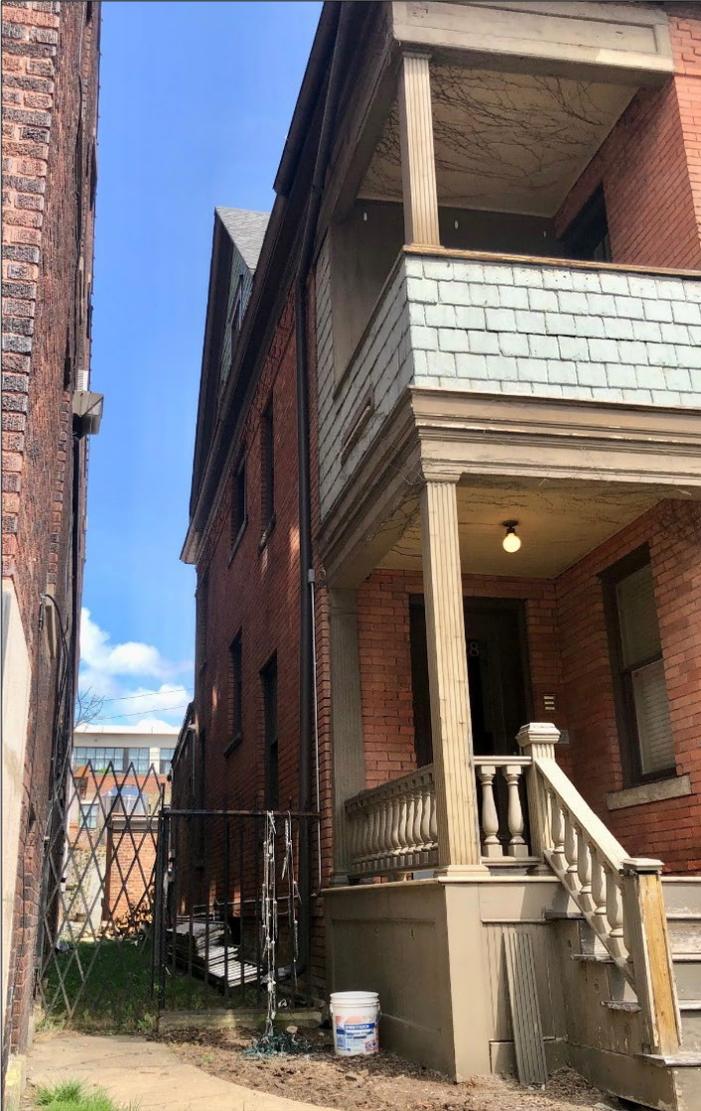
North-side elevation, staff photo.

The north-side wall and windows sills are minimally visible, and the windows are not visible.

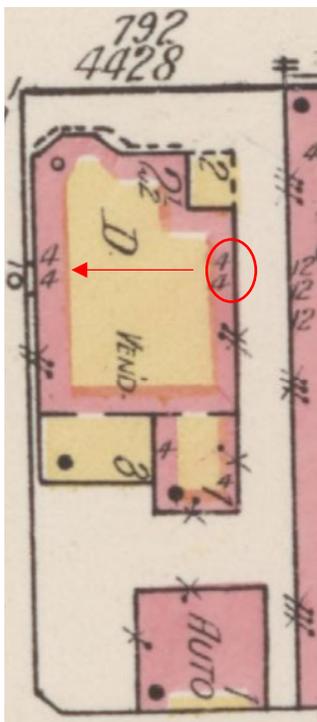
1921 Sanborn map

- Comparison of the 1897 and 1921 Sanborn maps illustrates what the 1913 permit card briefly explains, the structure was remodeled for use as a 3-unit dwelling. The roofing material changed (open circle means metal/slate/tile, closed circle means composite), the footprint of the structure was enlarged, the structure was veneered in brick (the “4” indicates the thickness of the first and second floor walls), at the front elevation a bay window and a wood-framed two-story open porch were added, at the side elevation an oriel window was added, and at the rear elevation a covered (with composite roof) wood-framed three-story porch was added. Staff also located two permits issued in 1920 - one for the one-story brick extension at the back of the building, and one for the one-story brick garage; both of which were covered with composite roofs and remain in situ.

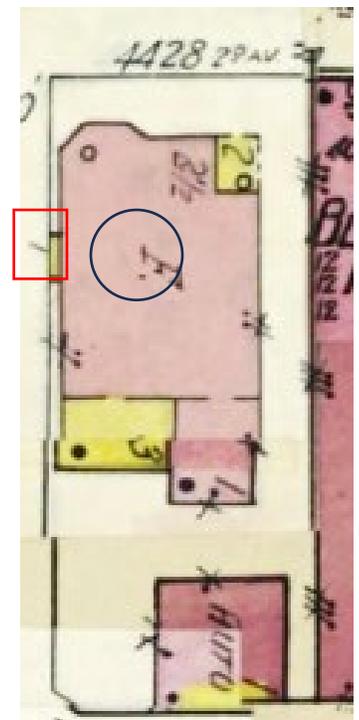
- The 1950 Sanborn map identifies the structure as a flat “F”, rather than dwelling “D”. The oriel window at the south wall is more visibly identified – the number “1” states the window is at the first floor. The previously front porch is now covered with a metal roof.

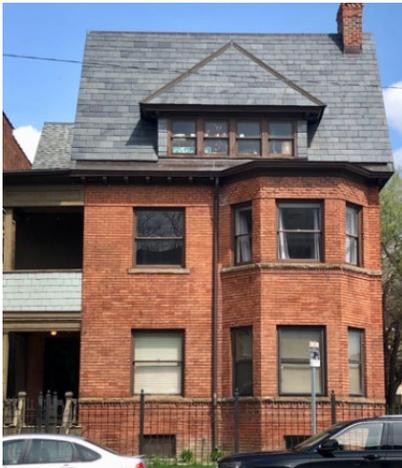
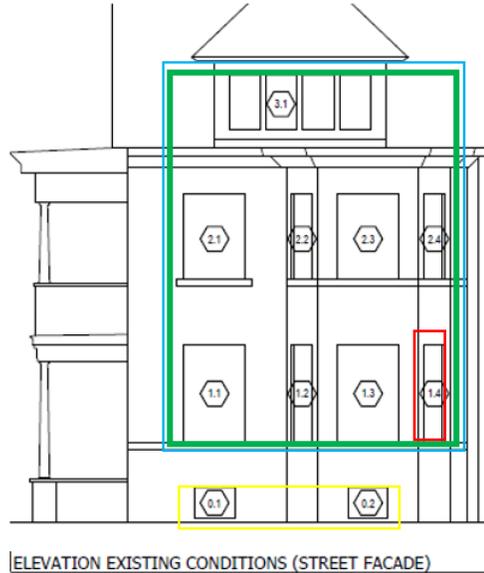
ELEVATION EXISTING CONDITIONS (STREET FACADE) ...

Staff determines the windows on the facade to be character-defining features and appear to be repairable. Notable exception is window 1.4 – staff recommends a new wood window be built for this opening.
