Front/West Wall

Elevations with window numbers, interior photos and close-up exterior photos provided by applicant. Windows in yellow indicate applicant will retain them.

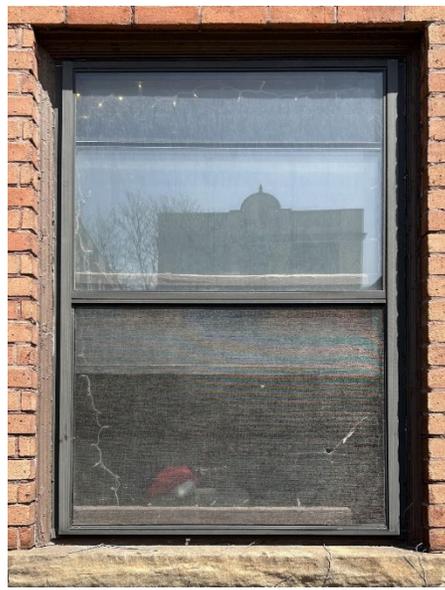
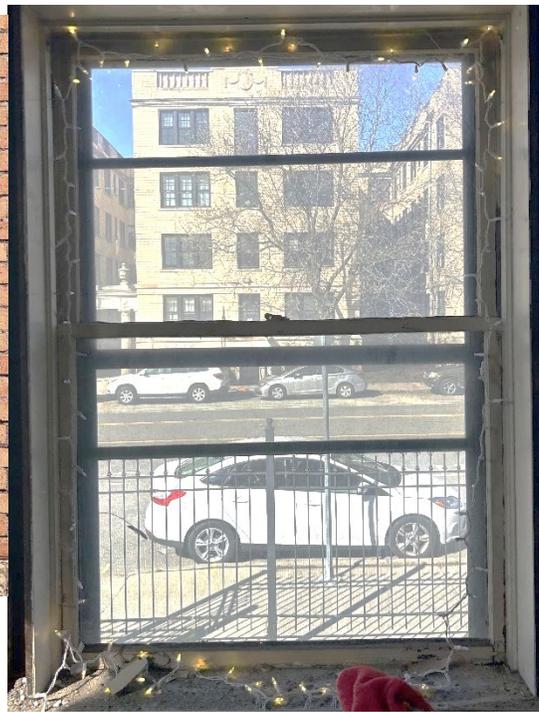
1.3

Central (1.3) and south-side windows (1.4) in first floor bay window.

Applicant requests they be replaced. Staff recommends #1.3 be retained and #1.4 be replaced with custom-fabricated wood window.

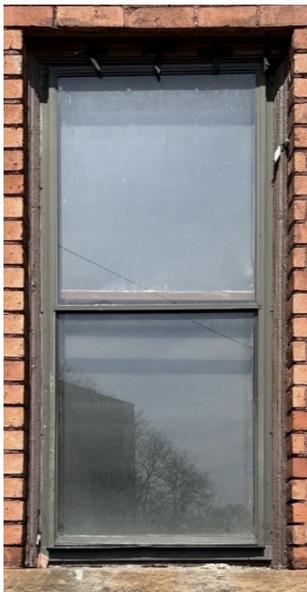
1.4

The above image shows an a/c unit installed, which was in place a minimum of six years. But due to time gaps in Google photos, it could have been in place longer. The exposure to the elements from the open window and a/c unit may be the main factor why this window sash is significantly more deteriorated than the other two bay window units.

It is staff's opinion this window may be deteriorated to the level of replacement. However, a new wood double-hung window, matching the sash dimensions and profile (and all other details) should be fabricated. This window opening is one part of the two-story bay window; a standard replacement window within this composition would stand out too strongly and would alter this distinguished character-defining feature on the façade.

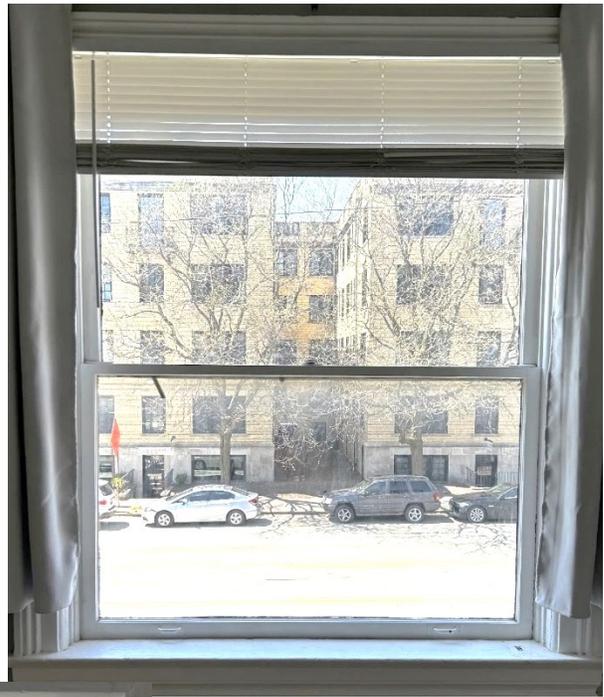
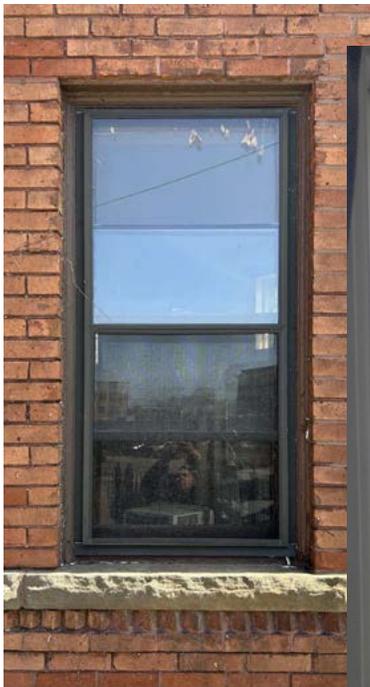
Windows 2.1 and 2.2–
 Front-facing single opening window at second floor.
 North-side window of second floor bay window.
 Applicant requests both windows be replaced.
 Staff recommends they be retained and repaired.

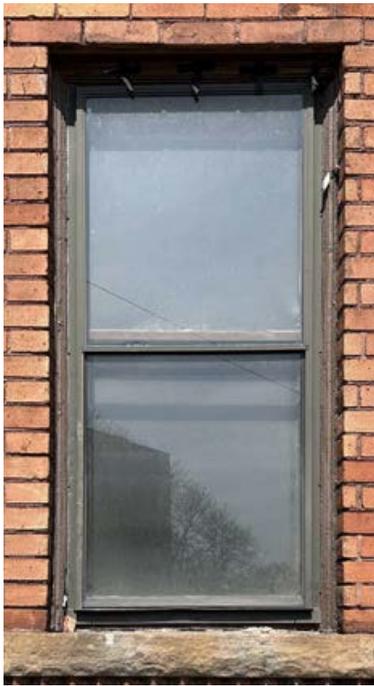
Windows 2.3 and 2.4 –
Center window and south-side
window of second floor bay
window.
Applicant requests they be
replaced.
Staff recommends they be
retained and repaired.

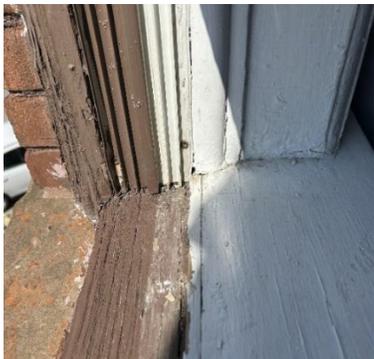
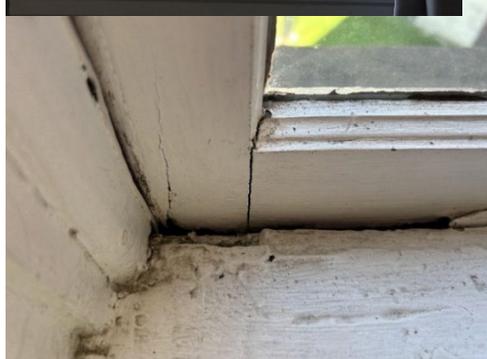
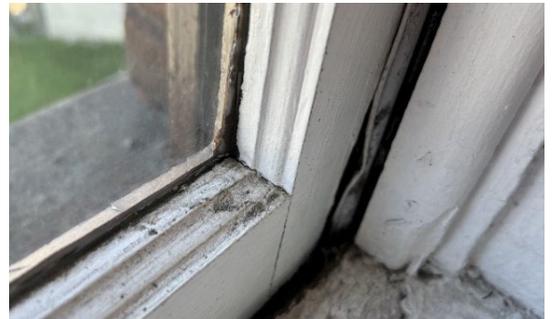
Window 3.1 –
Mulled windows in façade dormer.
Applicant requests they be replaced. Staff recommends they be retained and repaired.

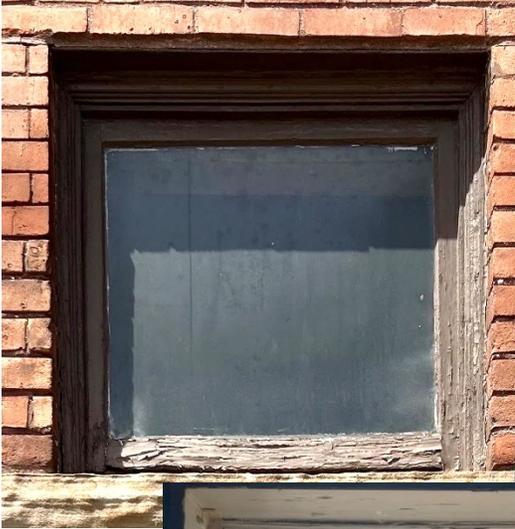
Windows 1.5 and 1.6 –
Small windows flanking chimney.
Applicant requests they be replaced.
Staff recommends they be retained and repaired.
Additional analysis by owner of conditions of window openings can be helpful to fully assess condition.

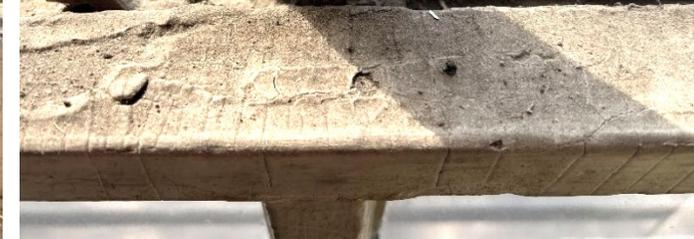
1.8_dtl1

Window 1.8 – Different design that the remaining windows at the first and second floor, the 2-over-2 double-hung (which at first appears to be 4-over-4 due to the interior moveable bottom storm window that is partially open) is also found in the same location on the north wall, as well as one window on the east wall.

This window pattern was popular from the mid-1850s to the beginning of the 20th century. It is possible, but can't be proven, that this window sash was from the original (pre-1897) dwelling and wasn't replaced in the 1913 remodeling.

Regardless, it is a window of historic age, and not a total outlier as there are two other identical windows in similar locations. The window is intact and appears to be in repairable condition.

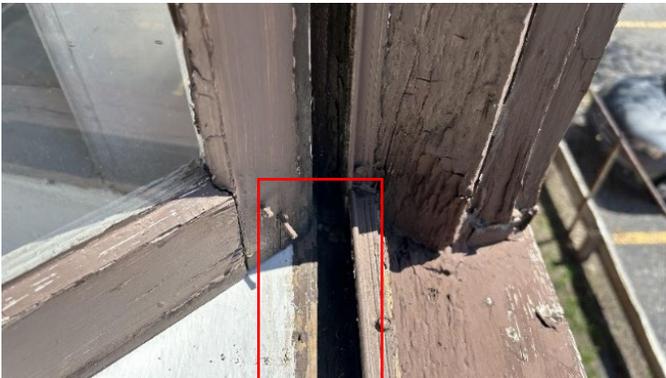
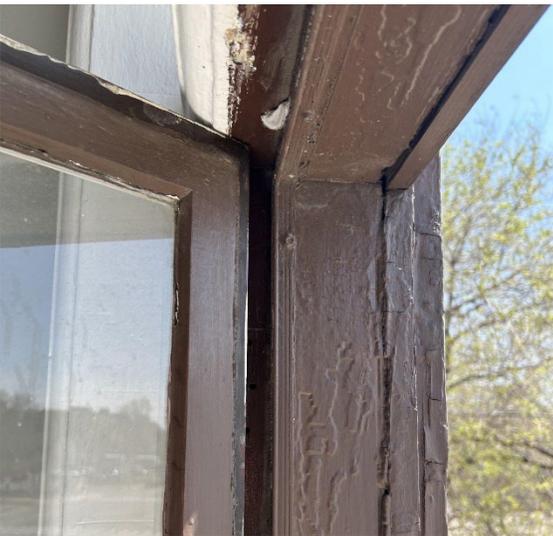
Windows 2.5
 The applicant requests these units be replaced. Staff recommends they be retained and repaired
 Staff isn't clear as to what appears to be open space between the interior wall of the house and outer window frame (bottom left photo), but inserting a replacement window would not fix this issue.

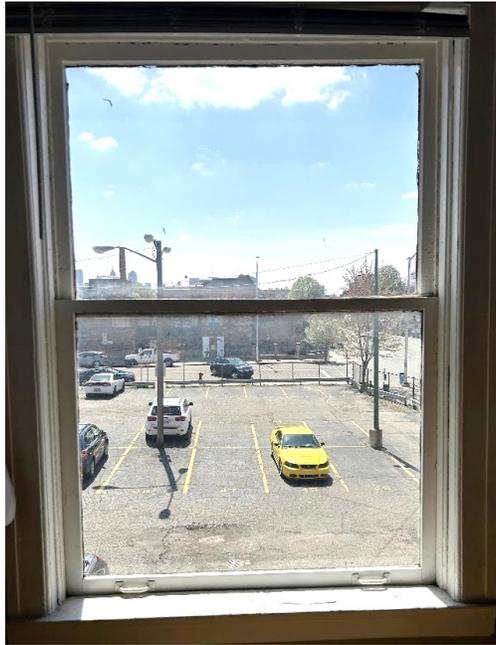
Window 2.6

Applicant requests it be replaced. Staff recommends it be retained and repaired.

This window appears to be a newer window (there is no open area on side of window frame for a sash cord), but the frame dimensions visually appear to be similar to the older double-hung windows.

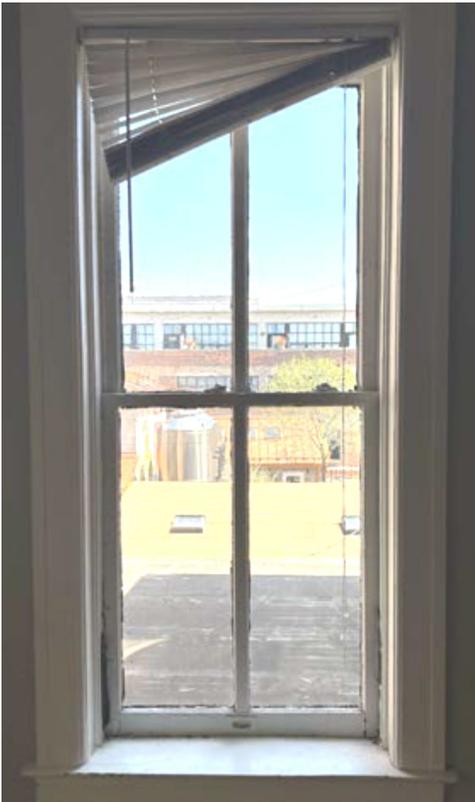
Window 2.11
 As discussed under Window 1.8, this is one of three historic age 2-over-2 double-hung windows within the house.
 Applicant requests replacement; staff recommends repair.

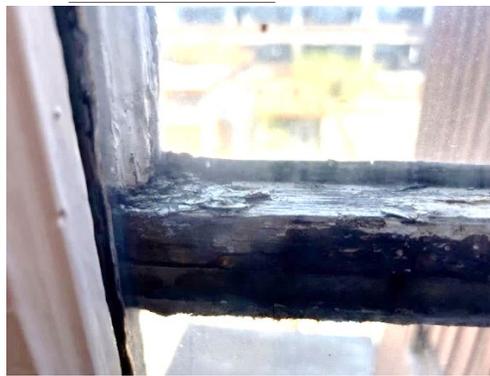
Similar to the façade window 1.4, window 3.7 suffers from additional deterioration due to long term exposure caused by a window a/c unit (although additional photos could help the assessment). The adjacent window, 3.8, appears to be in repairable condition.

However, as the windows are adjacent each other, it's staff's opinion they should be considered with the same action-repair or replacement. As these openings are on the rear elevation and recessed behind the three-story addition; they are not publicly visible.

The dimensions of the proposed windows are close to the historic units. And at the recessed second floor location, staff doesn't believe the replacement units will be noticeable, won't alter the historic features of the property and believes the replacement meets the National Park Service guidelines document [Replacement Windows that meet the Standards](#).

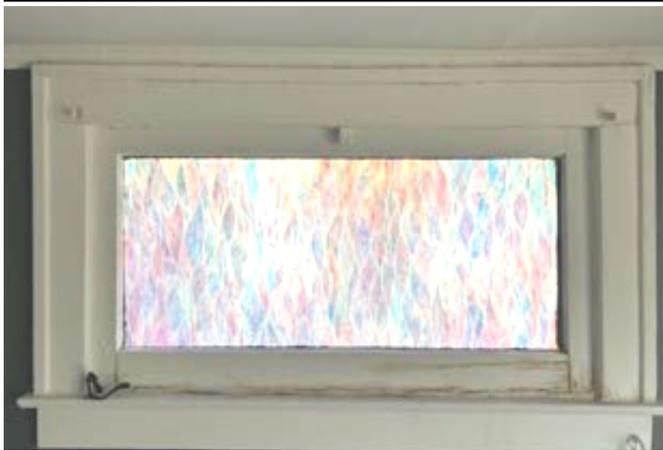
Applicant requests to replace 2.12 (on north wall of enclosed rear three-story porch).

These windows are not visible from any public view. Both windows appear to be repairable, therefore, staff determines that the replacement proposal doesn't meet Secretary of the Interior Standard 6.

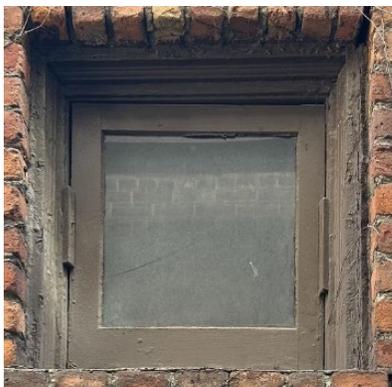
1.14

Applicant requests to replace 1.14.

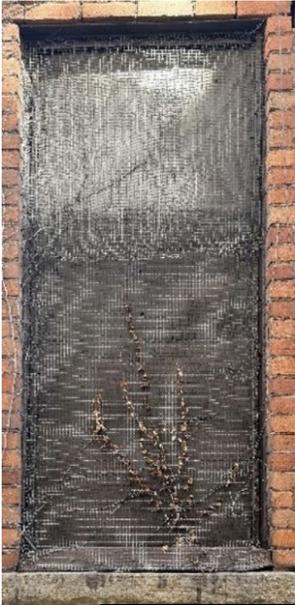
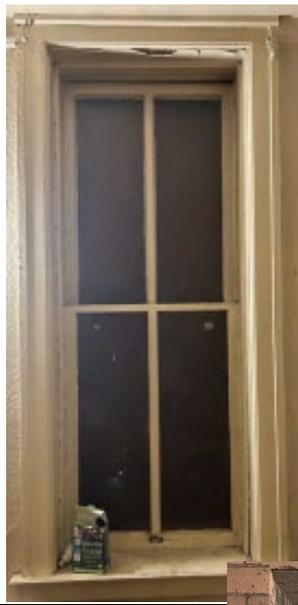
1.18

The applicant requests to replace remaining north elevation windows (shown on this and following pages).

It is staff's opinion that they all appear to be in good condition (likely due to their limited exposure) and can be repaired.
