STAFF REPORT: MAY 8, 2024, REGULAR MEETING
APPLICATION NUMBER: HDC2024-00079
ADDRESS: 3844 BAGLEY
HISTORIC DISTRICT: HUBBARD FARMS
APPLICANT: LUZ JANNET AYALA-MORENO
PROPERTY OWNER: LUZ JANNET AYALA-MORENO
DATE OF PROVISIONALLY COMPLETE APPLICATION: MARCH 4, 2024
DATE OF STAFF SITE VISIT: APRIL 23, 2024

SCOPE: ALTER SIDE PORCH (WORK STARTED WITHOUT APPROVAL), REPLACE WINDOWS AND DOORS, INSTALL VINYL SIDING

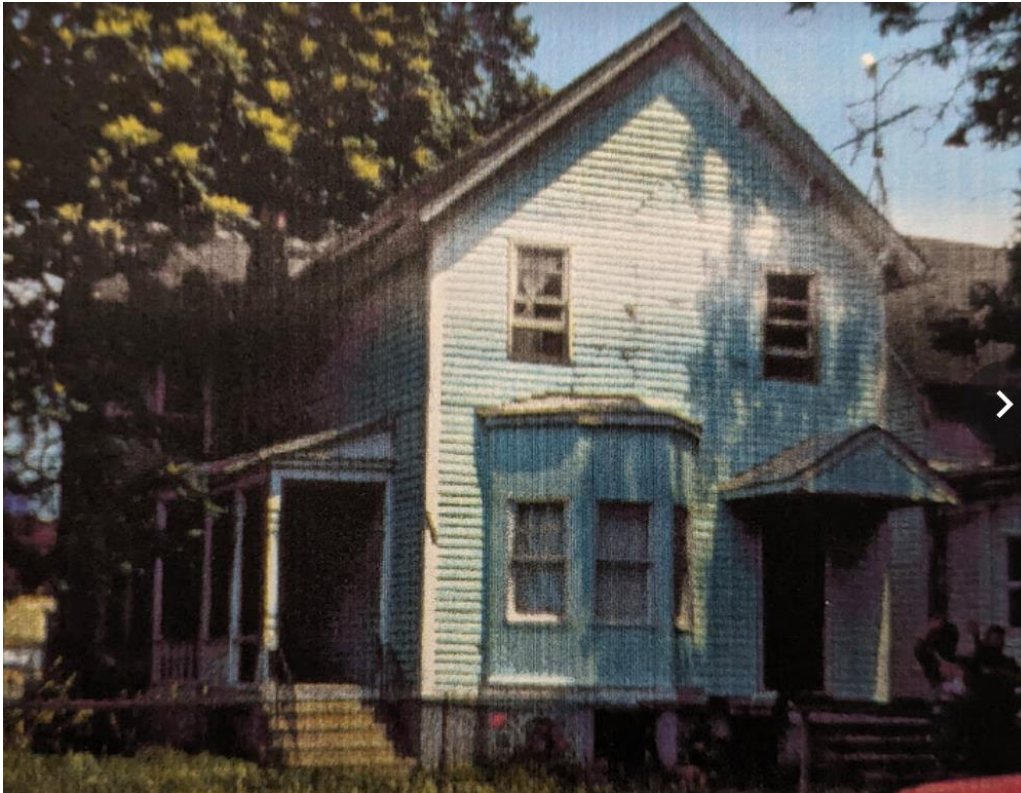
This work can be seen in the earliest available photo of the building, dating from 1993, when the Hubbard Farms Historic District was established. It shows a relatively plain façade lacking in the decorative details that likely once existed on the building. Front porch supports are aluminum and the bay window is clad in a smooth material.

1993 photo by Historic Designation Advisory Board.

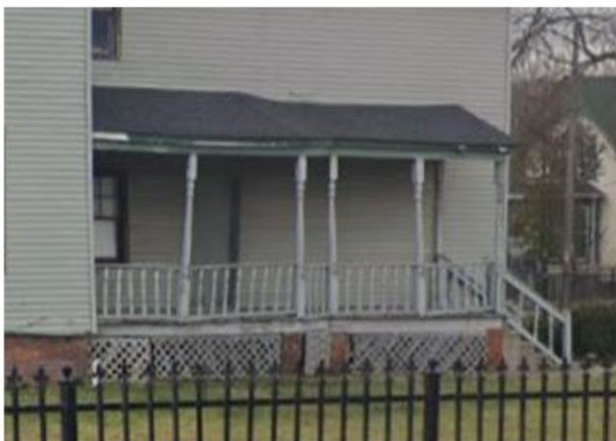
On the side (west-facing) porch, the applicant proposes to remove porch posts and balustrades and replace them with new materials. The proposed porch posts are 5”x5” solid pine posts. The applicant also proposes to add a layer of plywood on top of the existing porch flooring.

Left: 2022 Google image of historic porch. Right: Proposed new posts. Image from product website.

- The applicant has provided photos showing advanced decay of the porch posts and flooring. Google Street View photos also show the porch in a state of deterioration. Staff suggests that partial replacement of some elements is likely warranted, pending further inspection and documentation. (Full replacement is likely avoidable; for example, the rectangular lower portion of a column could be replaced without needing to replace the turned upper portion.)

- A porch repair should generally consist of minimal new material and the retention of most of the existing components. Staff suggests the existing porch is likely not structurally sound enough to be repaired without the insertion of some amount of new wood decking, railings, and columns. However, any new components should match the old, as directed by Standard #6 (quoted below).

- Replacement of porch elements shall be limited to those that are deteriorated beyond feasible repair; new elements must match the old, subject to approval by staff.
- The first and second floor windows shall be double-hung wood or clad-wood sash windows, subject to approval by staff.
- The basement windows shall be installed according to the Glass Block Guidelines.
- The doors shall be wood or metal panel doors with a rectangular vision panel, or no vision panel, subject to approval by staff.
- The color scheme shall be taken from either Color System A (mid-century vernacular), or Color System B (Queen Anne), but not both; or, another appropriate color scheme may be used subject to approval by staff.
