STAFF REPORT: 7/10/2024 MEETING

ADDRESS: 1480 SHIPHERD

APPLICATION NO: #HDC 2024-00086

SCOPE: ERECT NEW ADDITION, ALTER EXTERIOR OF BUILDING

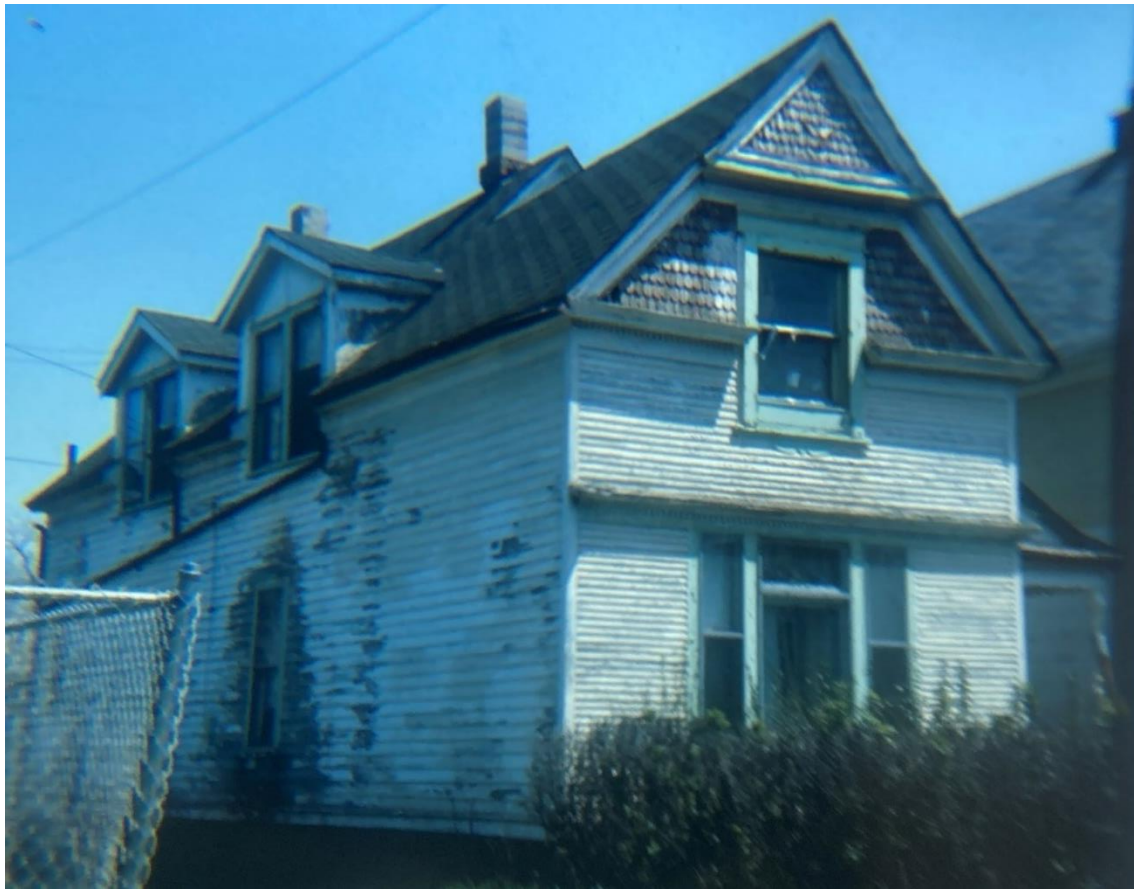
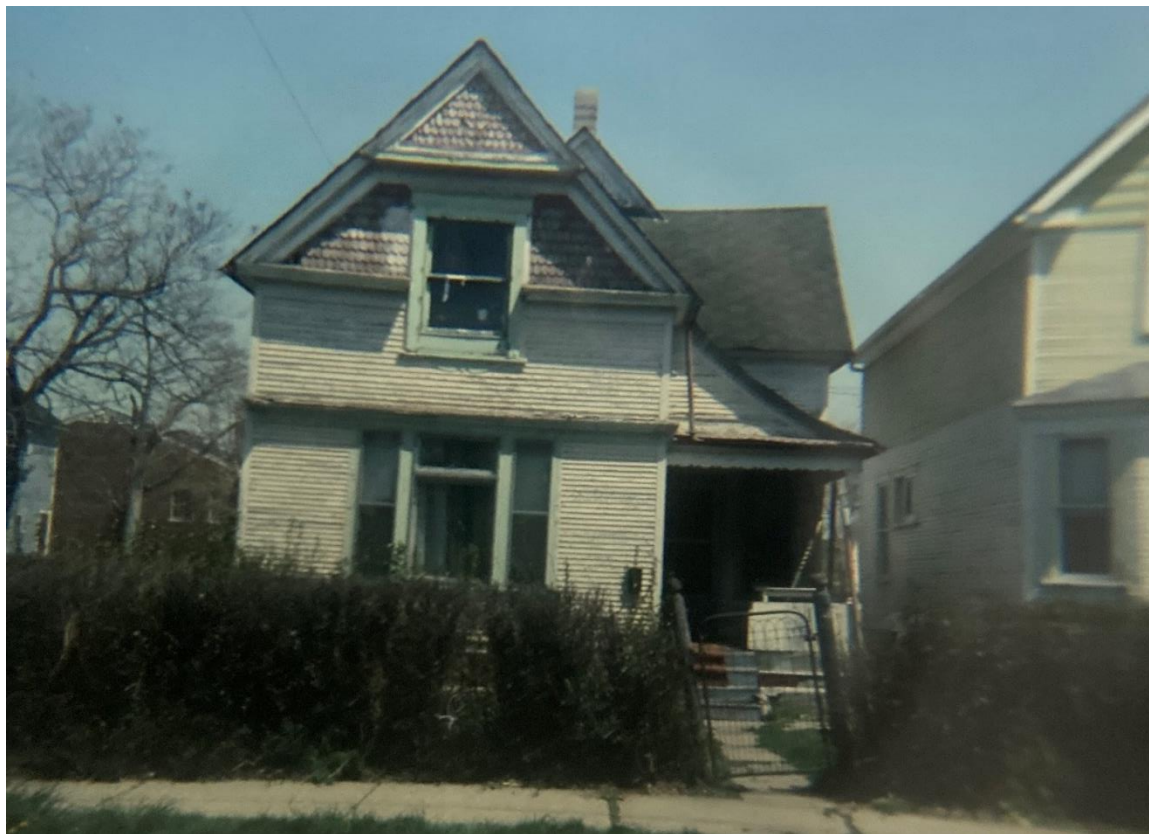
1480 Shipherd, designation slides. Photos taken by HDAB in 1983

- The fish scale shingle treatment proposed for the east gable is not accurate to the sunburst panel siding that was historically located within the gable/removed without approval

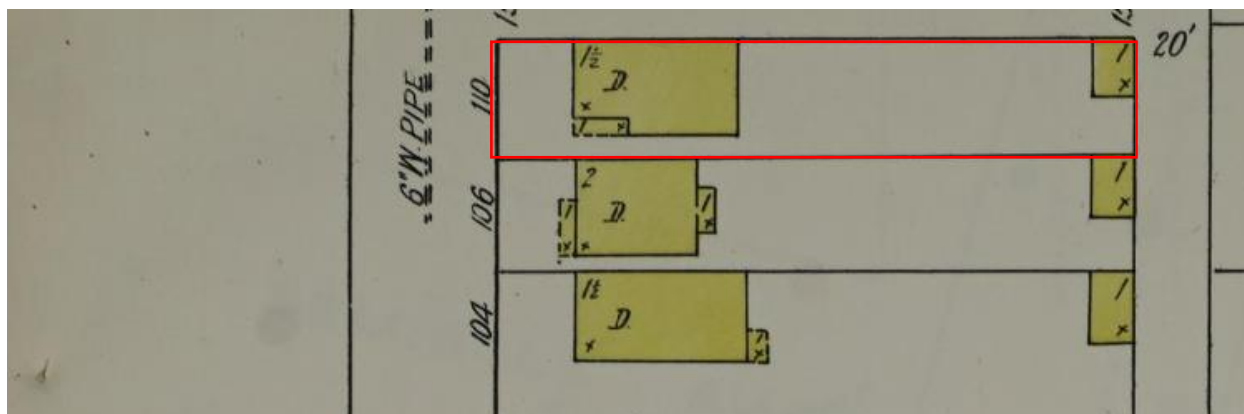
- The below Sanborn Maps indicate that the rear wing that was removed without approval was built sometime after 1910. A review of photos taken of the rear wing prior to its demolition, at both the interior and interior indicate that it was in poor condition and was not at all compatible with the historic character of the original portion of the house. Staff therefore supports its removal.

Sanborn Fire Insurance Map, 1910. 1480 Shipherd, outlined in red

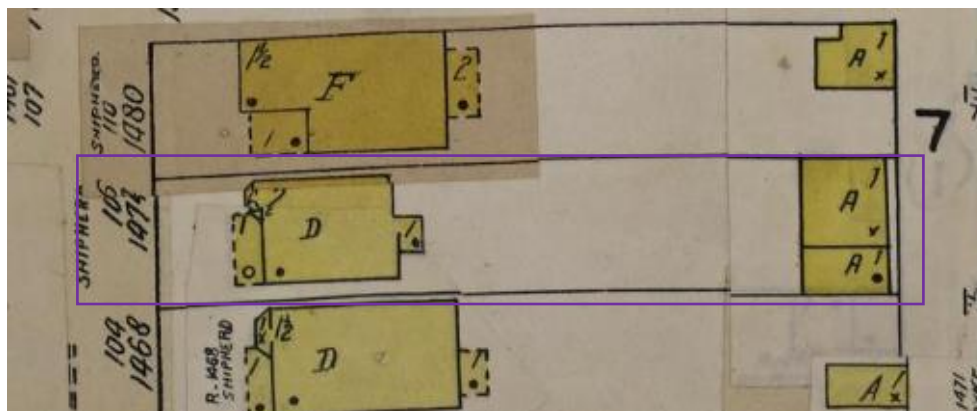
Sanborn Fire Insurance Map, 1921-1951. 1480 Shipherd outlined in purple.
