STAFF REPORT: JULY 10, 2024, REGULAR MEETING
APPLICATION NUMBER: HDC2024-00331
ADDRESS: 1730 EDISON
HISTORIC DISTRICT: BOSTON-EDISON
APPLICANT/OWNER: ANDRE GILBERT
DATE OF PROVISIONALLY COMPLETE APPLICATION: JUNE 12, 2024
DATE OF STAFF SITE VISIT: JUNE 24, 2024

SCOPE: REPLACE WOOD WINDOWS WITH ALUMINUM-CLAD WOOD WINDOWS

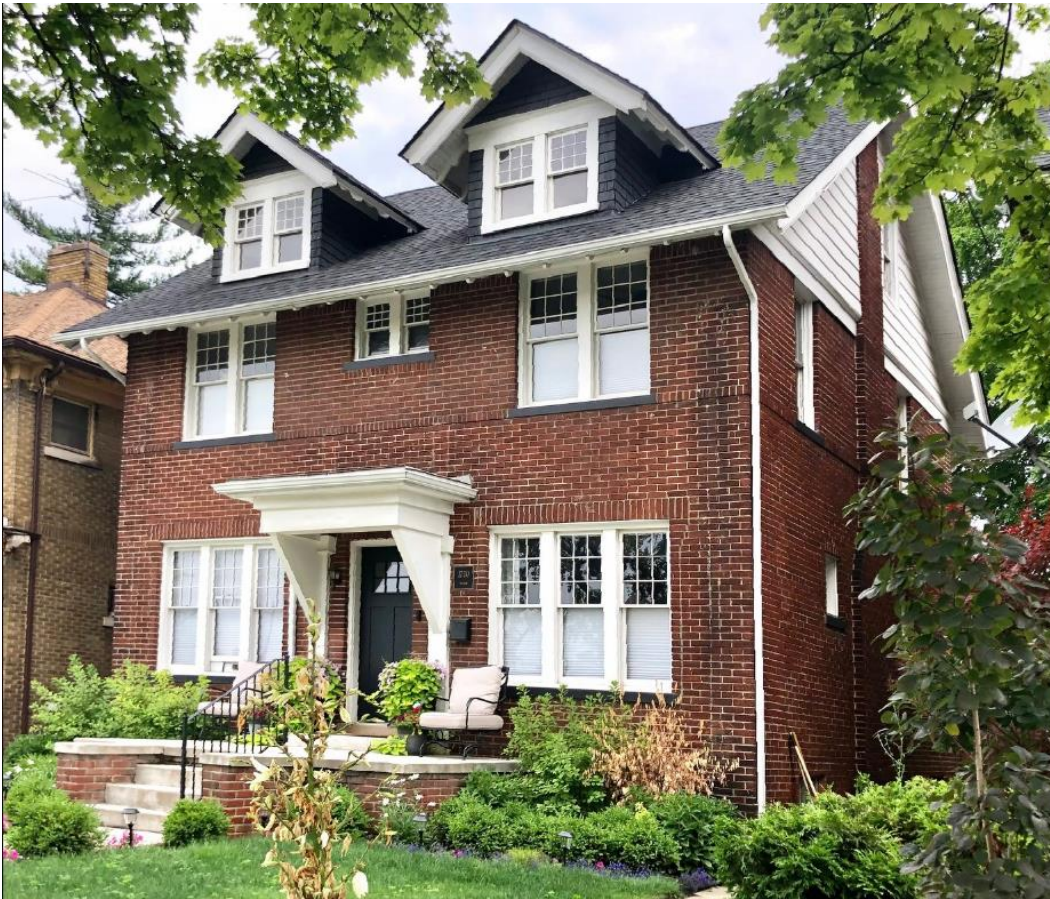
House with garage in background. April 2023 photo by staff.

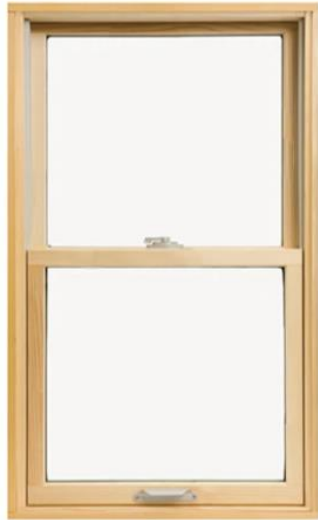
- The proposed Pella window replacement product closely approximates the dimensions and operability of the existing windows.

Interior view of Pella Lifestyle window. Image from product website.
