**STAFF REPORT:** AUGUST 14, 2024 MEETING

**APPLICATION NUMBER:** HDC2024-00114

**ADDRESS:** 14539 ARTESIAN

**SCOPE:** REPLACE WINDOWS WITH VINYL WINDOWS

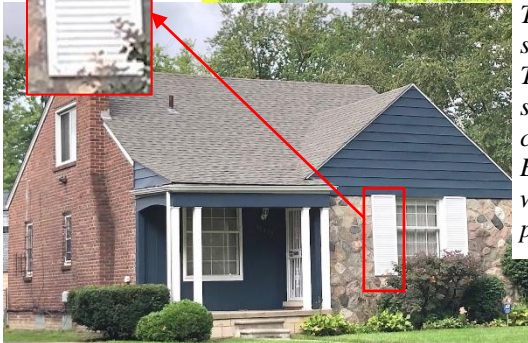
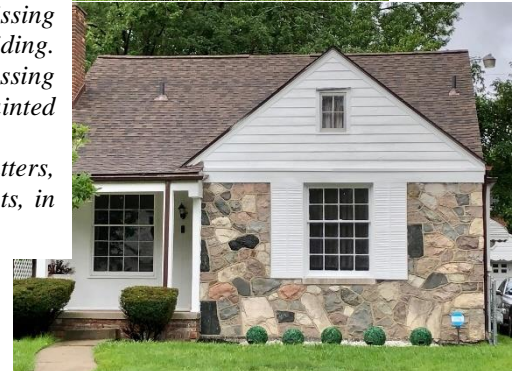
- There is also no record of HDC approval for the removal of the shutters at the front window, which are seen in the above designation photo. As noted in the current condition, this wall surface is brick, rather than stone, and was not meant to be uncovered. The shutters are a distinctive character-defining feature and a common detail on this sub-type of mid-century dwelling within the Rosedale Park historic district, as demonstrated in the below photos.

Top left: 14539 Artesian. Brick where missing shutters were located is painted to match siding. Top right: 14540 Greenview is also missing shutters and is more evident in unpainted condition.

Bottom photos are examples of historic shutters, which have very thin horizontal wood slats, in place.

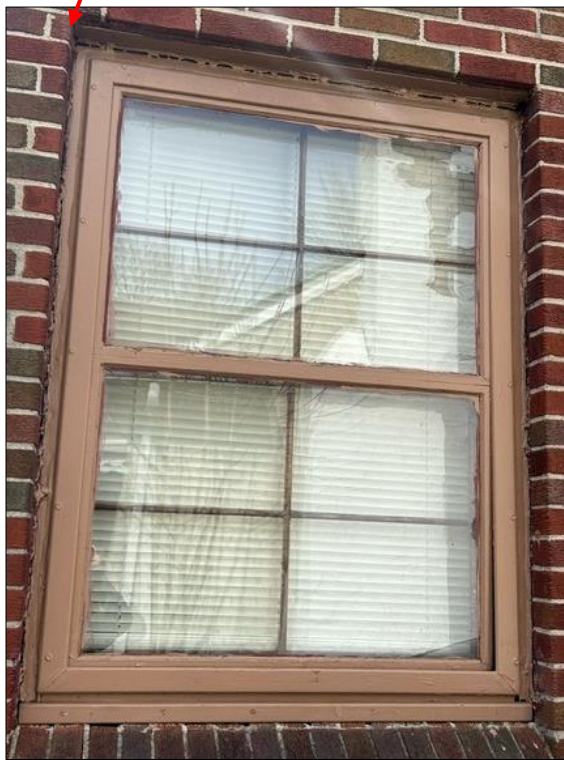
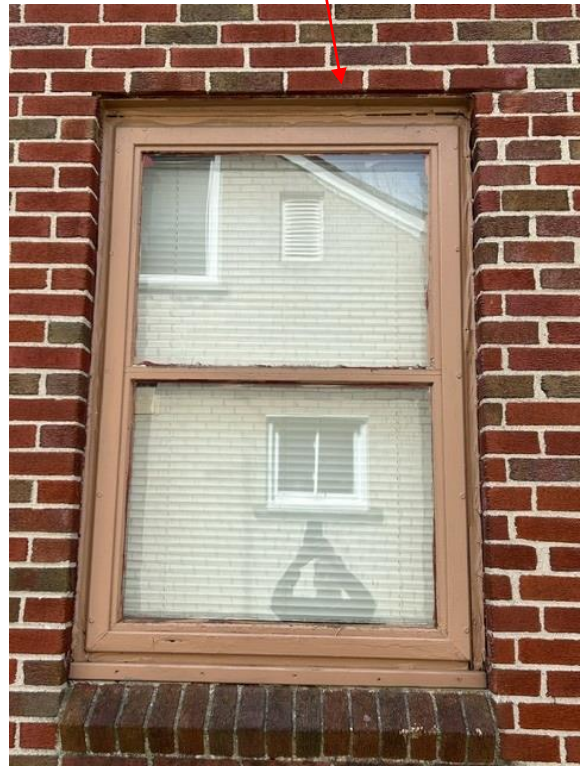
*North (side) wall. Applicant photos.*

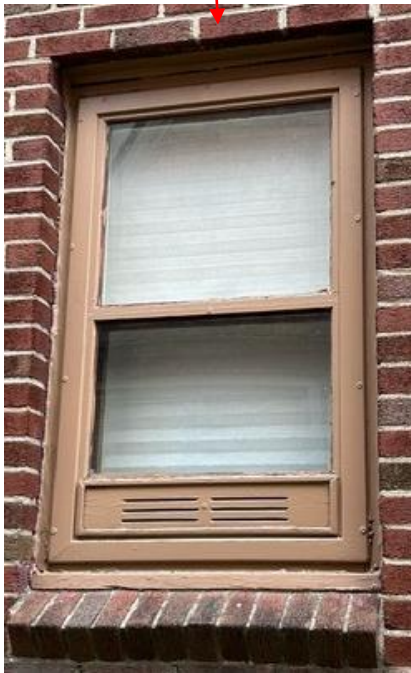
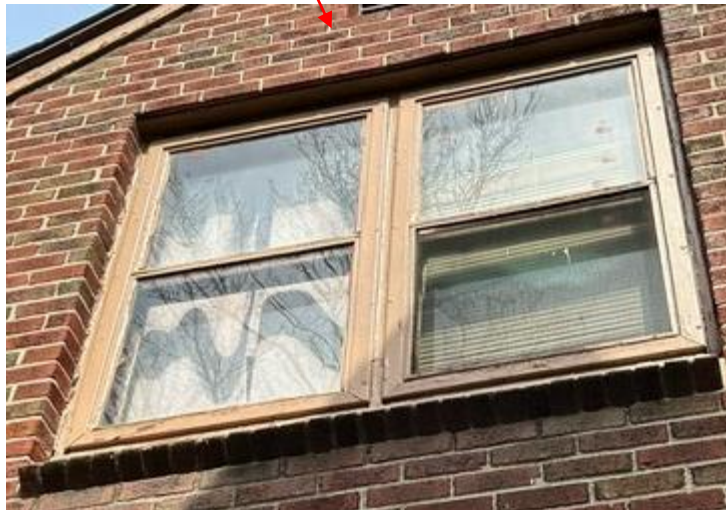
*South (side) wall. Applicant photos. This photo shows a little bit of the other glass block window (boxed in yellow) that flanks the chimney.*

- Also, when windows are removed without Historic District Commission approval; based on the Standards, new windows should match all the details of the historic windows that were removed. Therefore, the replacement of the three glass block openings should be completed with wood (or aluminum-clad wood) one-over-one double-hung windows.
