STAFF REPORT: SEPTEMBER 11, 2024 MEETING

APPLICATION NUMBER: HDC2024-00424

ADDRESS: 15302 PIEDMONT

SCOPE: REPLACE WOOD WINDOWS WITH FIBERGLASS WINDOWS

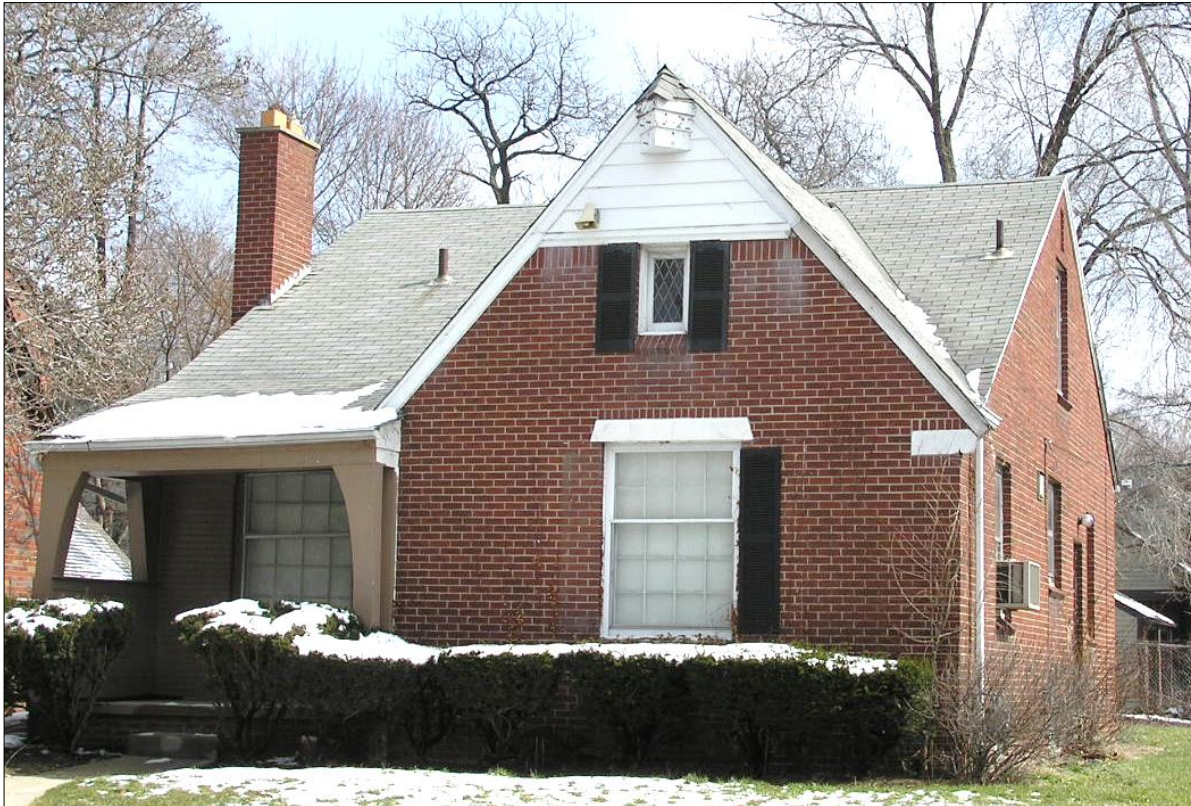
2007 designation photo, HDAB.

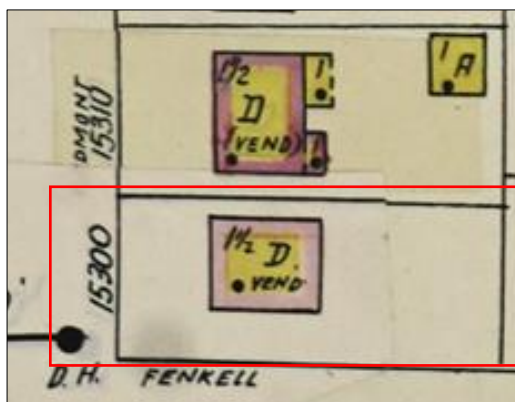
Vol. 25 Sanborn Map, 1950.

- The house was erected in 1948 and, according to the 1950 Sanborn map, did not include a rear porch or extension. Staff did not find a record of when the rear addition was erected. However, according to an October 2007 Google street view image, it was in place at time of district designation.
