STAFF REPORT: DECEMBER 11, 2024 MEETING

APPLICATION NUMBER: HDC2024-00674

ADDRESS: 1783 IROQUOIS

SCOPE: REPLACE WOOD WINDOWS, REPAINT EXTERIOR

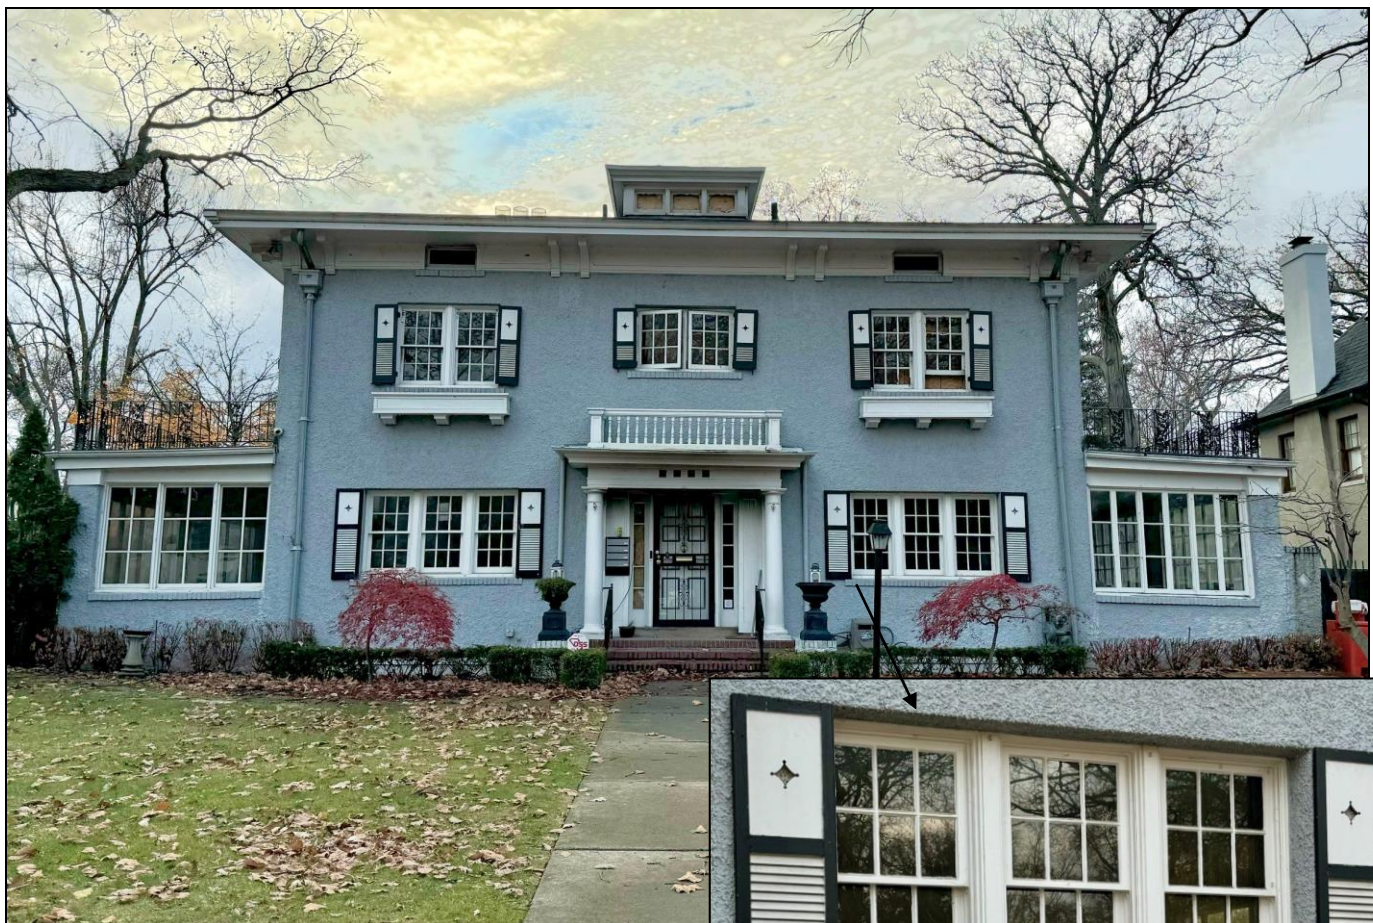
Facade of house. Staff photos, November 26, 2024.

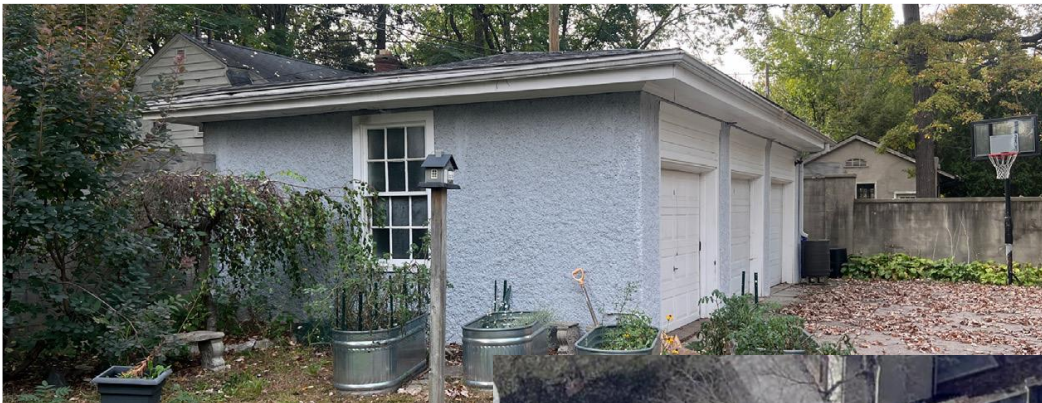
Above: Applicant photo.

A three-car garage is located at the northwest corner of the lot. The stucco walls, six-over-six double-hung window, and very low-pitched hip roof combines for a design that mimics the house's cladding materials, overall form and window openings. A concrete wall runs along the side and rear property lines and closes off the rear yard to the public alley; the walls end adjacent the front corners of the house.

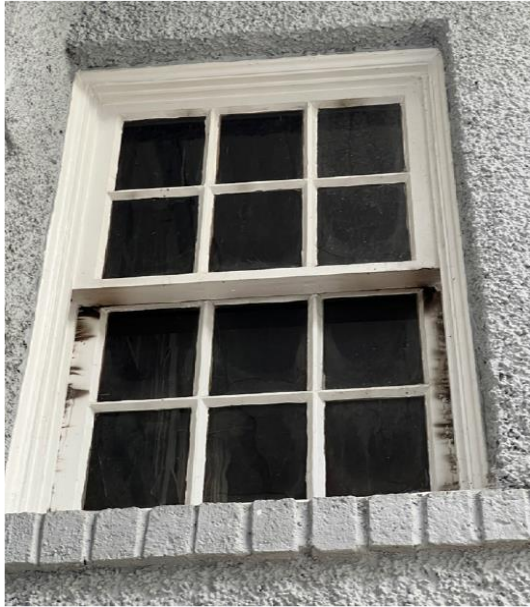
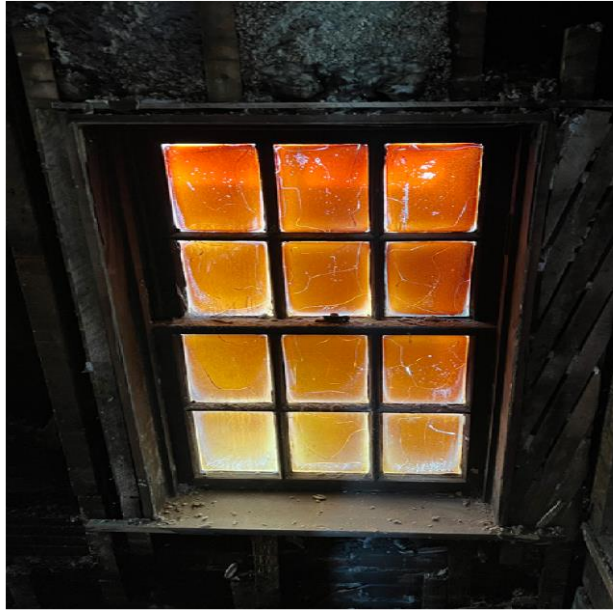
Applicant photos.

- According to staff’s research on immediate and lasting effects of fire damage, it is possible for fire to stress glass in way that, although intact, it has become extremely fragile and may break by a tap or a push. Intact wood frames might also have damaged seals and/or weakened integrity, and smoke can linger in the wood frames and cavities where operational components, such as the sash cords, are housed.

- Based on the technical and economic feasibility standard due to the level of confirmed and probable deterioration due to fire, staff believes the existing windows are deteriorated beyond repair. It is also staff's opinion the selected replacement windows may be an accurate replication of the historic wood windows and window trim.
