STAFF REPORT: DECEMBER 11, 2024 MEETING

APPLICATION NUMBER: HDC2024-00570

ADDRESS: 751 CHICAGO BOULEVARD

SCOPE: REPLACE FRONT DOOR AND TRANSOM

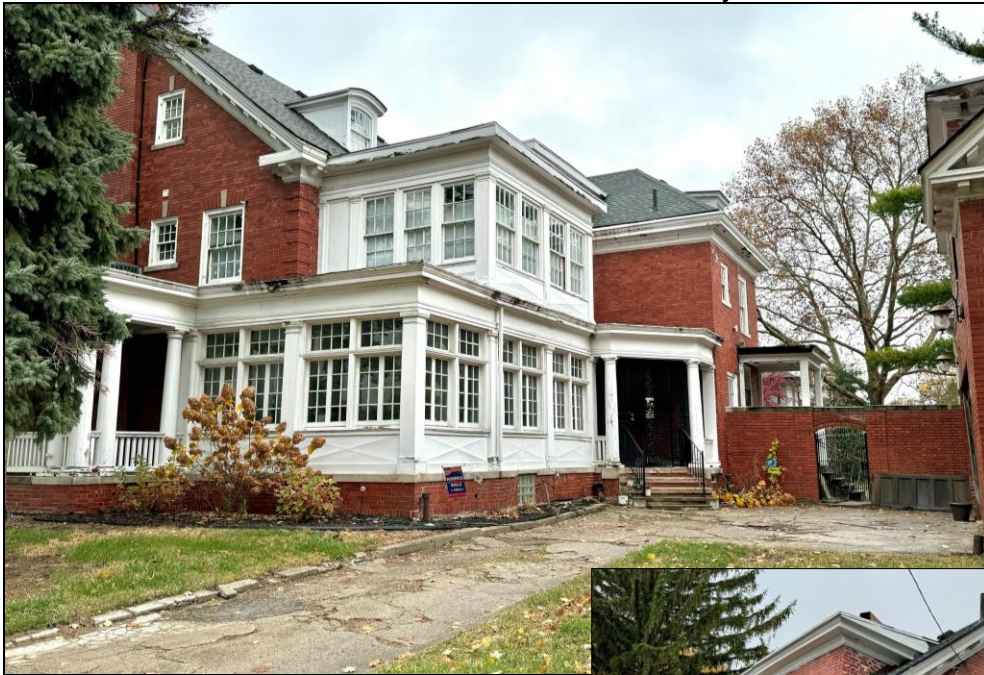
Above: Rear of house, looking northeast from Third Avenue sidewalk.

The rear of the house contrasts the mostly flat-fronted façade with large projecting elements. At the first floor, an enclosed porch spans the distance between the open side porch and another small open porch that leads to the driveway. Square Ionic columns and grouped windows sitting on low walls span both sides of the enclosed porch. Directly above, a smaller, but similarly designed porch extends from the rear wall of the house. A two-story masonry wing with hip roof has a small raised and covered entrance that leads to the backyard that is enclosed by masonry walls.

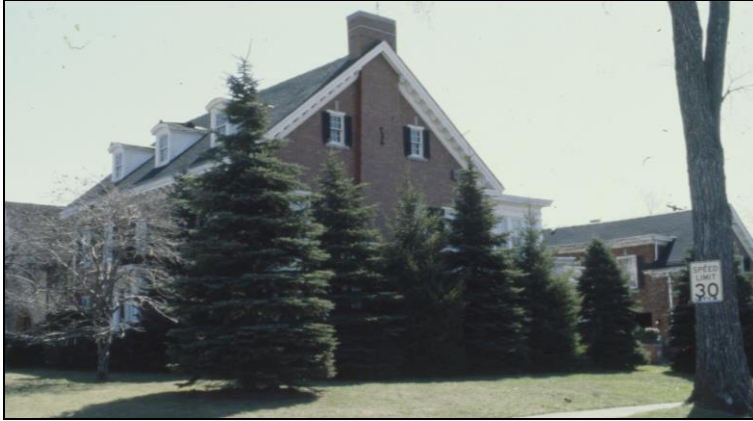
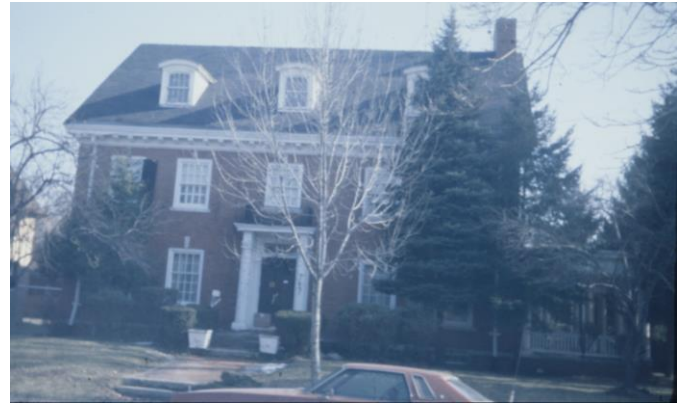
*Above: Looking southeast from Chicago Boulevard and Third Avenue, 1980. HDAB
Right: Façade, 1988. HDAB*

- The 1980 photo shows the evergreen trees at the side porch (visible in the side view 1974 designation photo on the preceding page) have grown to fully enclose the porch from public view.

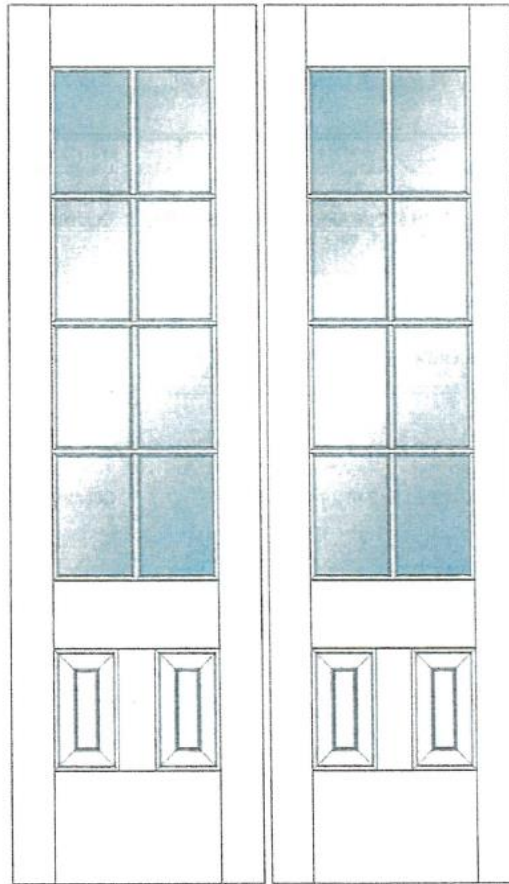
Applicant's proposed design for new doors.

- The installation of the new doors and undivided glass transom would impart a design that would alter the features that comprised the historic and architecturally distinctive portico/front entrance.

- The French doors and leaded glass transom are character-defining features, and the applicant has not provided information to support that they are beyond repair. Therefore, replacement products should not be considered at this time. Additionally, when windows and doors are beyond repair, the Standards require that the new components must match the old in design, dimension, and operation.
