STAFF REPORT: MARCH 25, 2025 MEETING

APPLICATION NUMBER: HDC2024-00599

ADDRESS: 1610 EDISON

SCOPE: INSTALL WINDOWS AT REAR PORCH

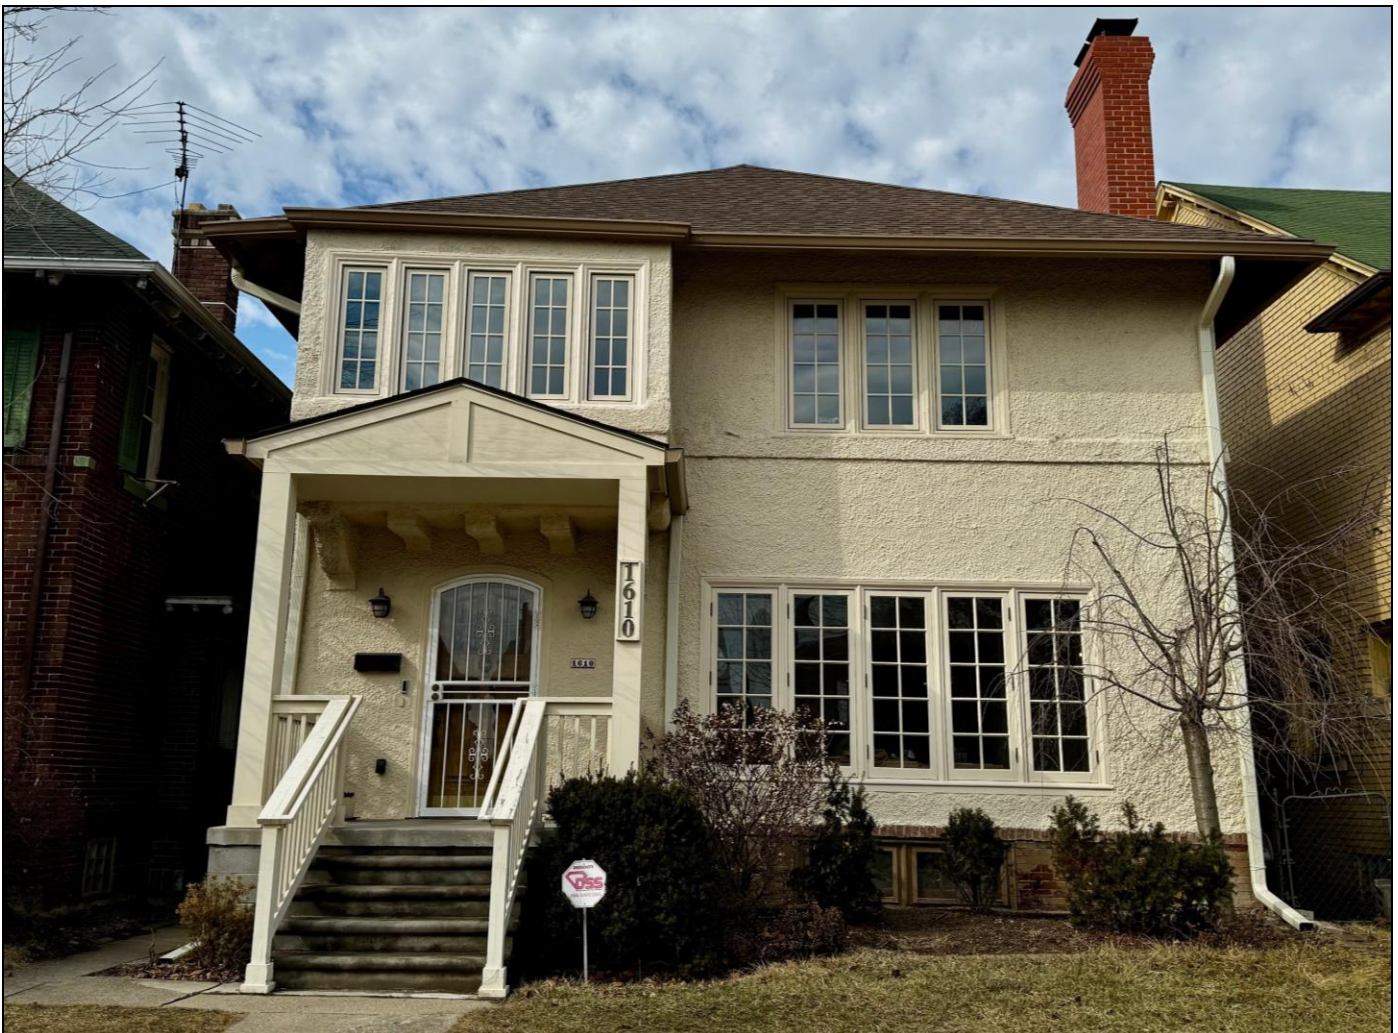
Facade. HDC staff photo, February 28, 2025.

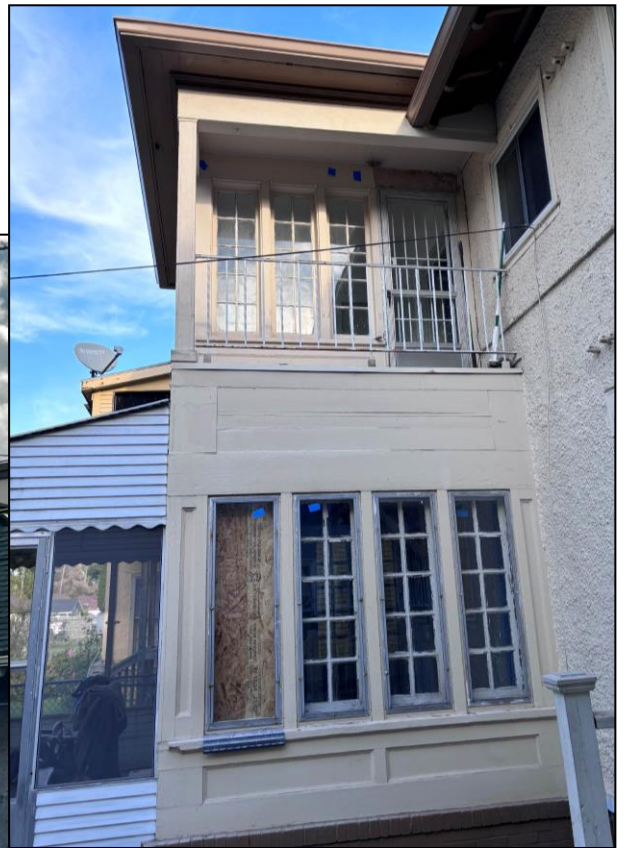
Above: View of west wall that faces the rear yard. Applicant photo.

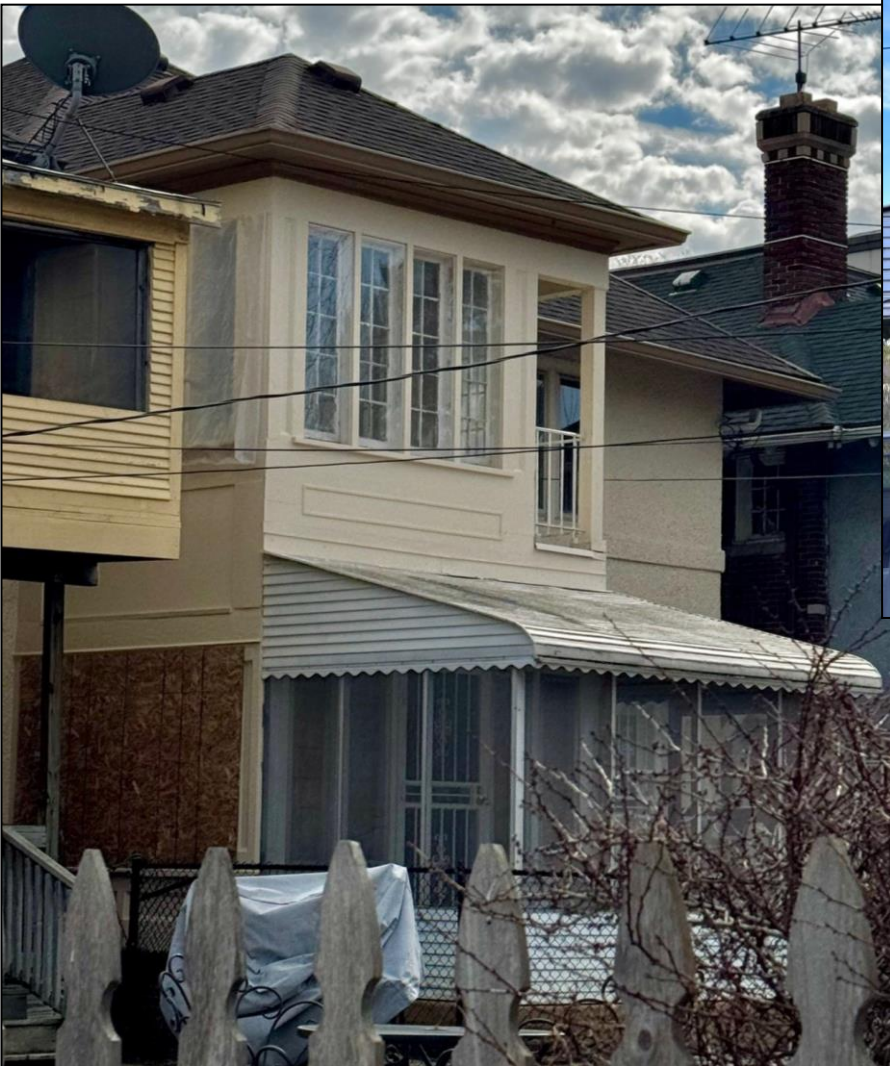
A two-story extension sits at the northeast end of the rear wall. Grouped casement windows are on each wall. A single door at the first floor leads out to a covered aluminum screened porch, and a single door at the second floor leads to a small open, covered porch. The extension has a hipped roof that matches the main roof, and the walls are painted wood.

Left: View of rear/north wall and partial view of east/side wall. Taken from sidewalk on Woodrow Wilson Street, looking southwest. Staff photo, February 2025.

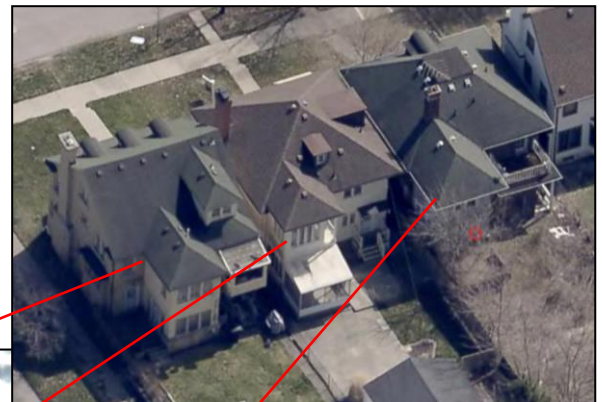
- Moving to the rear of the lot, staff noted that the three houses on the northwest corner of Edison and Woodrow Wilson have similarly-designed rear extensions. With the two-story massing, hip roof and flat wall space and multiple grouped window openings, the second floors of the extensions were likely sleeping/sun porches that were enclosed many decades ago. Based on the condition of the enclosures, staff believes the overall design and placement of these extensions are historic age and still read as early 20th century architectural building components.

Left: Rear walls of (from left) 1602, 1610 and 1616 Edison. Staff photo, February 2025.

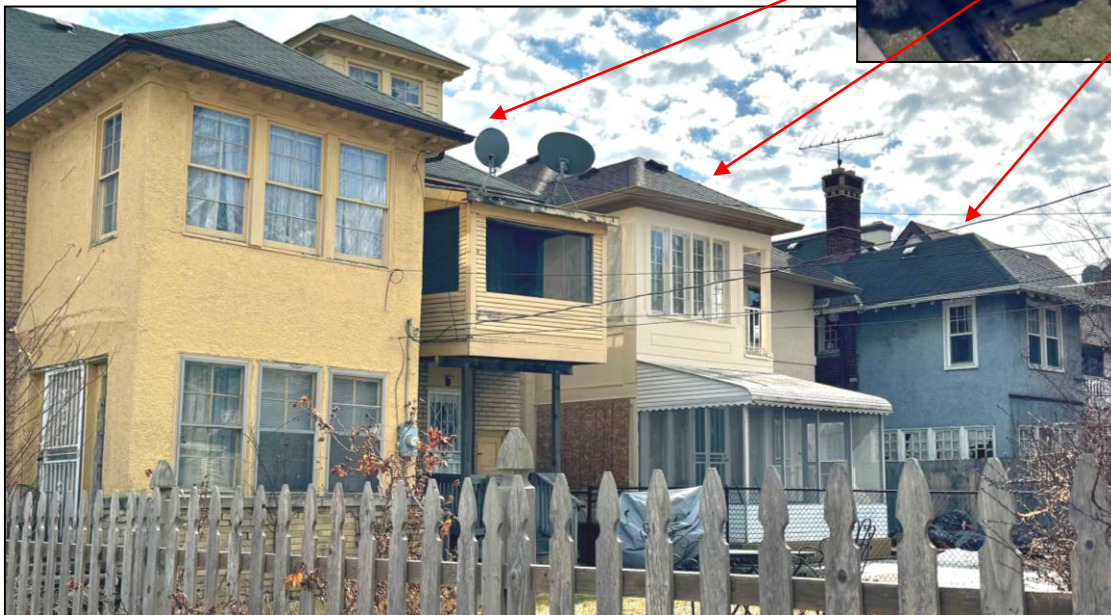
- The dissimilar design treatment to the half-walls below the grouped windows, and the small open porch suggest the exterior walls were modified at some point in time. The white aluminum railing matched the design of the 1970's-era aluminum railing at the front porch (a photo comparison of the front and rear porch rails is on page 8), so it is possible these walls were changed at that time.

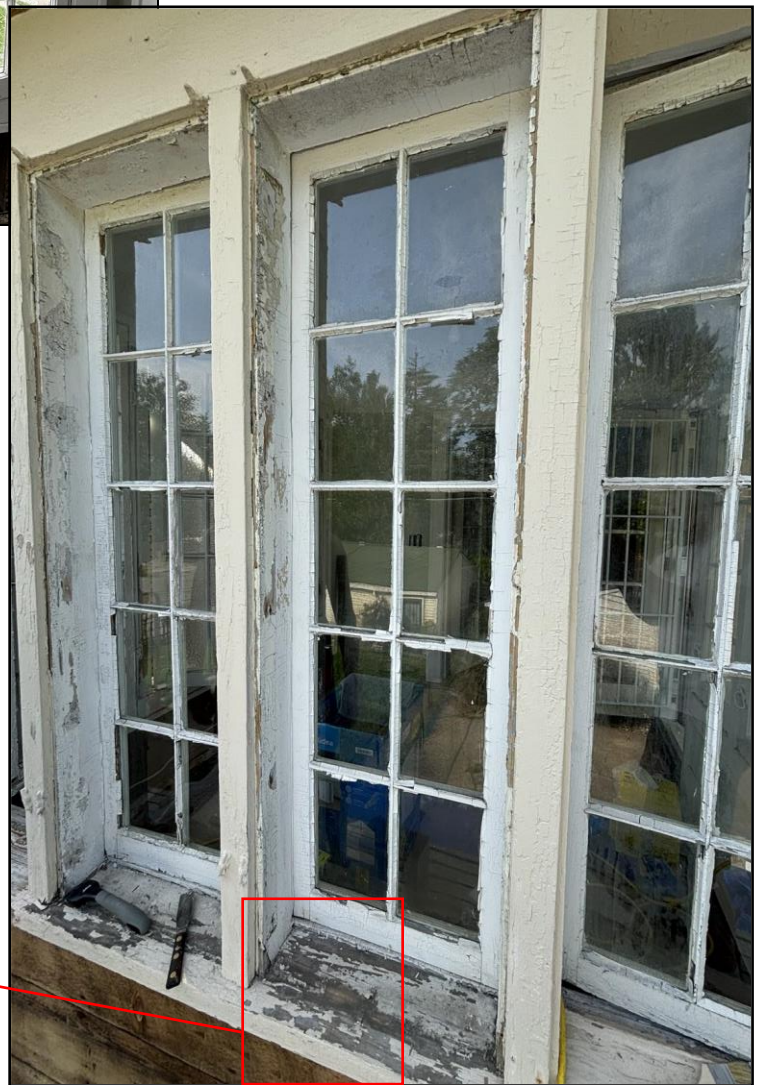
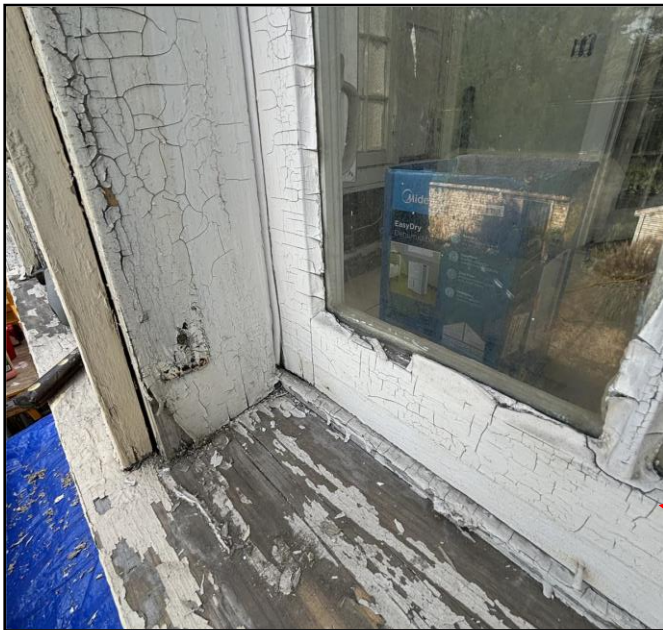
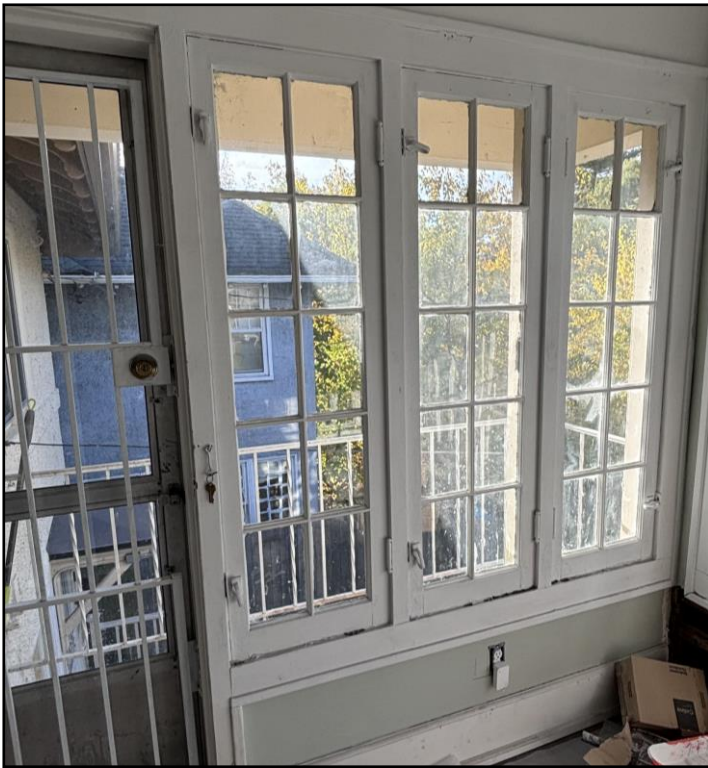
- The interior and exterior photos submitted by the applicant show the windows to be intact (with the exception of one missing window on the east wall) and in repairable condition.
- The applicant mentions in the “Description of Existing Conditions” part of the application form, that the water problems which caused deterioration to the interior porch walls are directly related to the current sills and how they were constructed. It is possible to fabricate new sills (and mullions, if needed) and reinstall the existing casements after the windows are repaired.

Interior and exterior views of the side-west wall and windows. The white aluminum railing has alternating twisted and straight simples, identical to the railing that had been installed at the front porch. Applicant photos. Bottom right photo is circa 2018.

- The window opening which is missing a window sash is on the public-facing elevation of the extension and should match the historic windows in all ways – including operation, material, finish, dimensions, profile(s), color and placement within the opening.
