STAFF REPORT: MARCH 25, 2025 MEETING

APPLICATION NUMBER: HDC2025-00032

ADDRESS: 8101 ST. PAUL

SCOPE: INSTALL ALUMINUM SIDING AND TRIM

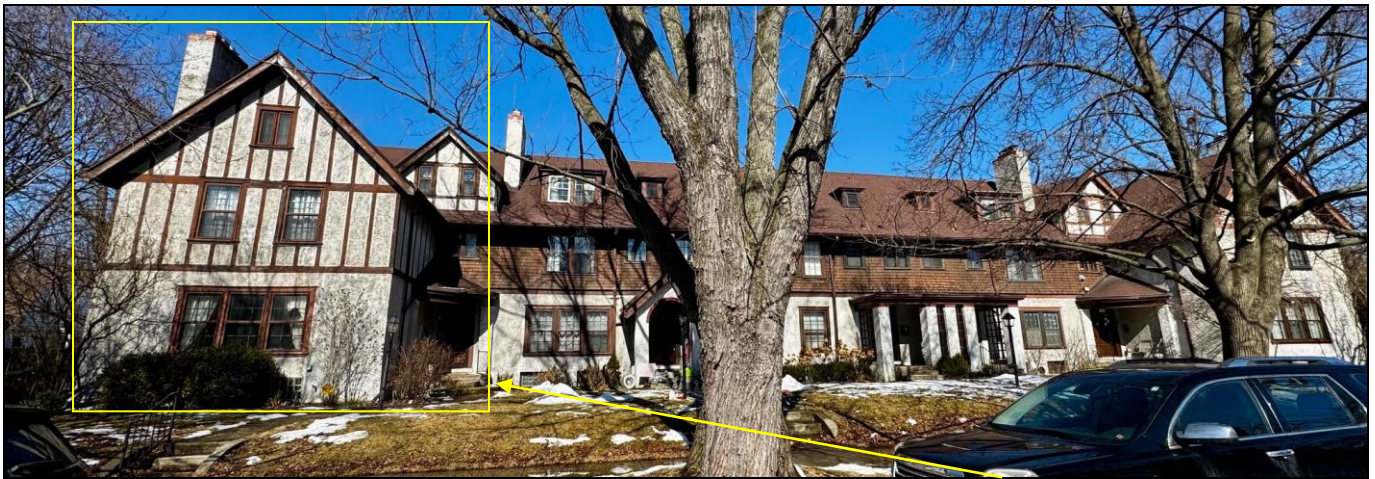
View looking north of the building's façade facing St. Paul. 8101 St. Paul is at the left end of this photo. Additional views of 8101 St. Paul are below. Staff photos, February 25, 2025.

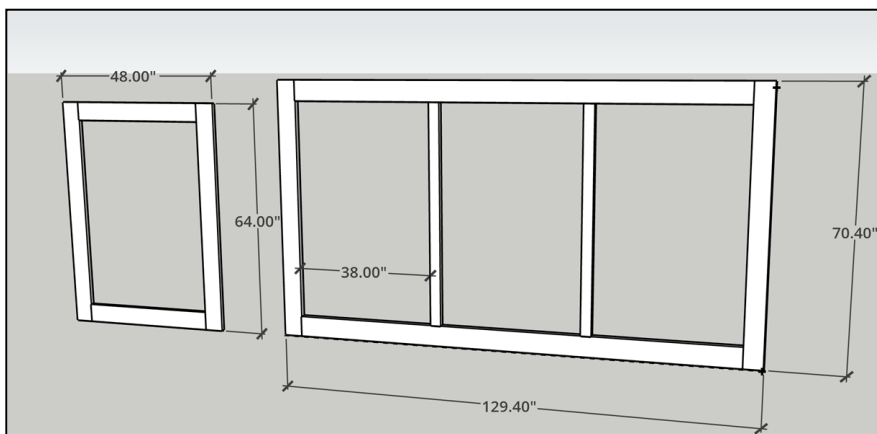
- The photographs also confirm the wood window trim is in good, repairable condition. Standard Six states, "Deteriorated historic features shall be repaired rather than replaced."

- The wood window casings are set within the stucco, and its removal may cause additional damage to the surrounding stucco finish, and staff expects the trim would need to be wider to compensate for the small areas where the existing horizontal trim extends beyond the vertical casings.

- The proposed wood trim is flat with square edges and doesn't match the details, dimensions and profiles of the historic wood trim.
 - Wrapping wood trim with aluminum emphasizes the flatness of a contemporary trim, as well as imparting a sheen which is incompatible with historic buildings.

Top: HDC staff photo, February 2025.

- As the features are not deteriorated beyond repair, it is premature to consider a proposal to replace the historic trim and mullions. However, as information was submitted for replacement trim, staff will offer the following comments:

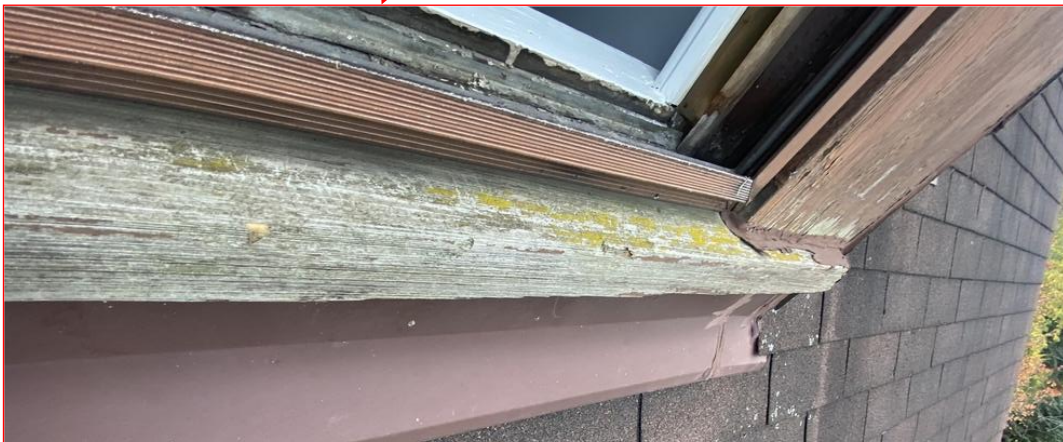
- Regarding the two dormers, the applicant proposes to remove deteriorated wood on the north and west dormer and then install aluminum “siding” around the dormers. Similarly to the photo documentation for the windows, the face trim around the windows is solid. The wood appears to need scaping, surface prep and painting, and perhaps wood epoxy filler, but it is not deteriorated beyond repair.

Above left: Rear wall dormer. The only area that shows any level of deterioration is near the bottom where water may pool due to the horizontal surface. Sanding, priming and repainting these surfaces is possible.

Above right: West-side dormer. The wood surfaces around the windows appears to have more flaking paint, likely due to its exposure to the sun. Again, repair can consist of surface prep, filler if necessary, and repainting.

- The dormer walls are covered with asphalt roof shingles. This design treatment is not approved by the Commission, so any repair work at this area would require removal of the asphalt shingles and repair of the wood siding that likely remains on the dormer walls. The small roof dormers with shed roofs and wide, flat trim surrounding the windows are minimally designed so that they are secondary features to sit quietly against the roof. Manufactured products, through their materiality, dimensionality and sheen, whether it be cementitious siding or an aluminum product, applied to these dormers would be clearly noticeable and detract from the general characteristics of this structure and its period of construction.
