ADDRESS: 4071 LESLIE**APPLICATION NO: HDC2025-00014****HISTORIC DISTRICT: RUSSELL WOODS-SULLIVAN****APPLICANT/CONTRACTOR: ALEXANDER BELILOVESKY/ALEXANDRIA
MANAGEMENT****OWNER: DARIN BARNES****DATE OF STAFF SITE VISIT: 2/25/2025****DATE OF PROVISIONALLY COMPLETE APPLICATION: 02/18/2025****SCOPE: REPLACE STEEL CASEMENT WINDOWS****EXISTING CONDITIONS**

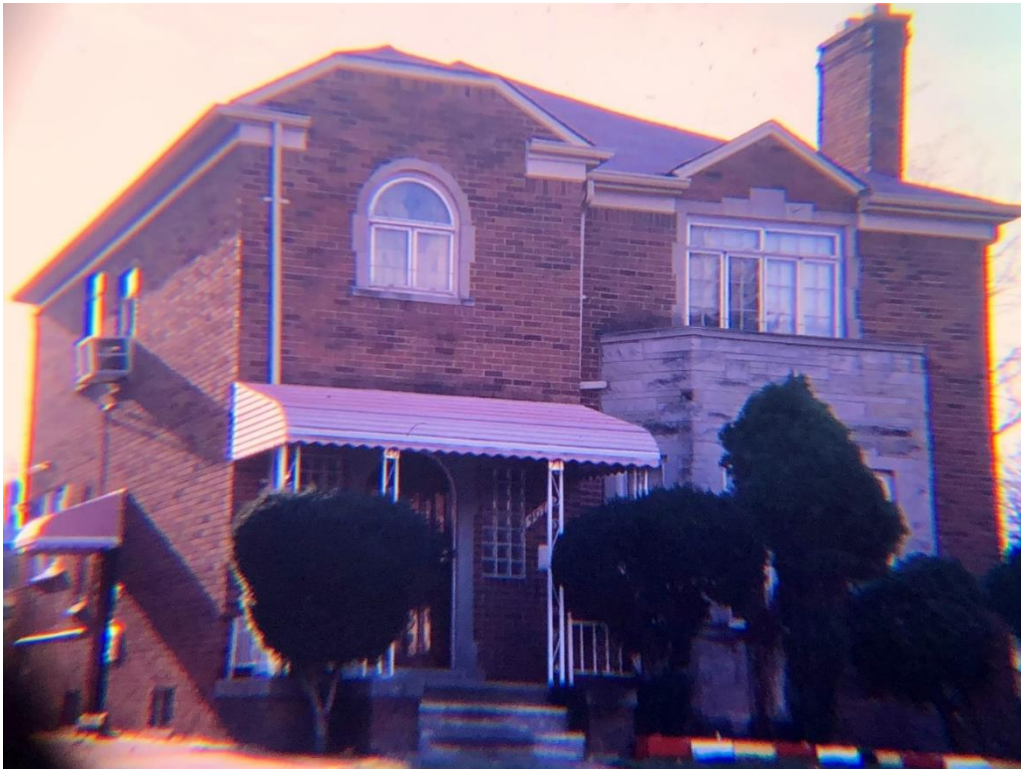
- See the below designation photo of the building to note the following:
 - The windows which flank the primary entrance were glass block at the time of designation.

- The aluminum awning which was installed in 1967 per building department records was extant at the time of designation
 - A window air conditioner condenser unit was present at a second-story, side façade window at the time of designation

Designation slide, taken in 1999 by HDAB

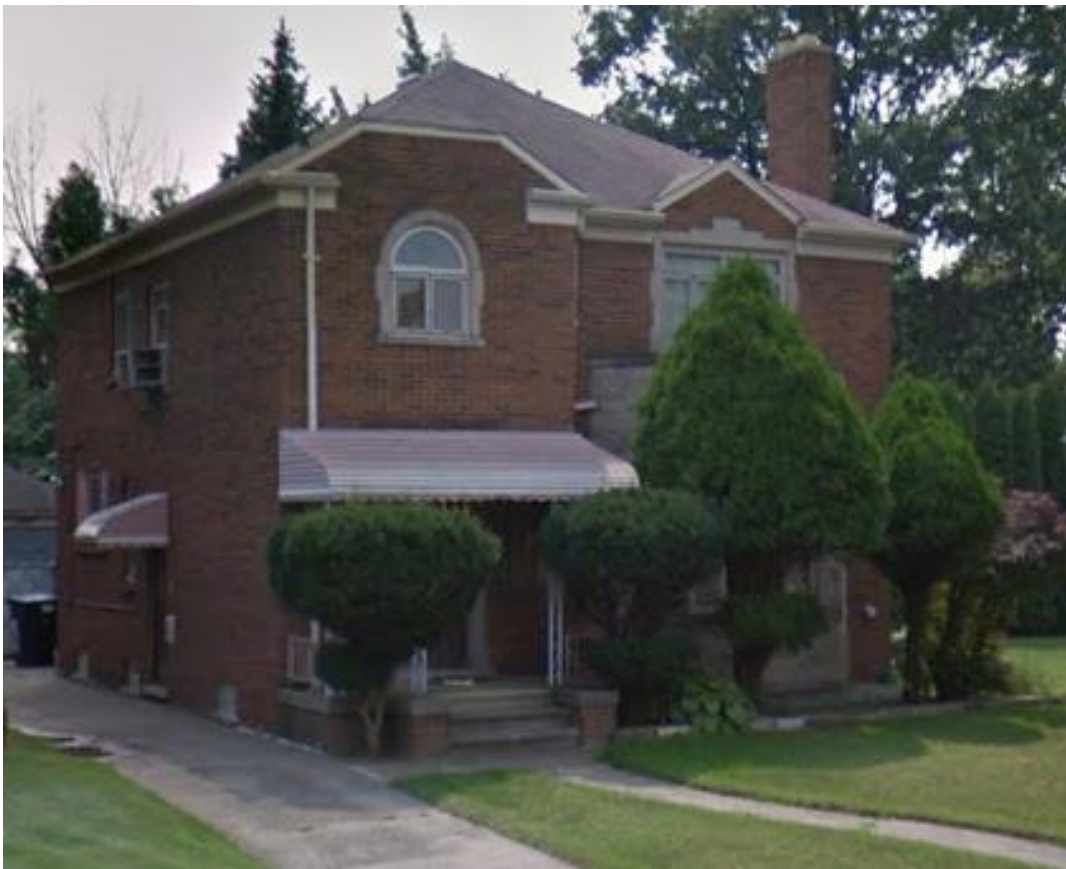
- Per the below images, the front façade glass block windows which flanked the front door, the awnings which were installed in 1967, and front yard foundation plantings were removed without HDC approval sometime between 2013 and 2018, by a previous owner

Google Streetview image from 2013. Note that the house appears much as it did at the time of the district's designation. Specifically, the awnings, foundation planting, and glass block windows at the front façade, flanking the front door, still remain
