Confidential Inspection Report

221 E. Boston
Detroit MI 48202

May 24, 2019

Prepared for: Evan Faye

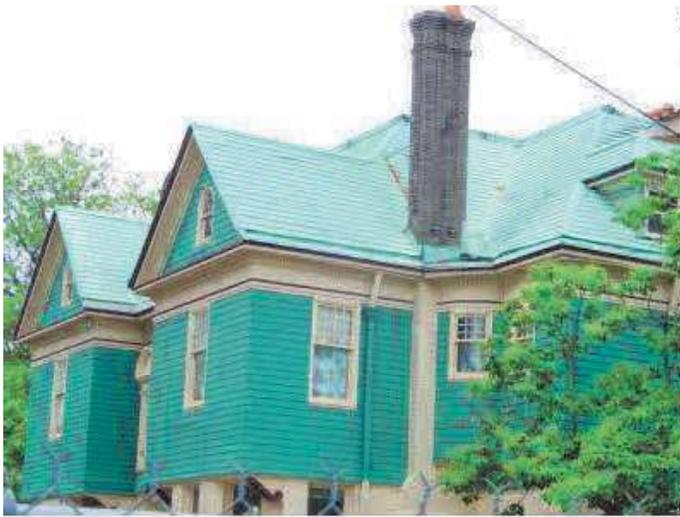
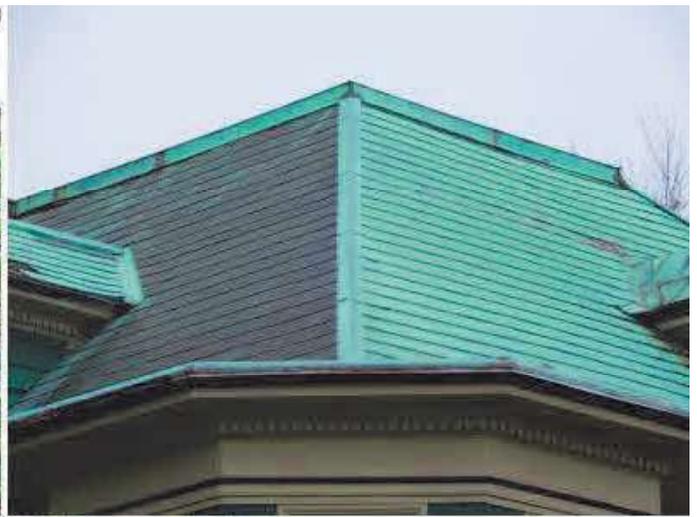
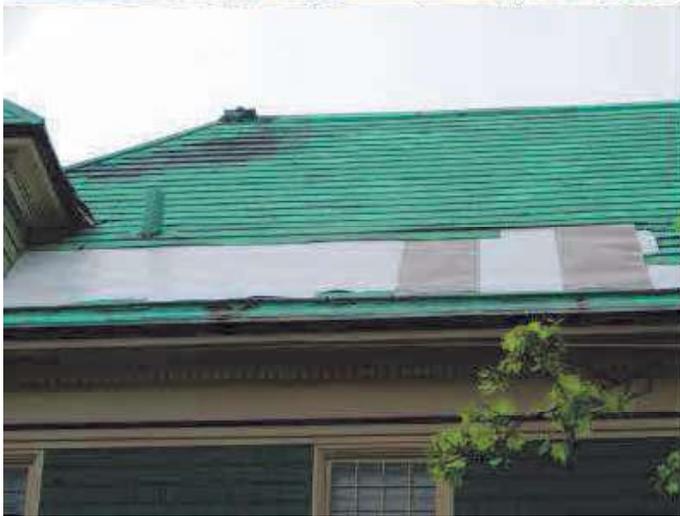
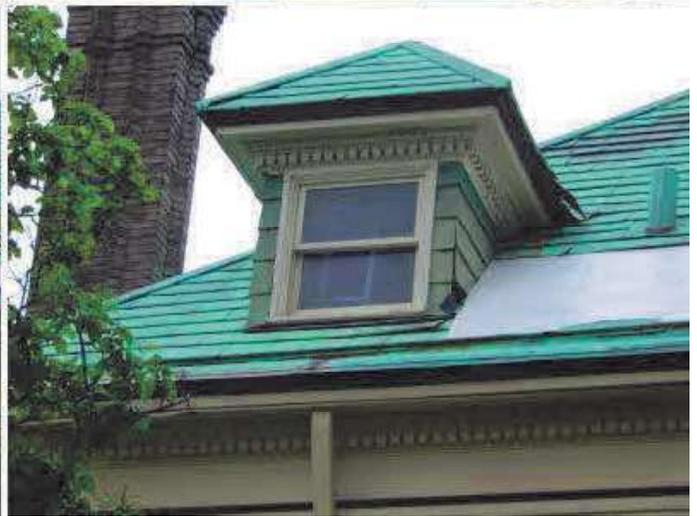
Added Space: Even without building an addition on top of your already existing roof, mansard roofs provide extra living space when compared to other types of roofs. Because all four sides of the roof are steeply sloped in a box shape, it is easy to convert the attic space into a loft or an extra bedroom if needed. This is a metal roof.

Metal, a terne roof is present in some areas. This is generally good material but is seldom used anymore.
